Woodbank House, Balloch Inspection Report

v01. 08/06/2017

Barham Glen Architects Ltd

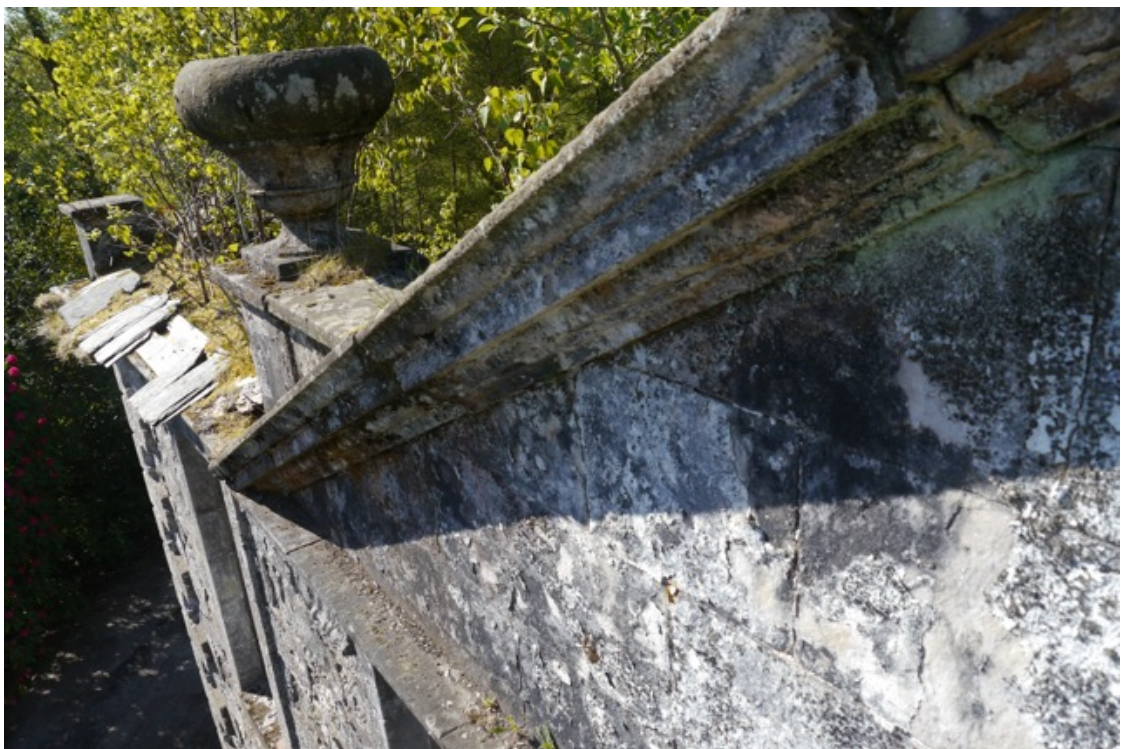
Above and below - pediment stonework is relatively sound.

The base of the pediment presents a different case and should be revisited when works progress - if possible, if the stones in this area are in salvageable condition every effort should be made to retain them in-situ as they provide the base to the pediment above.

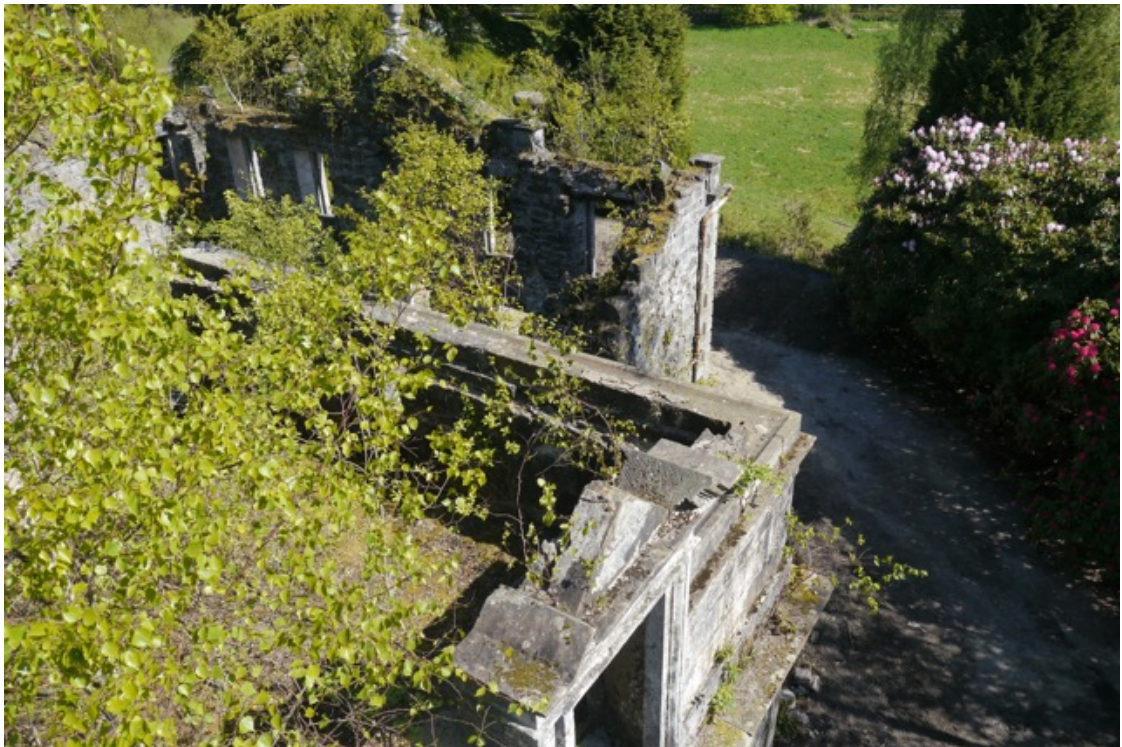
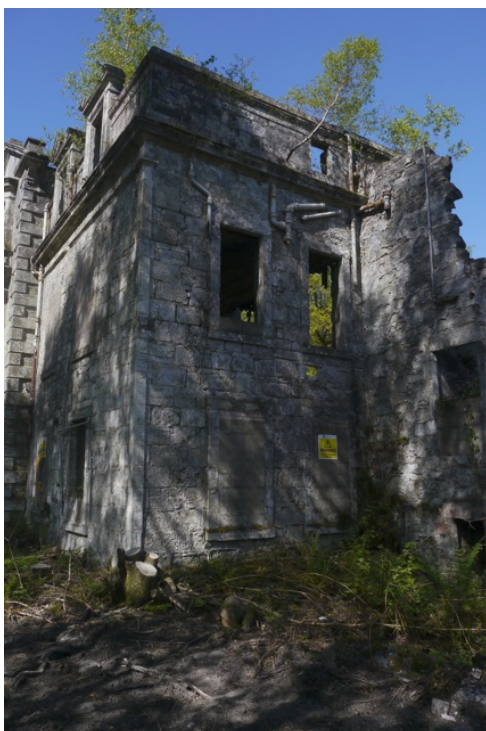
Rear east gable and parapet.

For this reason this wall should be retained and repaired to match as closely as possible its original form, including the re-bedding of cope stones (if sound) or their replacement (if not).

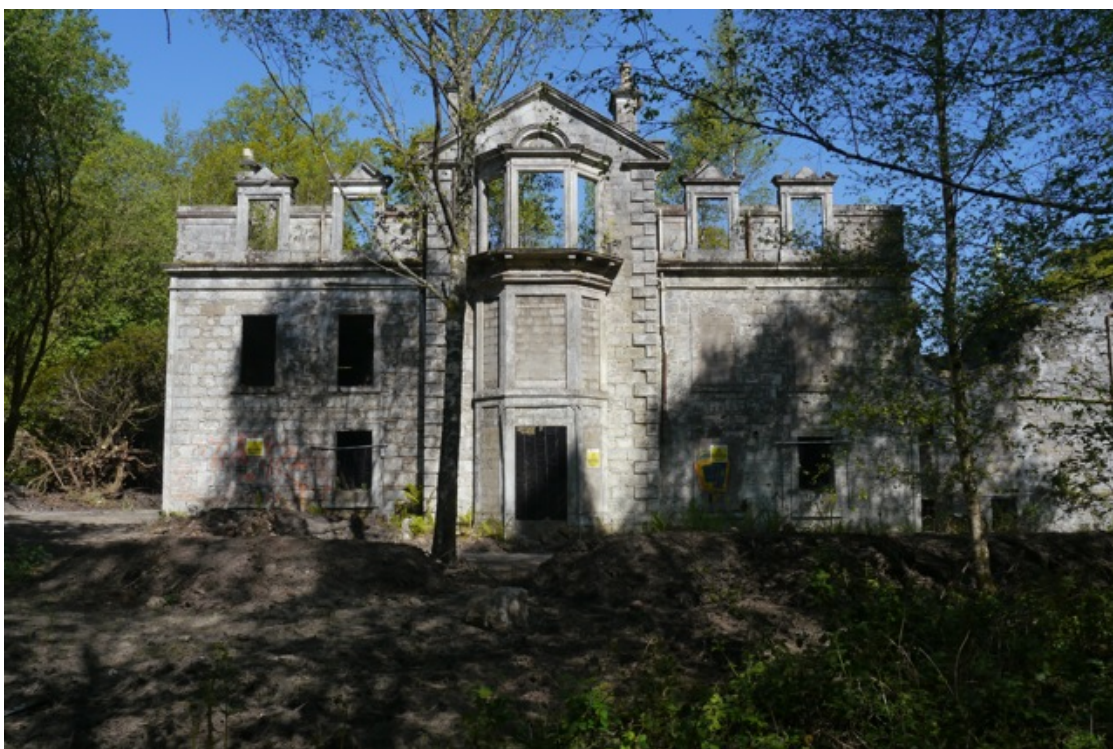
South elevation.

Missing cope and dormer skew stones should be replaced in stone to match existing. Care should be taken detailing external finishes which may be visible above the parapets.

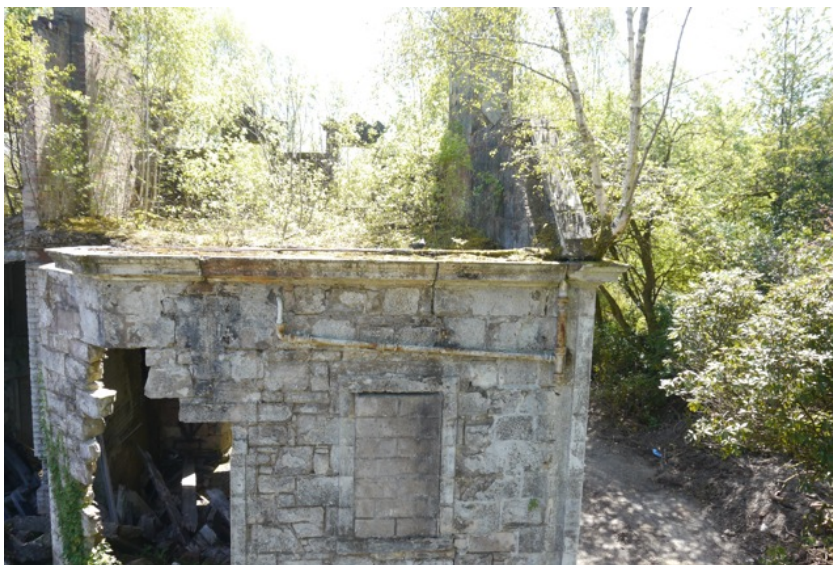
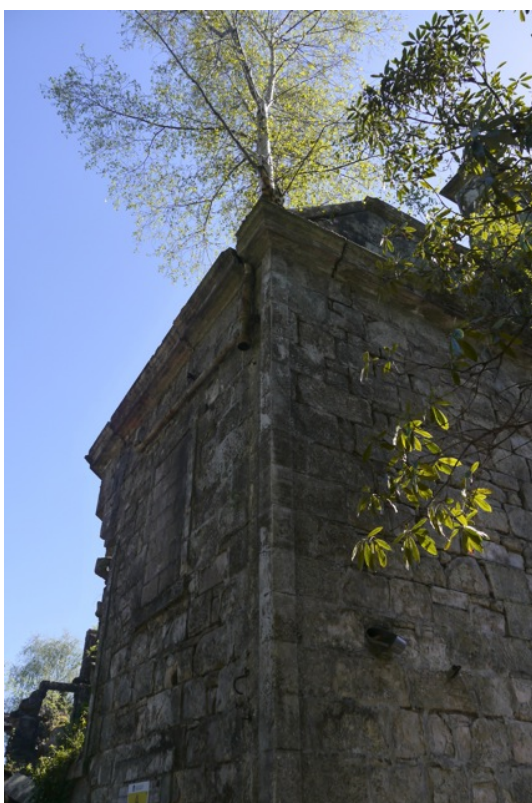
*Above - vegetation growing off concrete second floor behind west gable.
Left - open mortar joints to west gable.*

While this wall is less visible there are two reasons why it should be retained and the defective upper section rebuilt:

- (a) providing lateral stability to a retained and repaired main elevation;
- (b) the armorial plaque at second floor level is referenced in the building's listing.

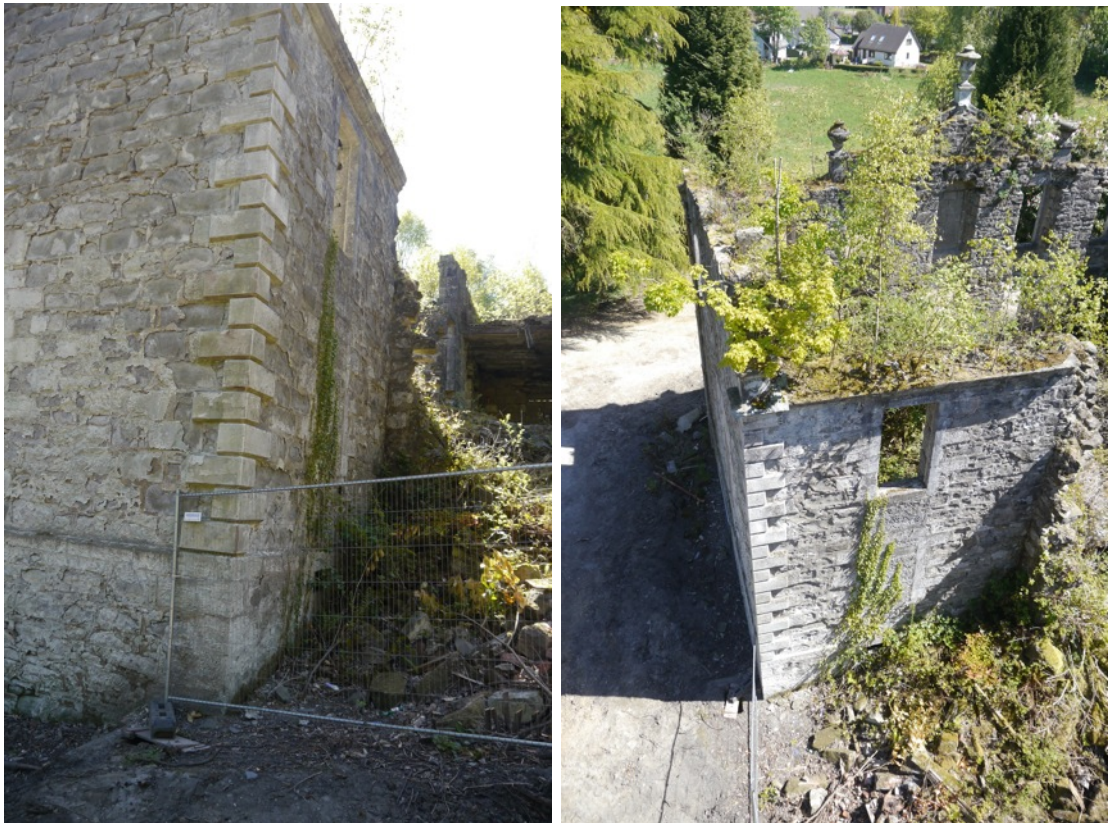
North gable and surviving rear wall of original house.

Old photographs show a steep roof to the original house, with high gables. This wall should be rebuilt, at least to eaves level:

The first bay of the wall returning along the back of the original house also remains intact and is similarly detailed. This short length of rear elevation should be retained - this return along with that at the west gable of the extension could then be conceived as bookends marking the boundary between the restored shell and new intervention.

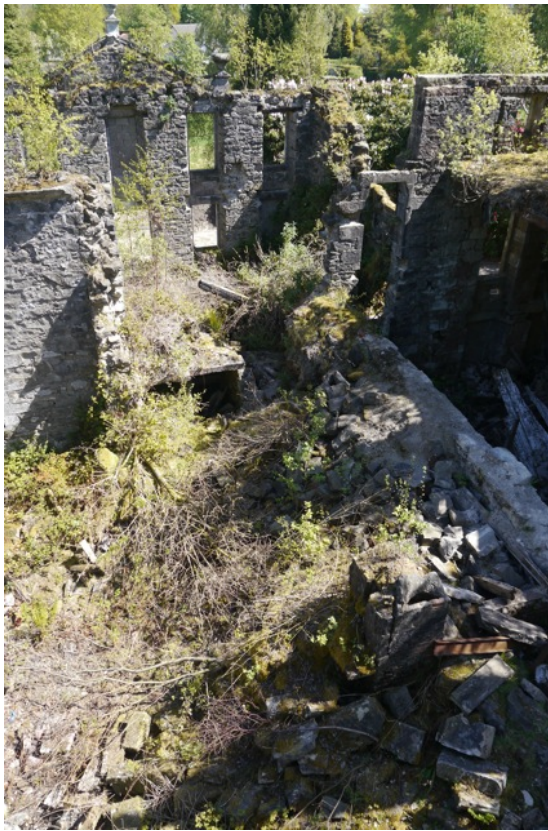
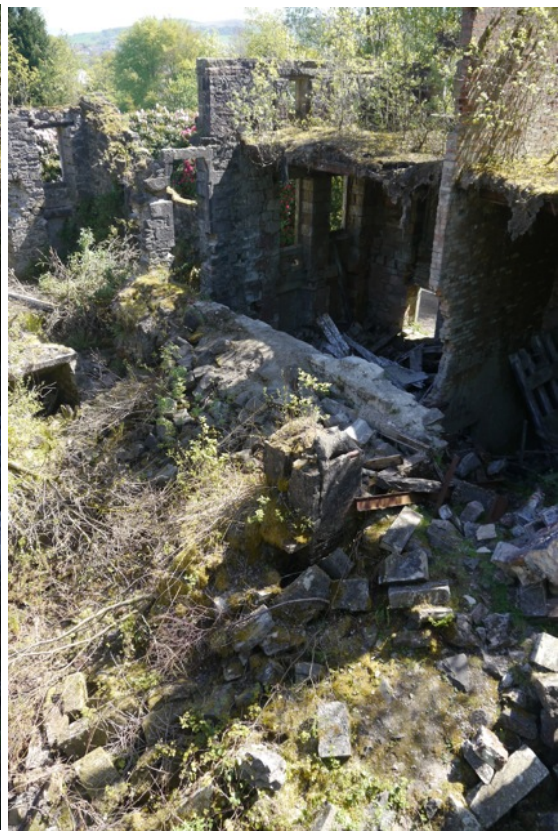
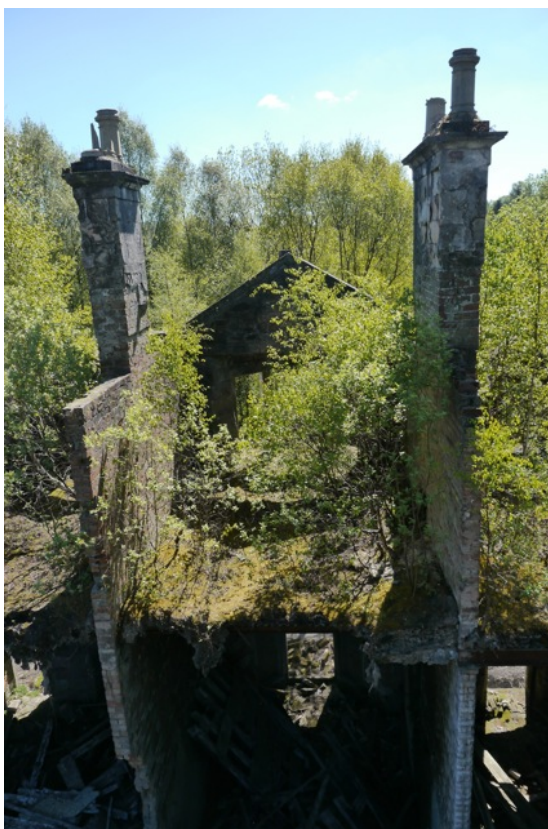
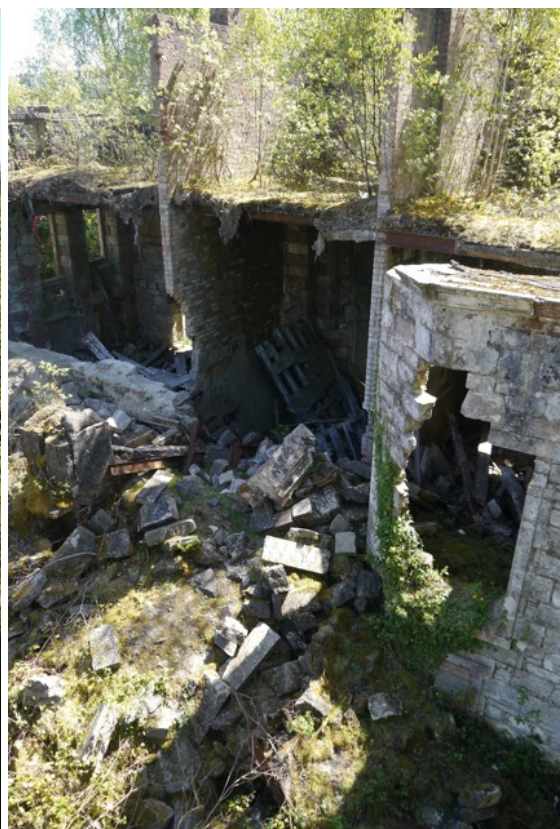
Views of ruined interior (from north).

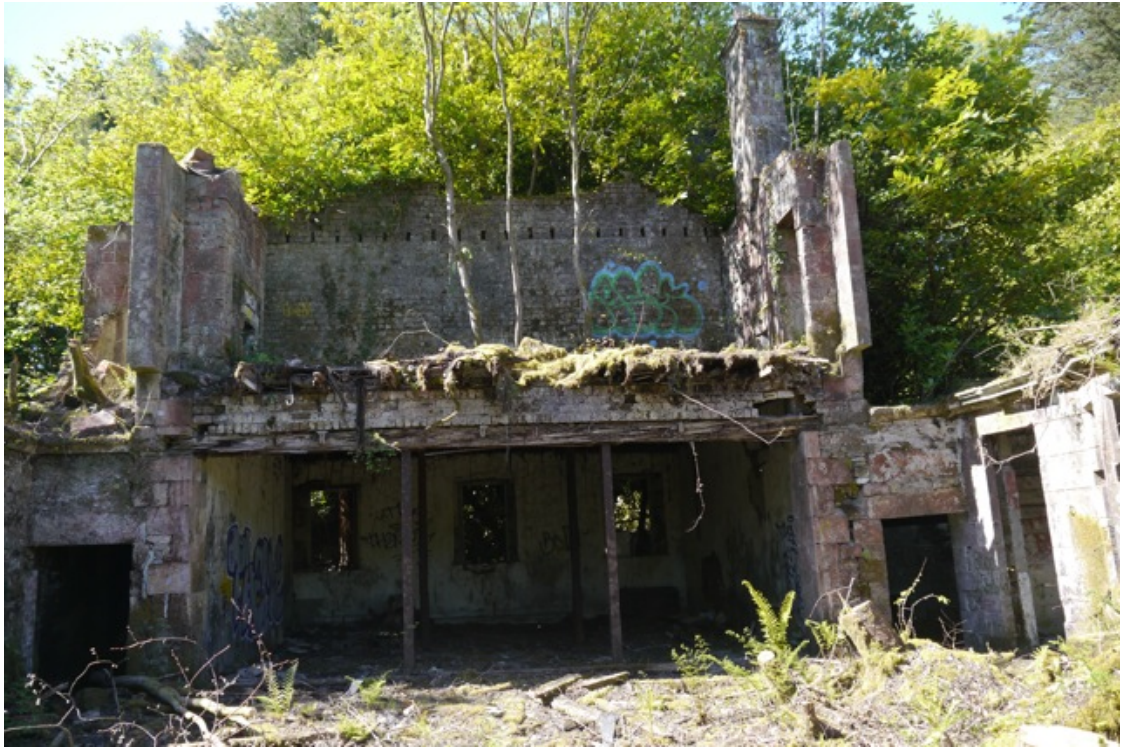
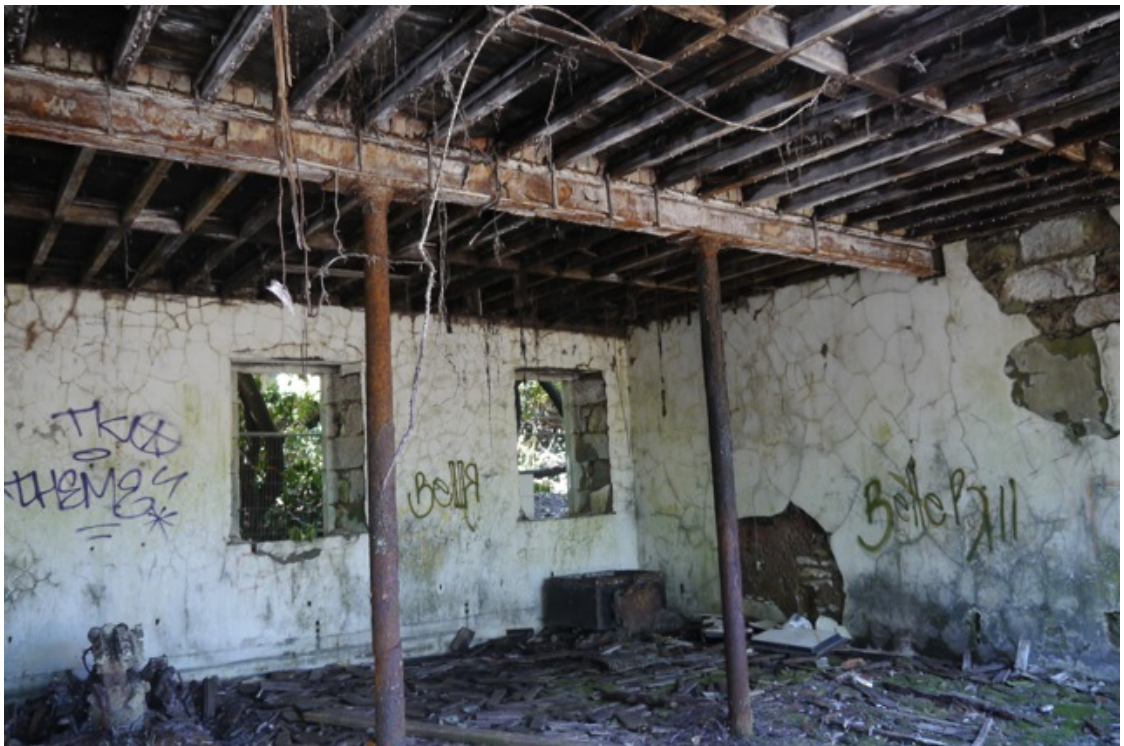
The two storey chimneyed structure is structurally unstable and should be taken down to first floor level. The rear wall appears to be repairable, although one of the internal cast iron columns has sheared.

*2-storey rear section: above - note mature trees growing out of first floor structure;
below - note shear crack in left-hand column (supporting brick spine wall).*

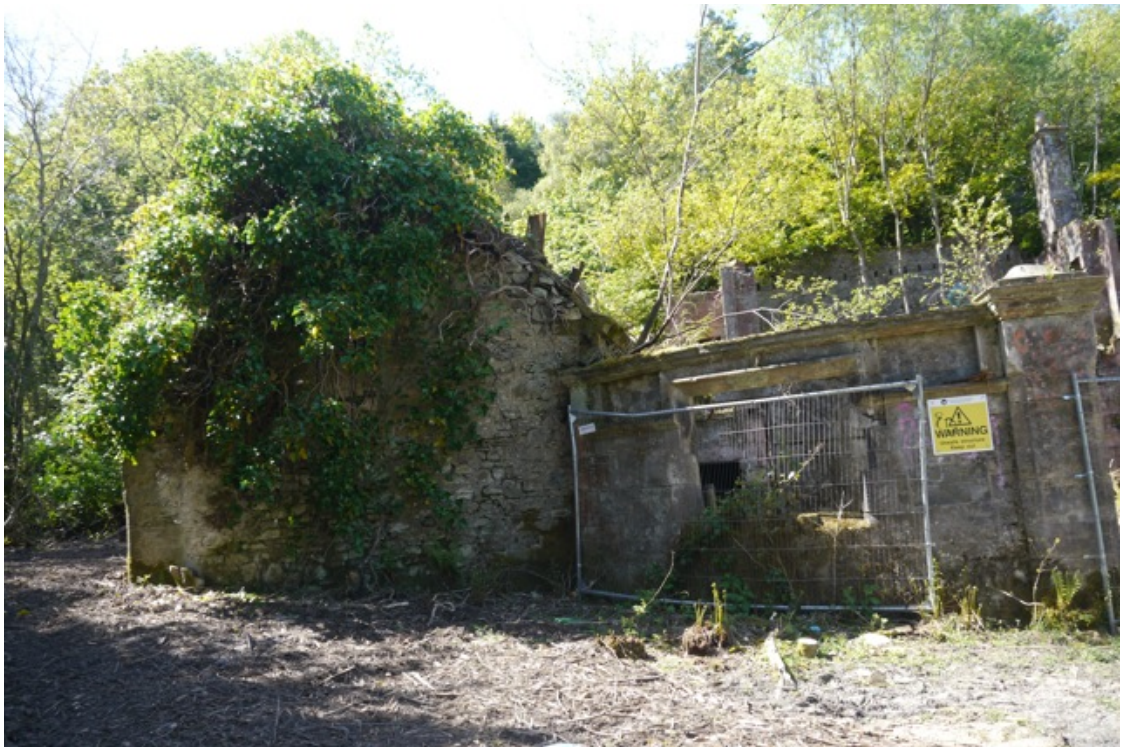
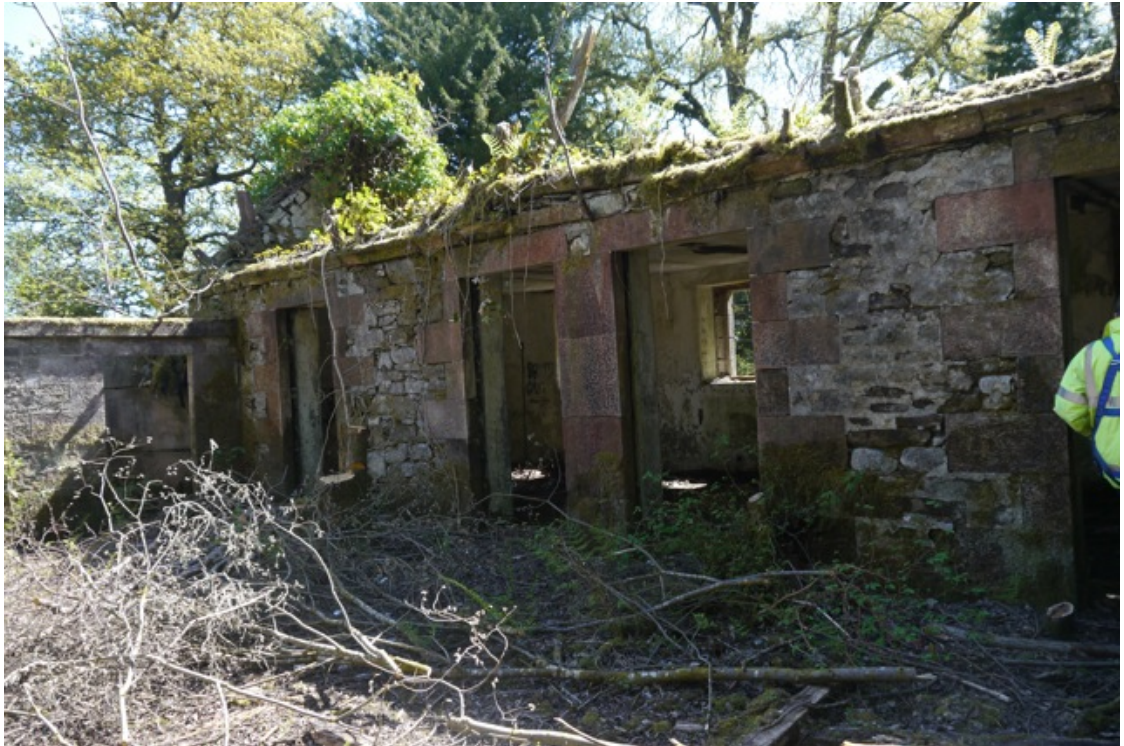
Above - south block from courtyard.

Below - within south block - ceiling still intact despite collapsed roof.

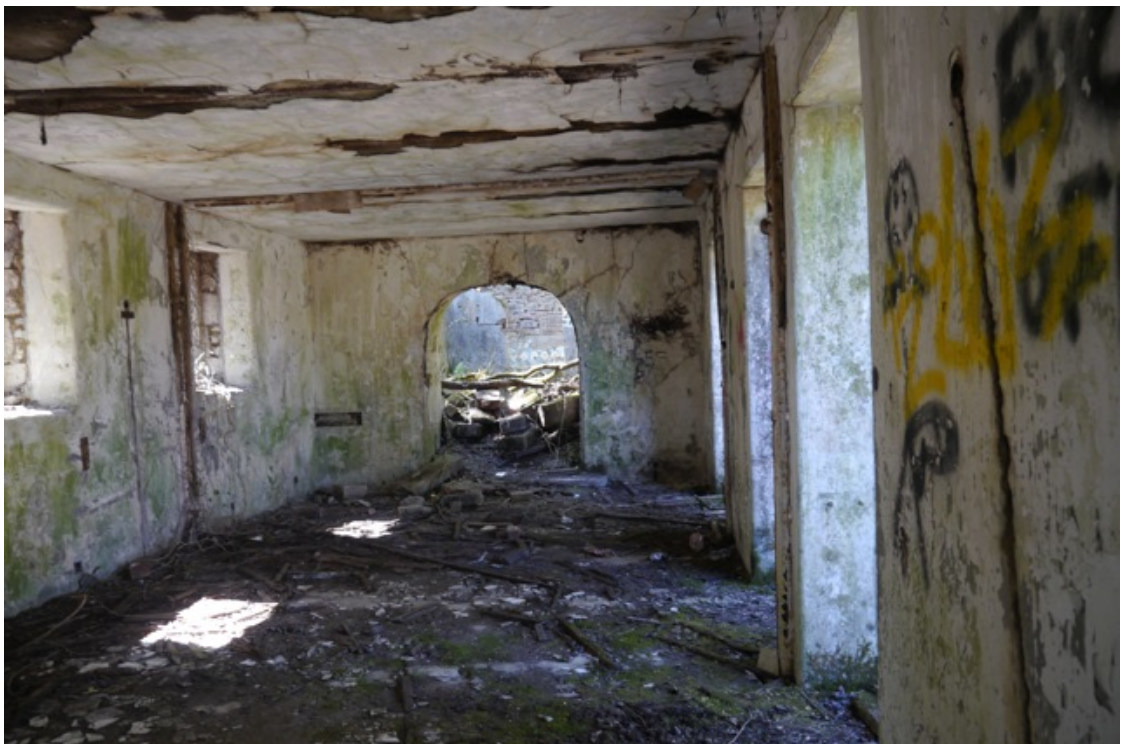
Above - interior of north block.

Below - failed end wall of north block.
