# Structural Inspection Report Woodbank House & Stables Luss Road Balloch

Project Ref: 35854 | Rev: 1 | Date: May 2017

**Report Title:** Woodbank House & Stables Structural Inspection Report

**Doc Ref:** 35852-ST01

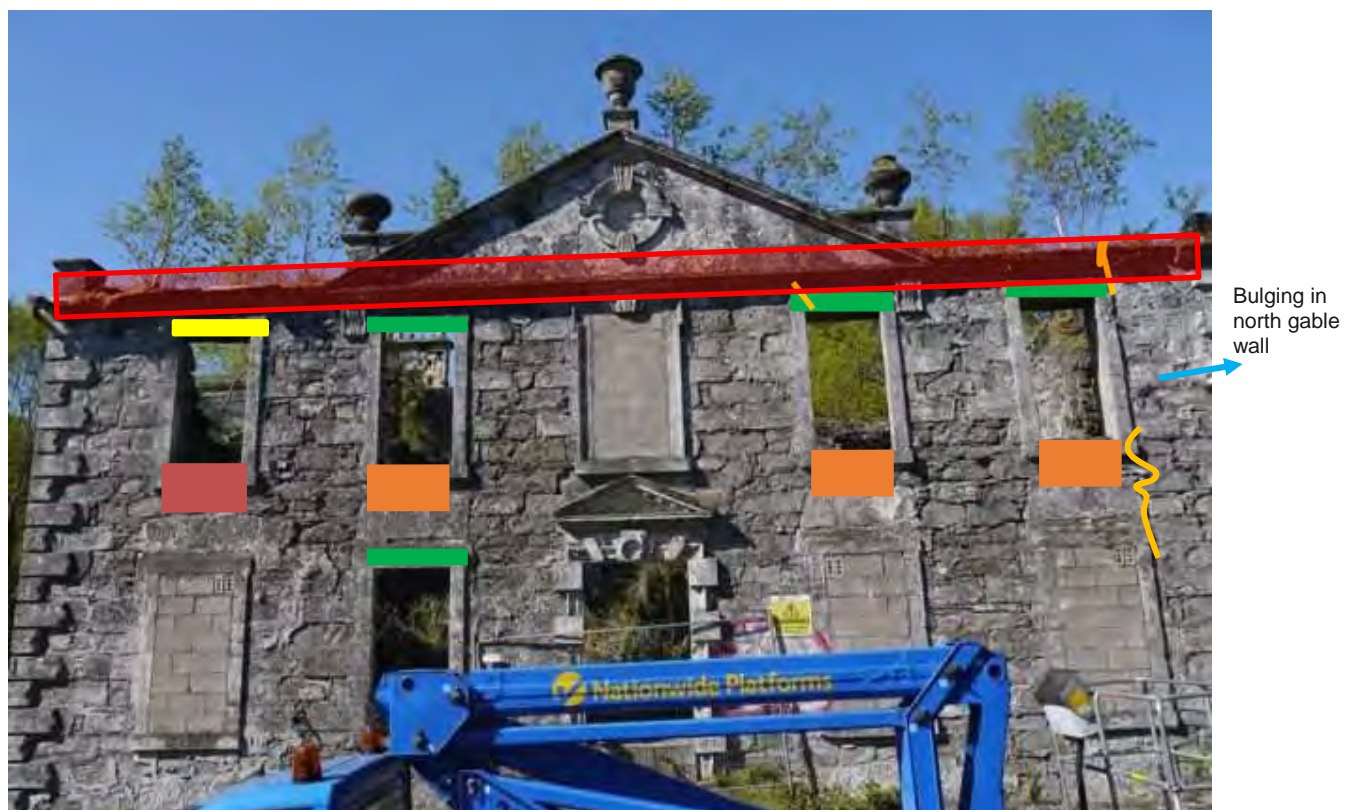
- 2.3.2 The dressed stone is in reasonable condition and the wall is generally plumb. However, the wall condition varies, there are areas of erosion and the mortar joints are failing. The cope stones are badly eroded and need replaced, as highlighted below in red.

- 2.3.4 Some cracks are evident to the north, as highlighted in orange on Photograph 2 below: related to bulging of the north gable, as highlighted below.

- 2.3.5 This elevation must be propped from outside, utilising the window openings, throughout the demolition clearance and proposed works.
- 2.3.6 All existing lintels are failing. The south first floor window has a timber safe lintel (shown in yellow) which needs replaced, as do the concrete lintels (highlighted in green) in the remaining windows as they are all cracked. All lintels need replaced in all elevations.

- 2.3.8 The floor has collapsed, as such only the external stone skin remains between the ground and first floor windows, as highlighted in orange. This occurs throughout all elevations.

Photograph 2 – East Elevation  
Down takings for safety shown in red.

- 2.3.7 The squared random rubble between the window mullions is of varied quality and is eroded in some areas. The wall is to be repaired and joints raked and pointed with a suitable lime mortar prior to rendering the walls with a suitable lime render.

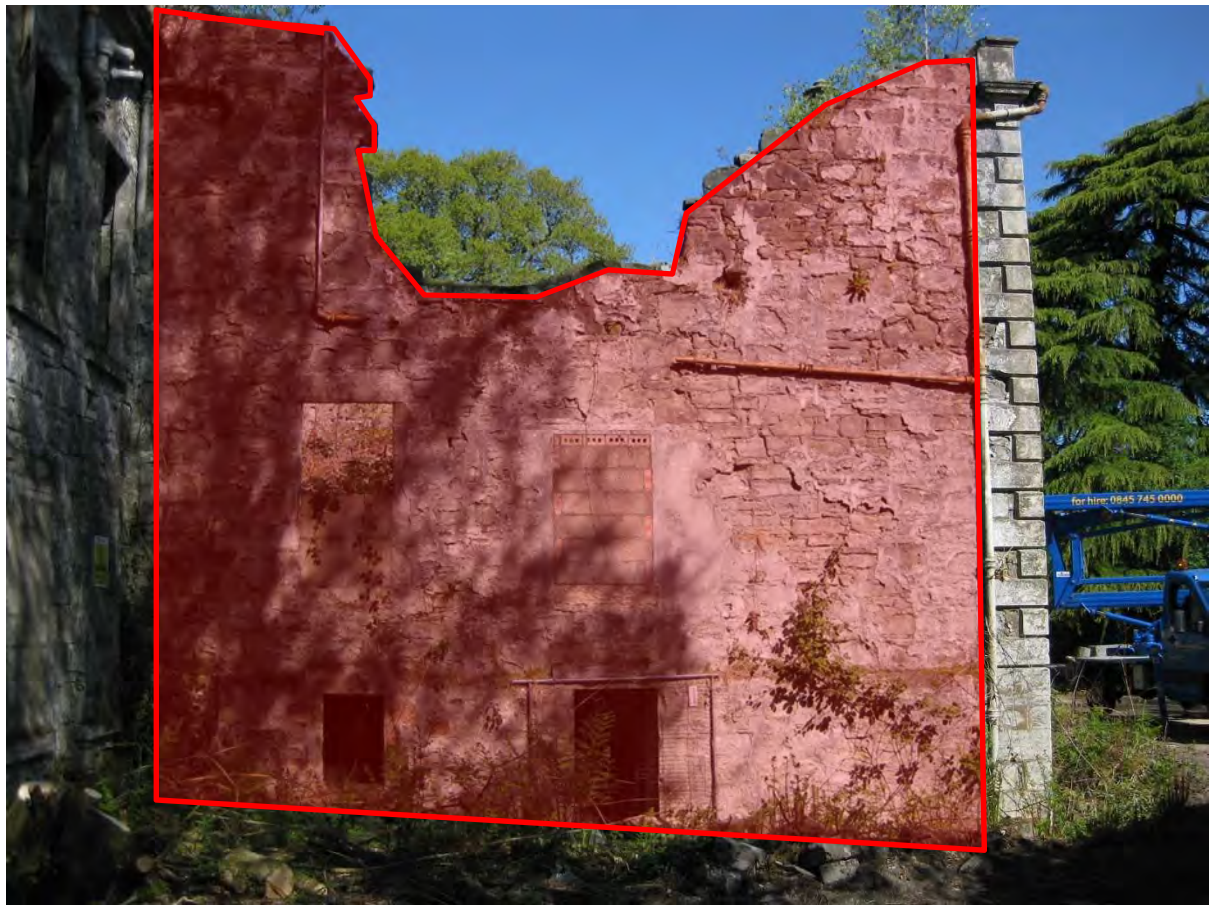
- 2.4.1 This gable elevation appears to originate from the 1774 building.
- 2.4.2 The wall is in poor condition following a partial collapse. A large area of the internal stonework skin has collapsed and the remaining wall is unstable. We recommend that this wall is demolished down to ground level, as highlighted red on photograph 3. The stone can be set aside for re-building.
- 2.4.3 As the wall is not visible out with the site due to trees, this elevation may have less historic significance and may be able to be removed. Future proposal and the conservation architect will inform the decision of whether this wall is to be re-built.
- 2.4.4 The East elevation and Rear East elevation will need to be propped prior to this demolition of the south wall, for stability.

Photograph 3 - South East Elevation  
*Down takings for safety shown in red.*

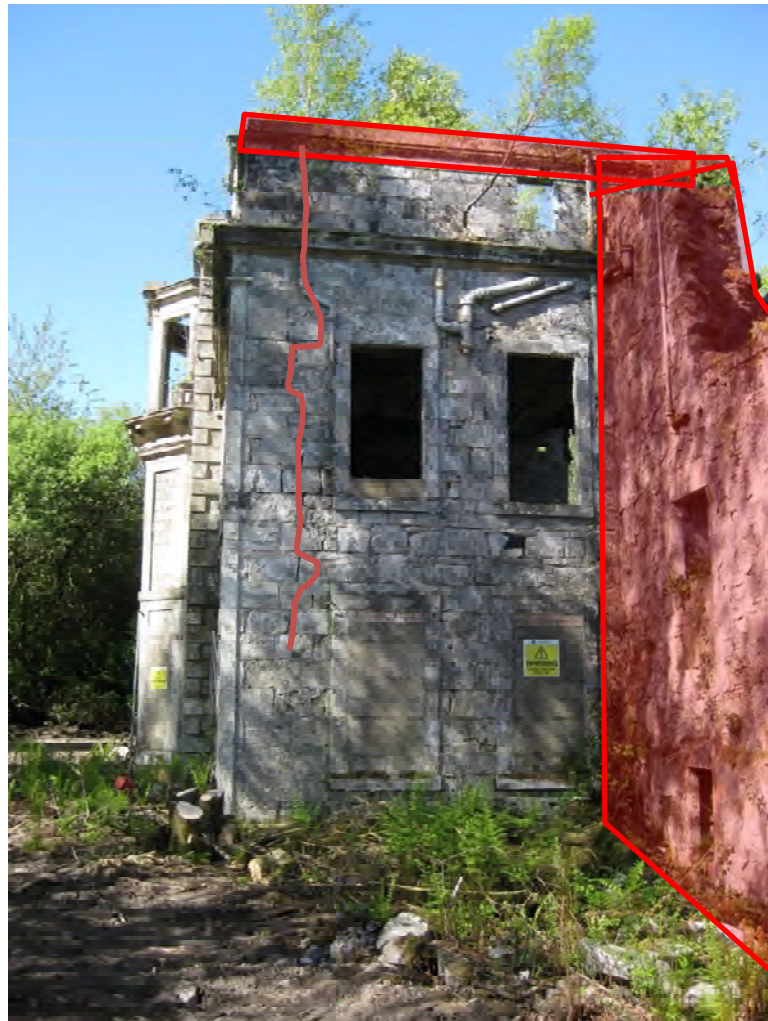
- 2.5.1 This elevation appears to originate from the 1880s extension.
- 2.5.2 The walls are in good condition. Cope stones are missing. The crack to the south indicates rotation of the southern wall outwards. We recommend that loose stones are removed and that the wall heads are remediated, highlighted below in red.

Photograph 4 – Rear East Elevation  
*Down takings shown in red*

- 2.5.4 The south-east wall should be demolished for safety reasons; the rear east elevation must be fully propped prior to any demolition.
- 2.5.5 If this wall is to be kept, it will need to be propped for stability throughout the demolition, clearance and proposed works. If the wall is to remain, the stone should be repaired and joints raked and pointed with a suitable lime mortar prior to rendering the walls with a suitable lime render.

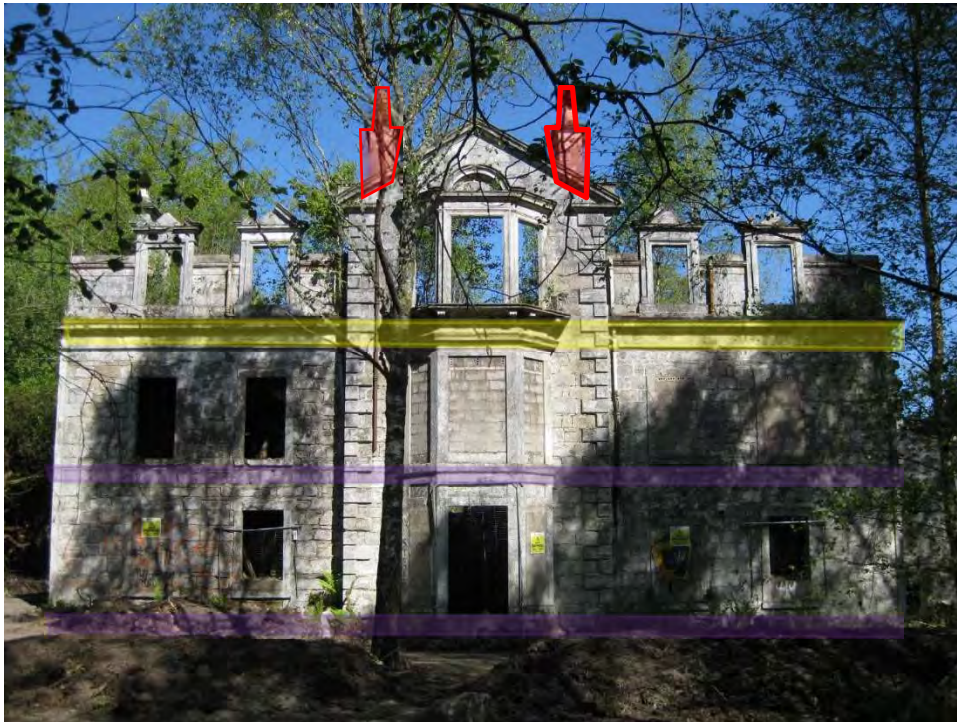
- 2.6.3 The two central chimneys are unstable. The walls supporting the chimneys are slender and the floors which originally provided restraint have collapsed. These chimneys should be demolished down to first floor level in the first instance, as highlighted in red on photograph 5 below.

Photograph 5 – South elevation

*Down takings for safety highlighted red, unstable floors behind highlighted yellow and missing timber floors highlighted in purple.*

- 2.6.6 Behind the south elevation the concrete second floor is constructed of concrete deck spanning within the steel beam depth, shown in yellow on Photograph 5. The floor cannot be safely accessed/inspected due to the debris from the partial demolition and past collapses. Visual inspection from ground level at the North appears to show large deflections in the East span. The steelwork supporting the floor appears to be very corroded. This floor and internal spine walls should be demolished down to ground level. Photograph 6, taken from the east, shows the extent of the walls and floors.

- 2.6.7 The timber ground and first floors, highlighted purple on Photograph 5, are no longer in place throughout the building, highlighted in purple. Wall restraint is missing in these areas as such the wall requires to be propped.

- 2.6.5 If the wall is to remain, it will require to be propped throughout the demolition, clearance and proposed works. If the wall is to remain the stone is to be repaired and joints raked and pointed with a suitable lime mortar prior to rendering the walls with a suitable lime render.

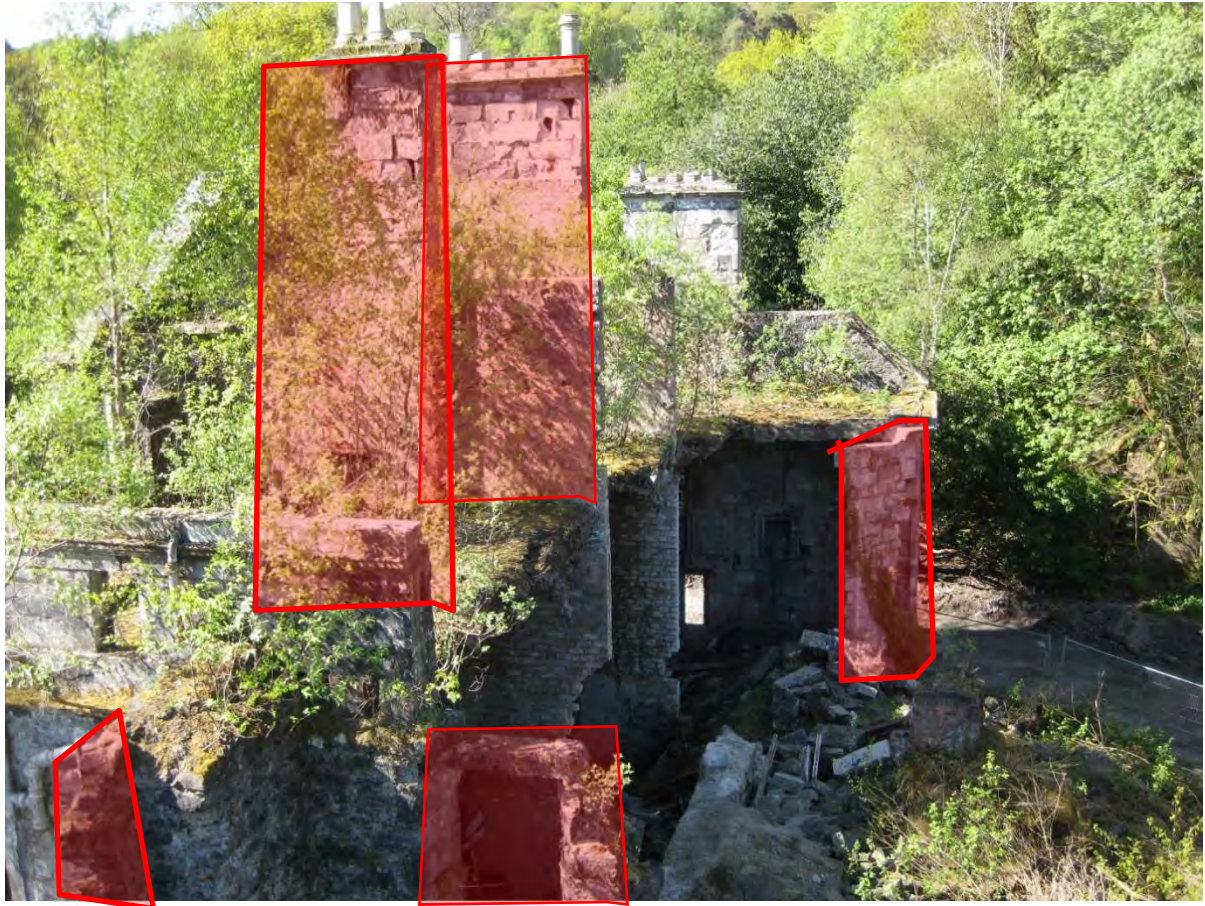
Photograph 6 – View of the walls and slab behind the south elevation (taken from the east)  
*Priority down takings for safety shown in red*

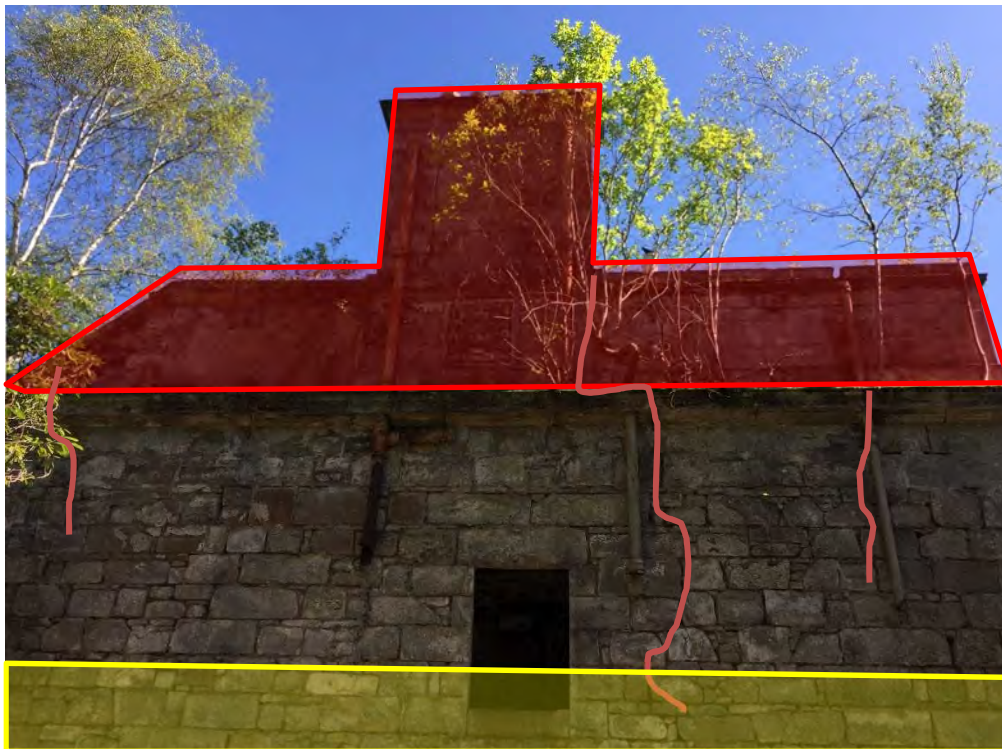
- 2.7.6 The stonework forming the external wall on this elevation was badly weathered and joints were open and loose. There appears to be some areas of cement render repair which should be removed. The cope stones are damaged /missing and need to be replaced/repared, as highlighted on Photograph 7. Due to the poor condition of the stone and the copes on this elevation, the high-level wall should be removed.

- 2.7.7 There are some large bushes/trees growing at gutter/cope level on this wall. This vegetation should be removed as soon as possible to avoid a collapse on site.

Photograph 7 – West Elevation  
*Demolition highlighted red and badly corroded stone highlighted yellow.*

- 2.7.8 If the wall is to remain, it will require to be propped throughout the demolition, clearance and proposed works. If the wall is to remain, the stone is to be repaired and joints raked and pointed with a suitable lime mortar prior to rendering the walls with a suitable lime render.

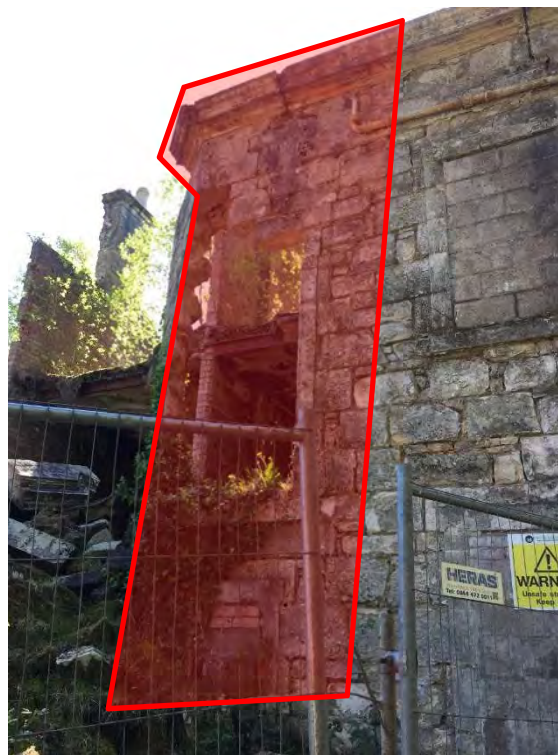
- 2.8.2 This wall is in poor condition, the east corner of the wall has partially collapsed, leaving a large area of unstable wall. This section of wall should be demolished as soon as possible to avoid collapse and is highlighted on photographs 7 and 8.

- 2.8.3 There are some large bushes/trees growing at gutter/cope level on the corner of this wall and the west elevation. The vegetation has lifted the copes and there is a gap between the copes and the wall below. The vegetation should be removed as soon as possible to avoid a collapse on site.

Photograph 8 – North (Rear) Elevation – East section  
*Priority down takings highlighted red.*

- 2.8.4 If the wall is to remain, it will require to be propped throughout the demolition, clearance and proposed works. If the wall is to remain, the stone is to be repaired and joints raked and pointed with a suitable lime mortar prior to rendering the walls with a suitable lime render.

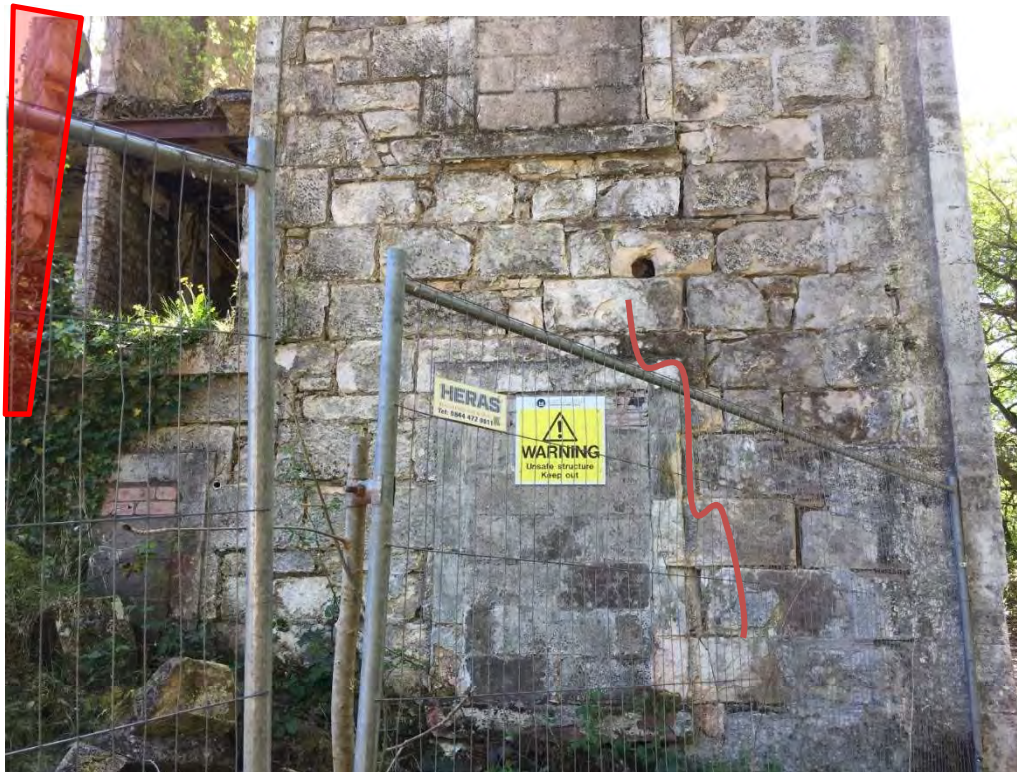
Photograph 9 – North Rear Elevation West low level  
*Priority down takings highlighted red, cracks highlighted in orange.*

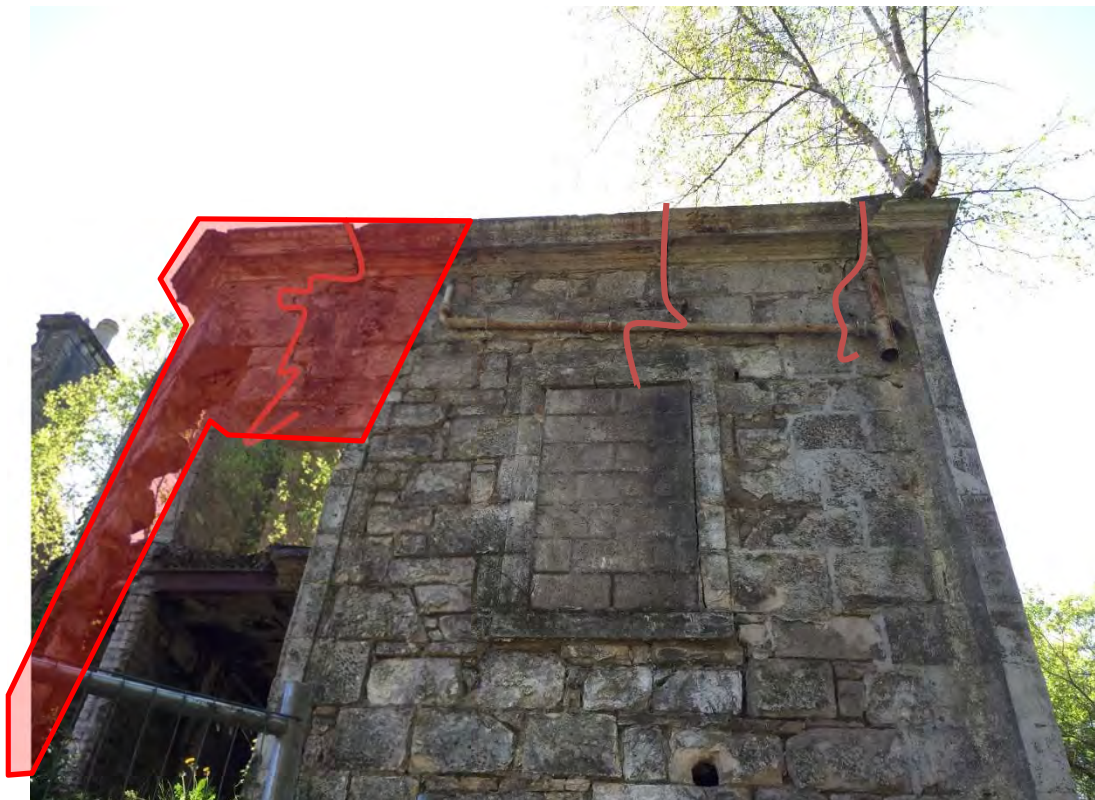
Photograph 10 – North Rear Elevation West high level  
*Priority down takings highlighted red, cracks highlighted in orange.*

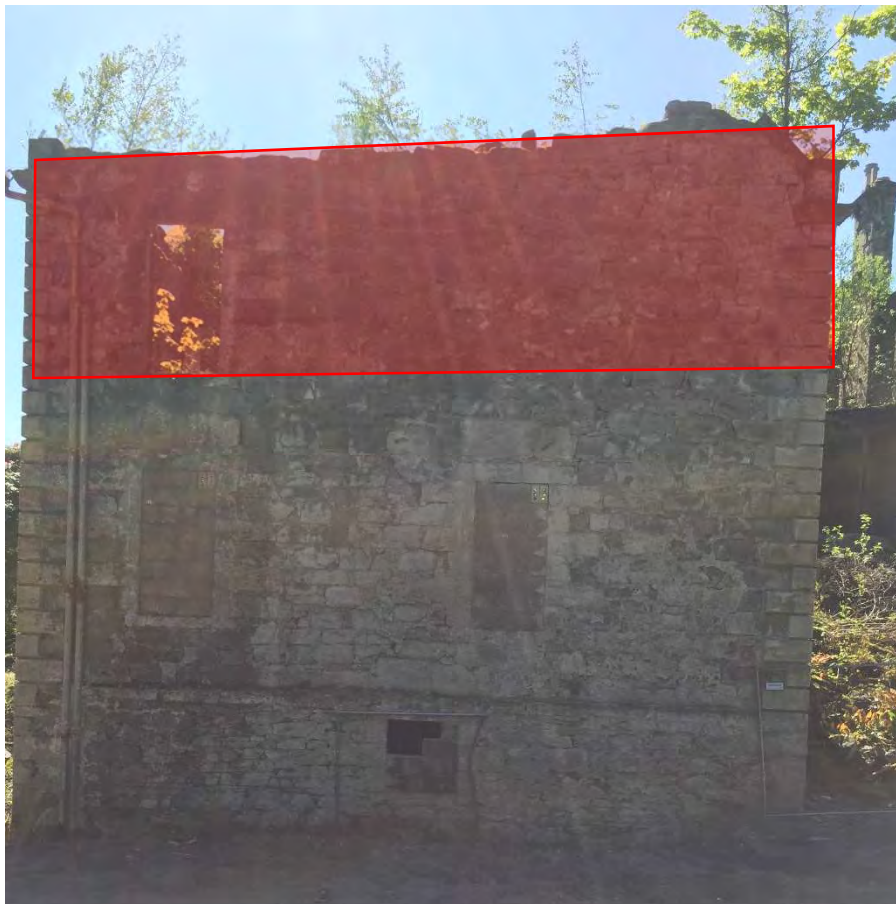
- 2.9.1 This gable elevation appears to originate from the 1774 building.
- 2.9.2 The wall is in poor condition following a roof collapse. The wall is leaning into the building and needs to be taken down to underside of first floor window level. The internal stone skin has partially collapsed and the wall is unstable. We recommend that this wall is demolished down to a safe level. The East elevation will need to be propped prior to this demolition to ensure stability.
- 2.9.3 If the wall is to remain, it will require to be propped throughout the demolition, clearance and proposed works. If the wall is to remain, the stone is to be repaired and joints raked and pointed with a suitable lime mortar prior to rendering the walls with a suitable lime render.

Photograph 11 – North east Elevation  
Down takings highlighted in red.

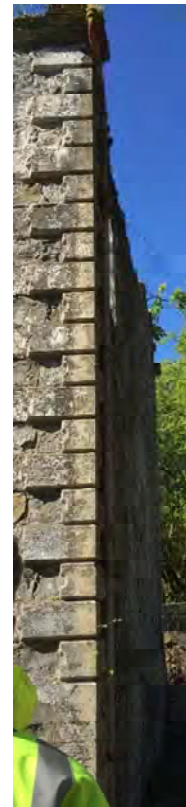
Photograph 12  
– bulge in  
North east  
elevation

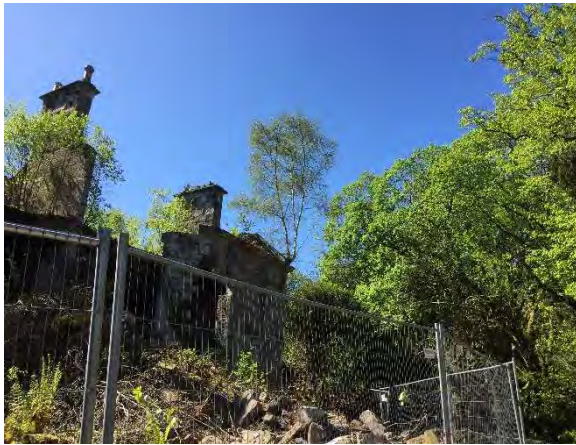
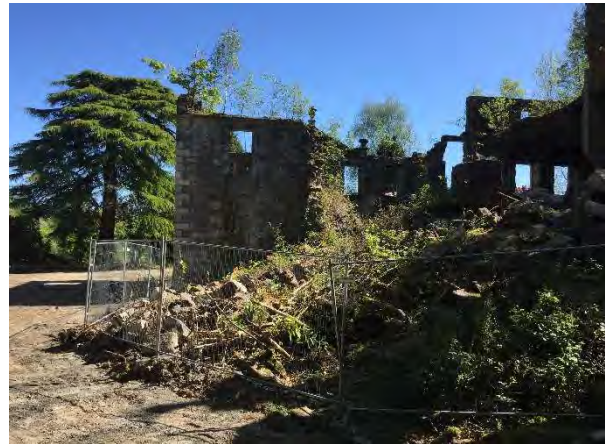
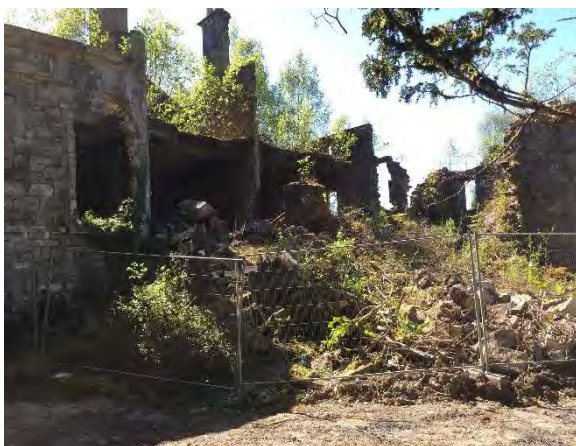
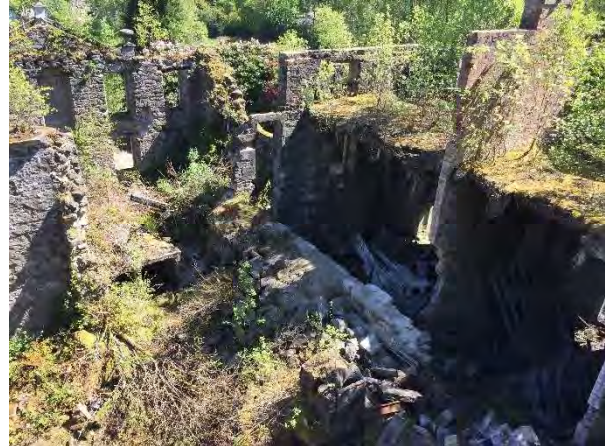
- 2.10.1 Following the 1996 partial demolition the central internal area is piled up with stones, timber and other materials, which makes the area unsafe for inspection.
- 2.10.2 The internal walls and floors are in poor condition and we recommend that only the elevations are worth saving.
- 2.10.3 The demolition will need to be carried out in a sequence to be agreed between the structural engineer and the demolition contractor. The demolition will require temporary works design to prop/support all walls which are to remain.
- 2.10.4 We recommend that the earlier partial demolition debris is cleared to allow access. The extents of clearance and demolition will need to be limited to consider the areas of unstable structure. Specifically, the chimneys and the free-standing masonry doorways, as highlighted on the photograph 6.

Photograph 13 - Internals from North east

Photograph 14 - Internals from South

Photograph 15 - Internals from North

Photograph 16 - Internals from South west

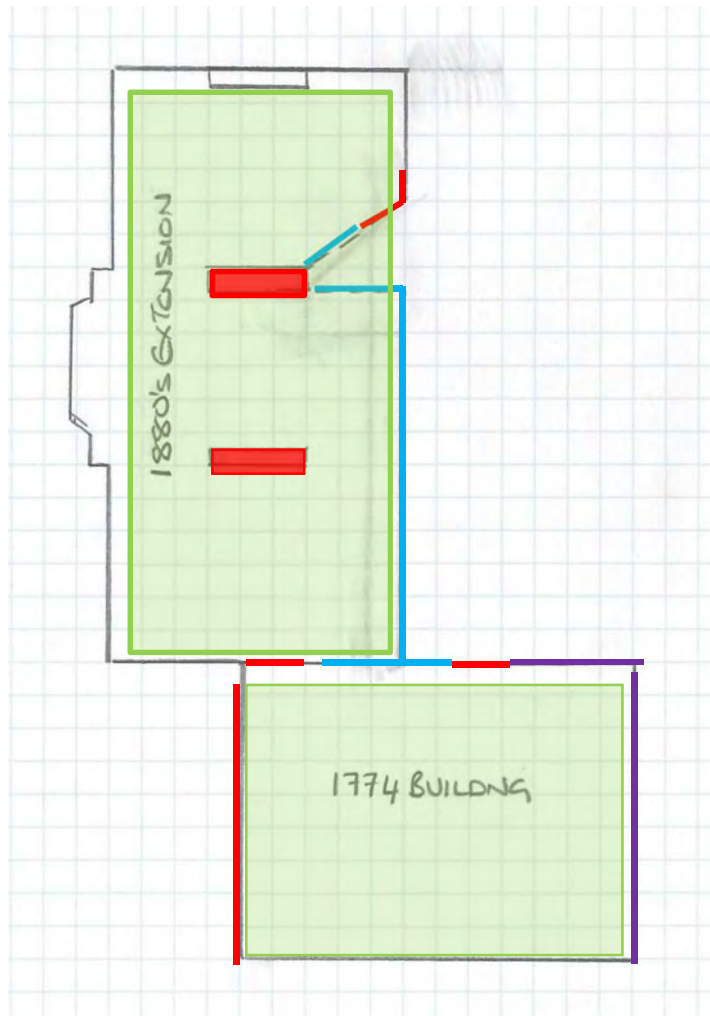
Figure 2 – Main House Summary Plan

- 2.11.1 Some urgent demolition works are required in order to render the building safe, due to the instability of the building. The undernoted plan highlights the most significant areas of demolition required.
- 2.11.2 Red highlights urgent demolition, the purple highlights partial demolition and the blue shows areas already partially demolished/collapsed. The green shows areas which are to be demolished in an agreed sequence once proposals are known. Once this has been carried out and the rubble removed a further inspection can be carried out.

- 2.11.3 The internal walls and floors are in poor condition, as such we recommend that only the elevations are worth saving. The extents of elevations to be saved can be agreed taking consideration of the future proposals and the Conservation Architect's report.
- 2.11.4 The demolition will need to be carried out in a sequence to be agreed between the structural engineer and the demolition contractor. The demolition will require temporary works design to prop/support the walls which are to remain.
- 2.11.5 We recommend that the earlier partial demolition debris is cleared to allow access. The extents of clearance and demolition will need to be limited to consider the areas of unstable structure, Specifically, the chimneys and the free-standing masonry doorways, as highlighted on the photos.

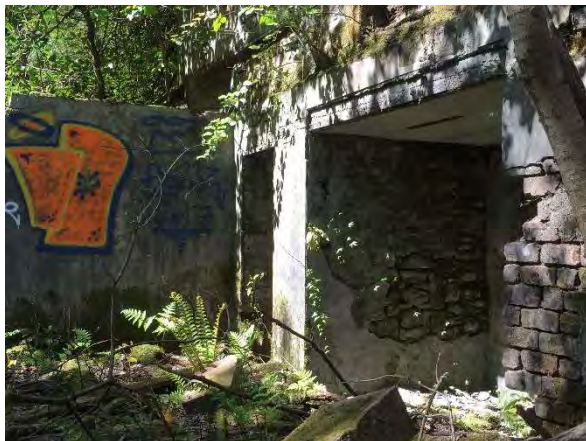
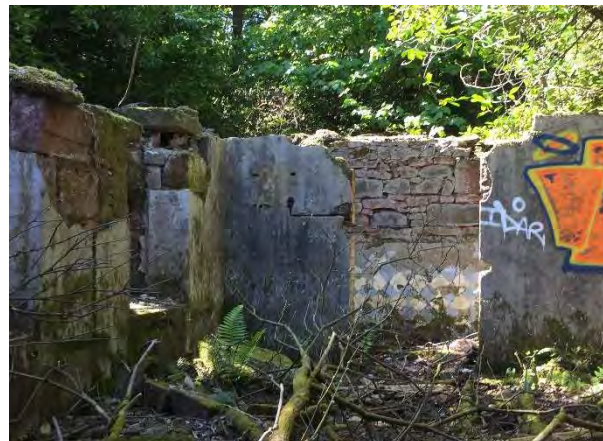
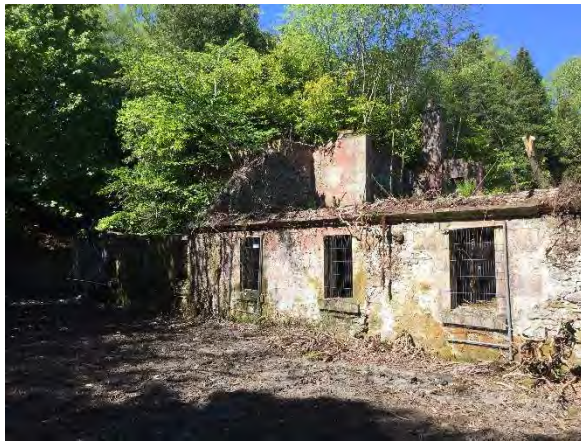
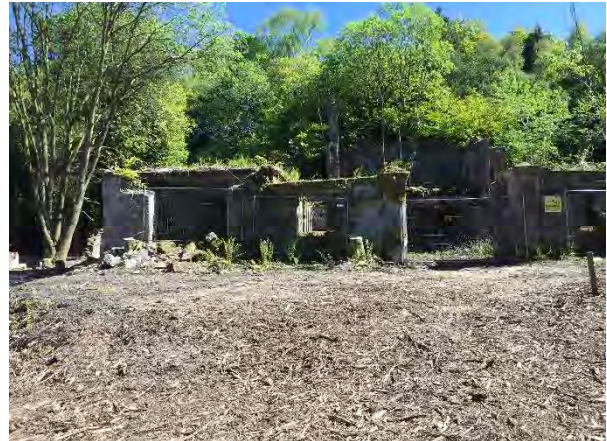
- 3.2.1 The North and South blocks are built with single storey stone walls and there appears to have been some additions throughout the life of the building, carried out in masonry. The single storey stone sections are generally plumb; however, they are in poor condition and in areas the stone is eroded. If the building is to be kept the masonry will need repairs and all joints would need to be fully raked and re-pointed with suitable lime mortar.

Photograph 17 – Internal views of south block

Photograph 18 – Internal views of south block

Photograph 19 – South elevation of south block

Photograph 20 – North east elevation

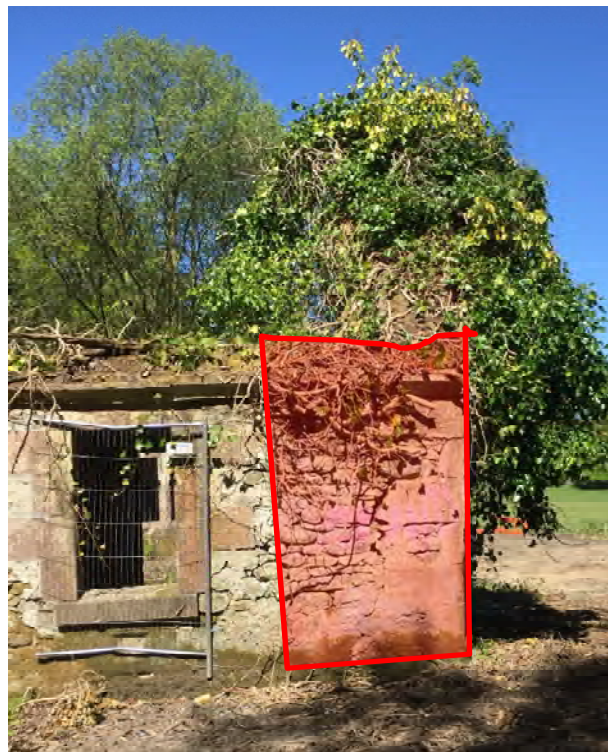
- 3.2.2 The east wall of the south block has rotated out from the building, see the undernoted photo. This is likely caused by the vegetation which is growing on the east wall. We would recommend that the vegetation is carefully removed and that the bulging wall is demolished, as highlighted below.

Photograph 21 – East end of South elevation of south block  
*Showing bulging wall and down takings in red*

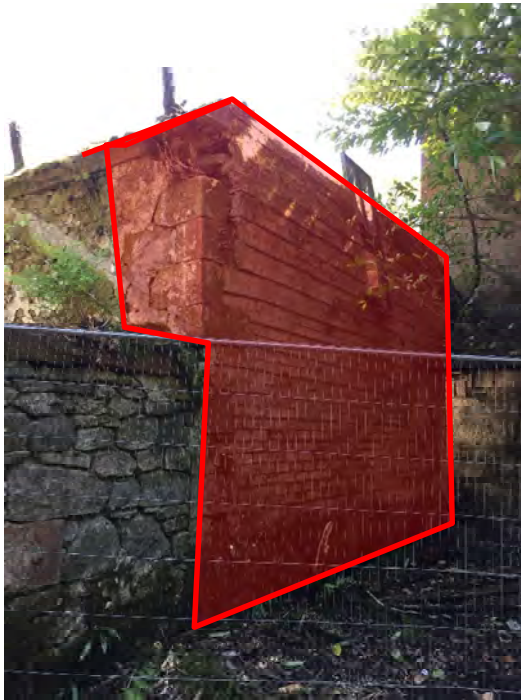
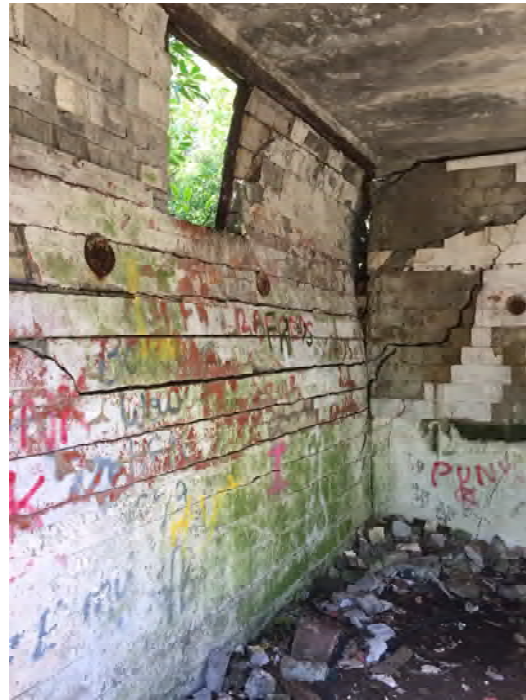
- 3.3.1 The rear section is constructed in masonry, single skin brick in most areas. These sections are in poor condition and should be demolished.
- 3.3.2 The West wall of the North block has failed and is being held up by the corroded steel plates within the mortar beds. See the photo's below. For safety, this section of wall is demolished.

Photograph 22 – West wall in north block  
*Showing failure and down takings in red*

Photograph 23 – internal view of west wall in north block  
*Showing failure*

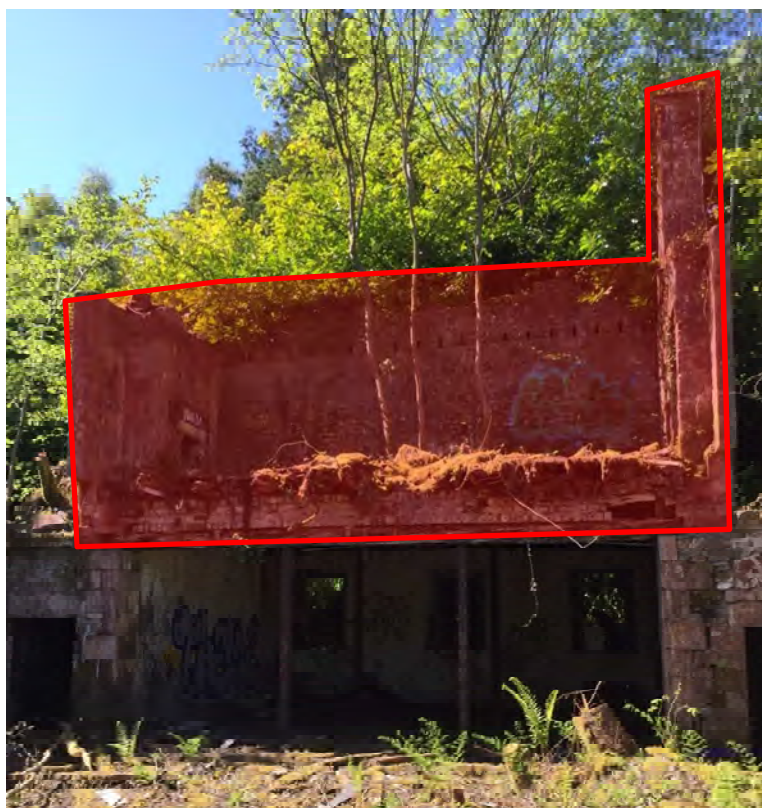
- 3.3.3 The first floor to the rear is timber joists supported on steel beams on steel circular columns. A central masonry wall approximately 3m high is also supported on the steel beam. The structure in this area is unstable, the rear wall is being supported by some trees. The timber is rotten, the steel beams and connections are very corroded and the south column has fully sheared, this risk of collapse is exacerbated by the masonry over and a large tree growing on the suspended first floor. We would recommend that the structure is removed down to at least the underside of the suspended floor, for safety, as soon as possible.

Photograph 24 – first floor of rear section  
*Showing priority down takings for safety in red*

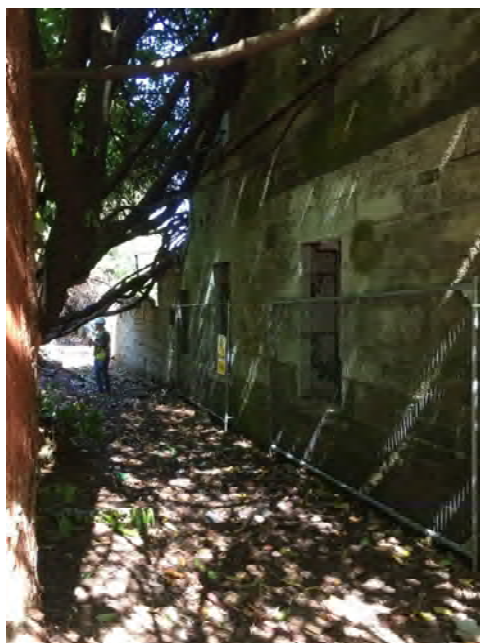
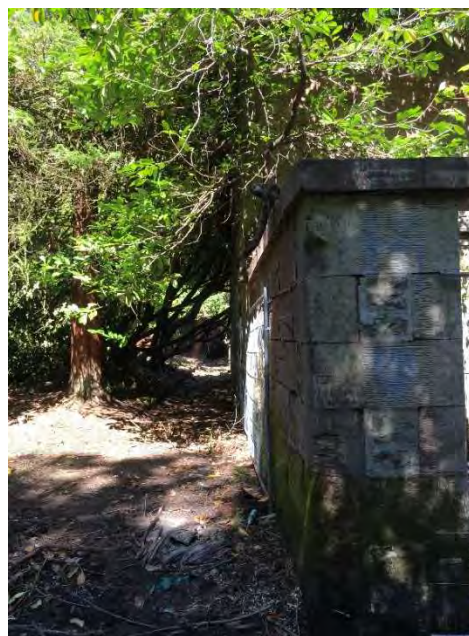
Photograph 25 – West wall of rear section  
*Showing unstable walls and trees.*

Photograph 26 – West wall of rear section  
*Showing unstable walls and trees.*

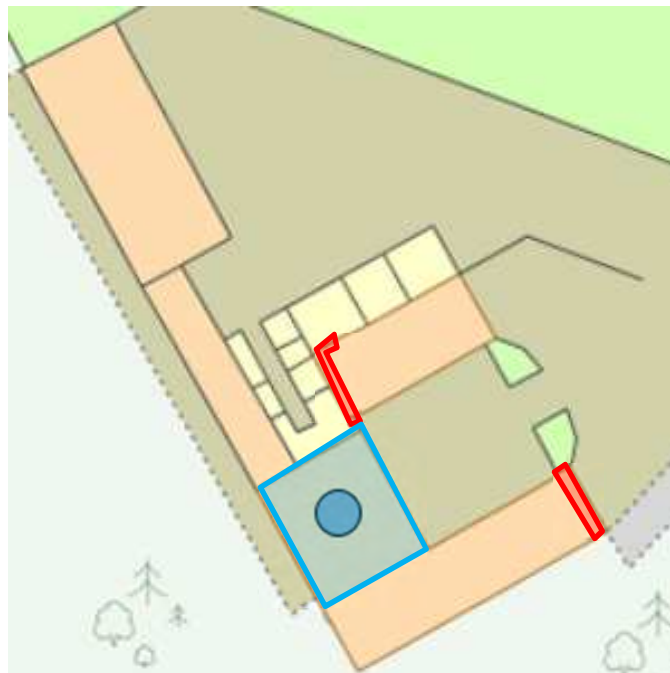
Figure 4 – Stable block summary plan

- 3.4.1 Due to the poor condition and lack of stability, a considerable area of the building must be demolished for safety reasons. It is debatable whether the remaining sections of the building are significant enough to be retained and renovated.
- 3.4.2 Initial demolition extents for stability are noted below:
- Demolition to Ground level, shown red.
  - Demolition to at least the underside of first floor level, shown in blue.
- 3.4.3 Once the partial demolitions have been completed further investigations can be carried out to assess the remainder of the structure.

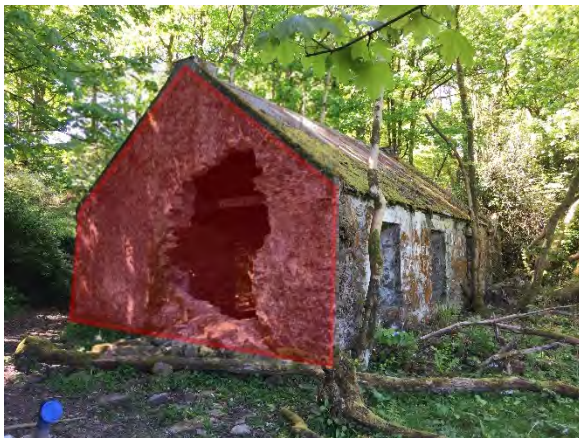
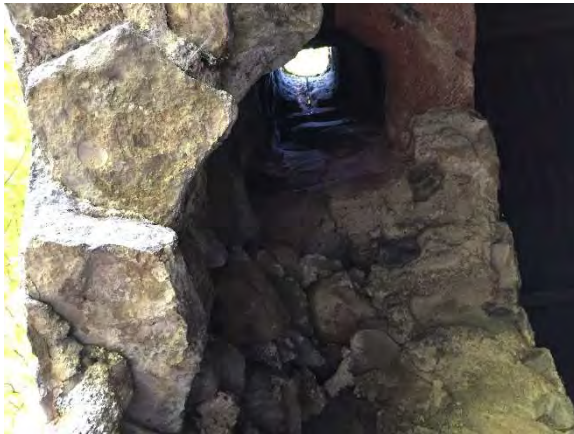
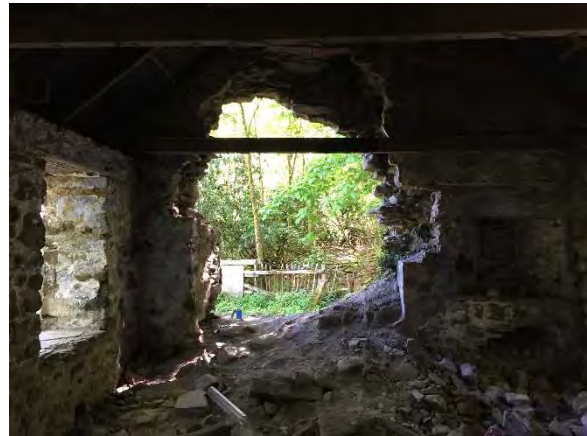
- 4.3.1 The building is small with no floor slab and has a large section of the south wall missing. The walls are in poor condition and a chimney collapse has exposed the single stone skin sections that form the flue and the wall is unstable, as shown in photographs 27, 29 and 32. Due to the instability of the south wall we would recommend demolishing the wall.
- 4.3.2 The corroded lintels are formed with steel rails and would need to be replaced if the building is to be refurbished.
- 4.3.3 Due to the instability of the south wall we would recommend demolishing the wall.
- 4.3.4 We would recommend that the building is demolished given the state of repair. If the full building is not demolished the east and west walls will need propped prior to the demolition taking place.

Photograph 27 - South wall showing collapse  
*Priority down takings for safety highlighted red.*

Photograph 29 – South wall, showing unstable flue.

Photograph 32 – South wall, showing collapse.

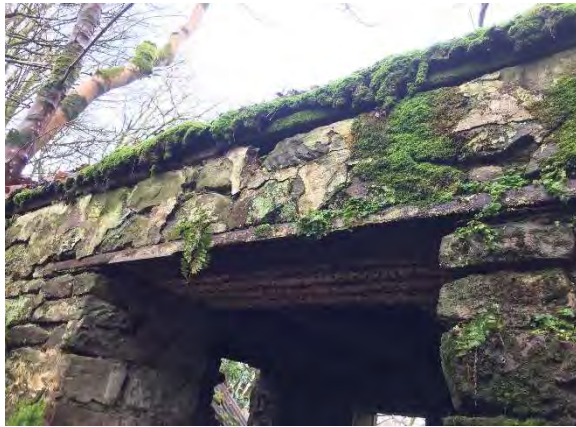
Photograph 31 – West wall lintel, formed with rails

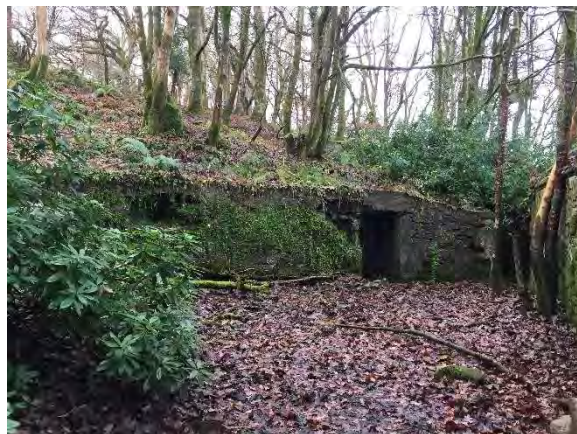
- 4.3.5 The retaining wall to the west of the building(as shown below) is in poor condition with numerous holes along its length. If the building is being demolished re-grading should be considered to avoid the need to replace or remediate the retaining wall.

Photograph 33 – South West Retaining wall
