Appendix 7 – Noise & Vibration

Client	LOMOND BANKS - WEST RIVERSIDE Sound Survey

Client	LOMOND BANKS - WEST RIVERSIDE Noise Sensitive Receptor Locations	 Contains OS data © Crown Copyright and database right 2020	1:5,000 @ A3		Date: 28/04/2022
	Flamingo Land Ltd			Drawn: LW		Checked: MH
				Figure 7.2		Rev A

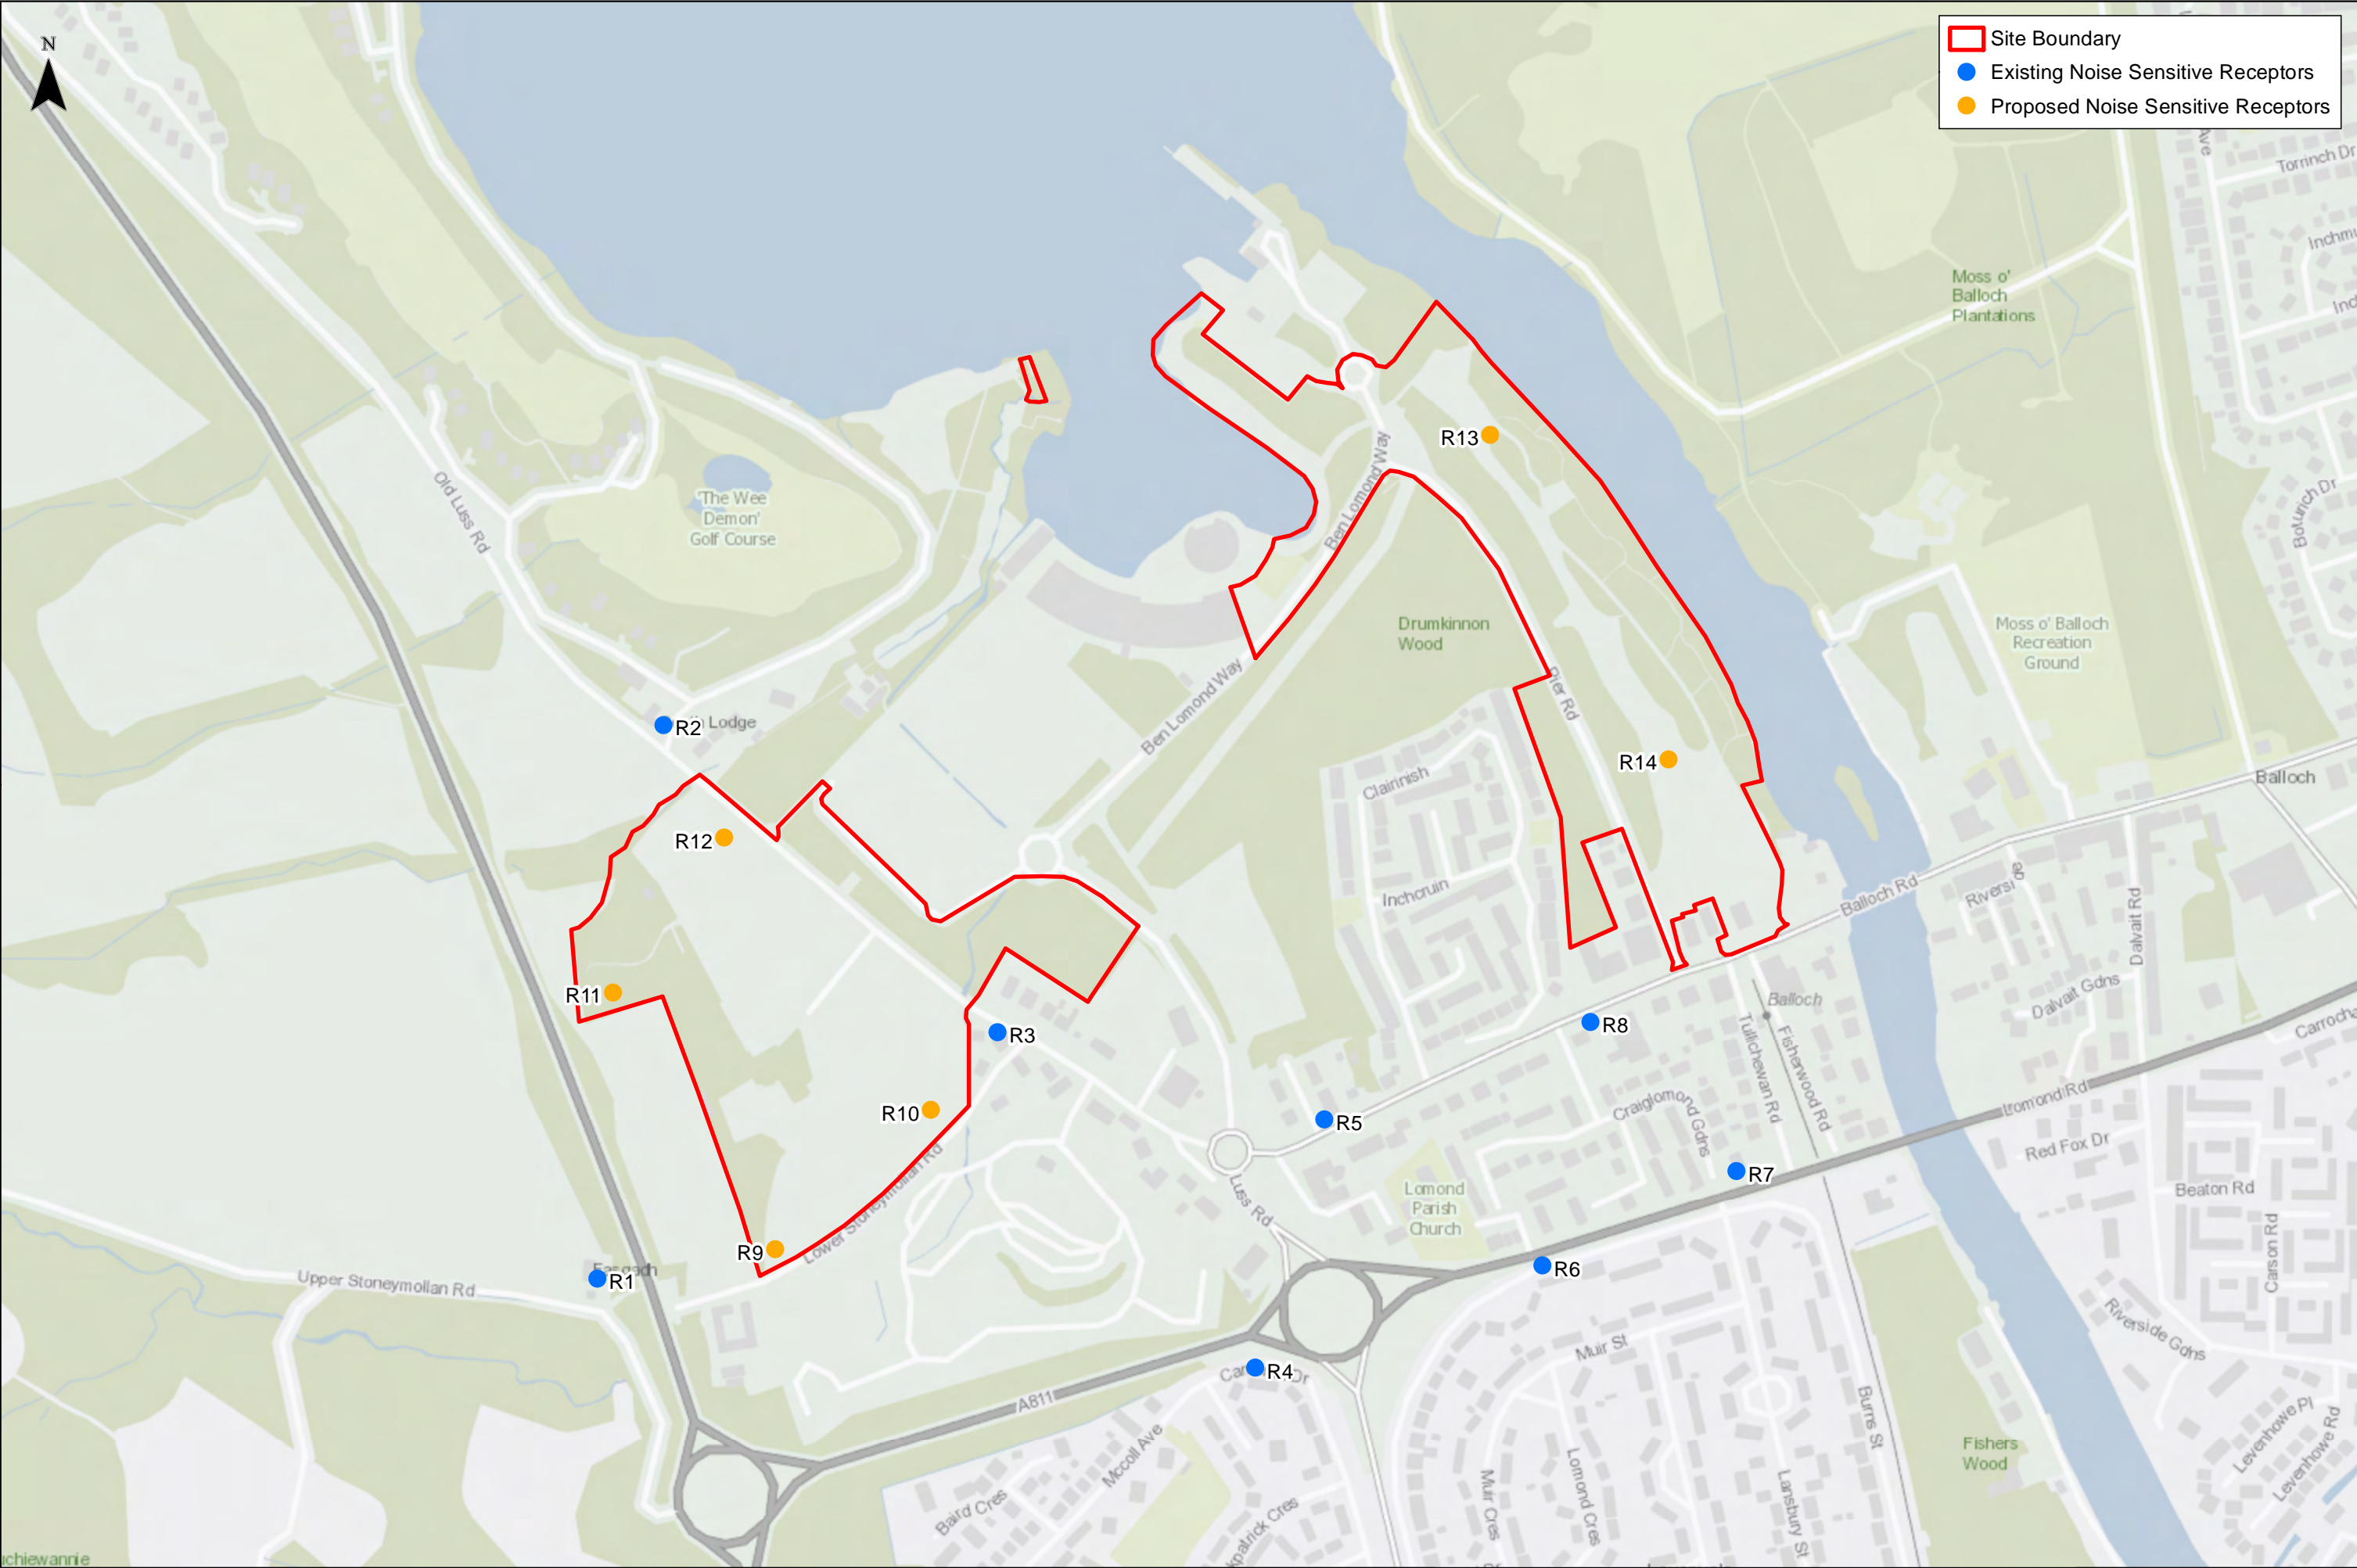
- Site Boundary
- Existing Noise Sensitive Receptors
- Proposed Noise Sensitive Receptors

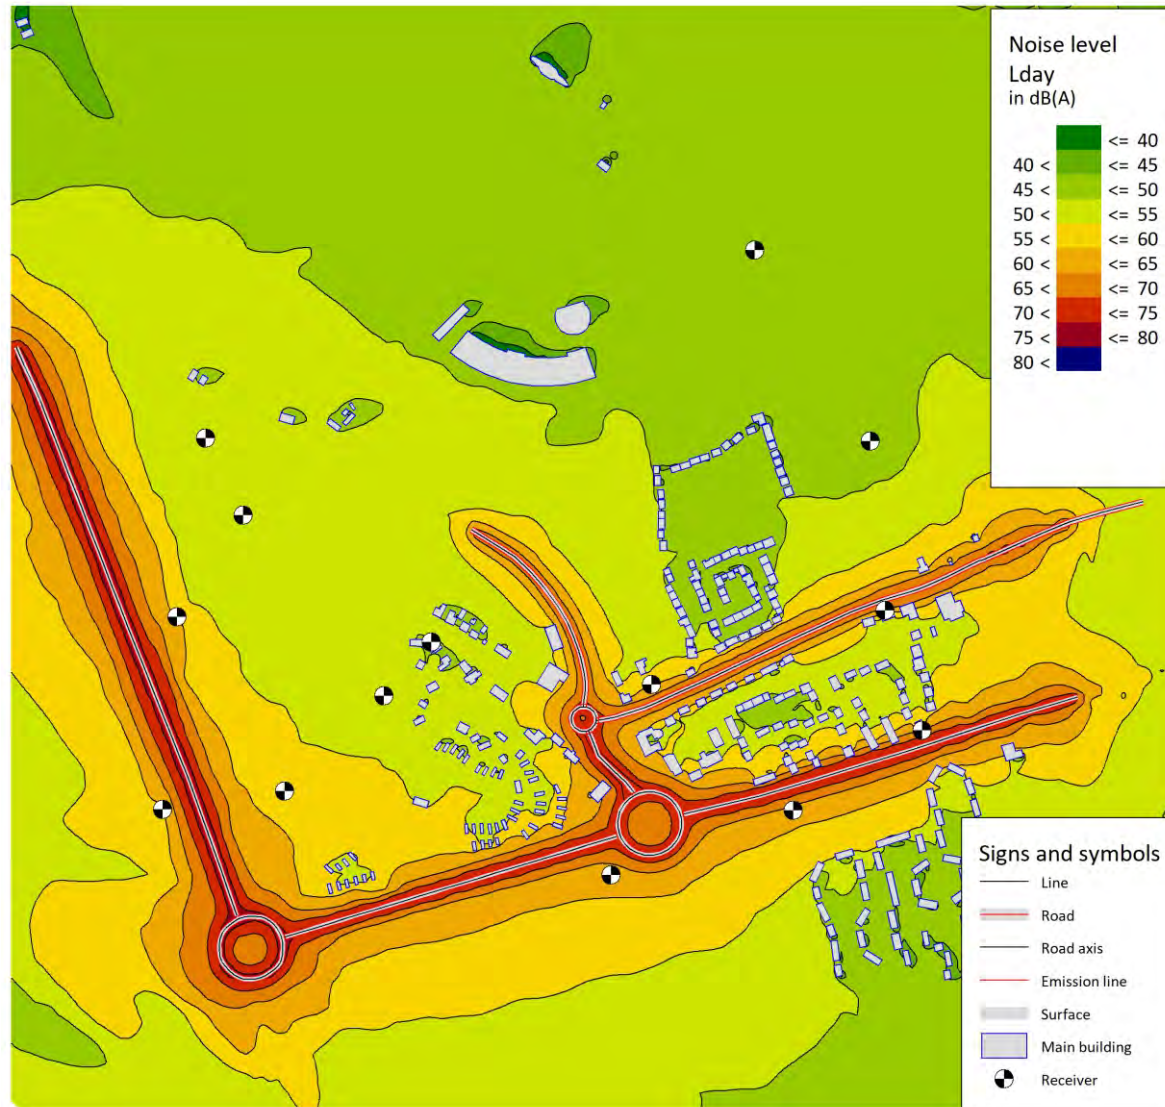
7.3

Daytime Baseline Sound Levels $L_{A10,18\text{hour}}$

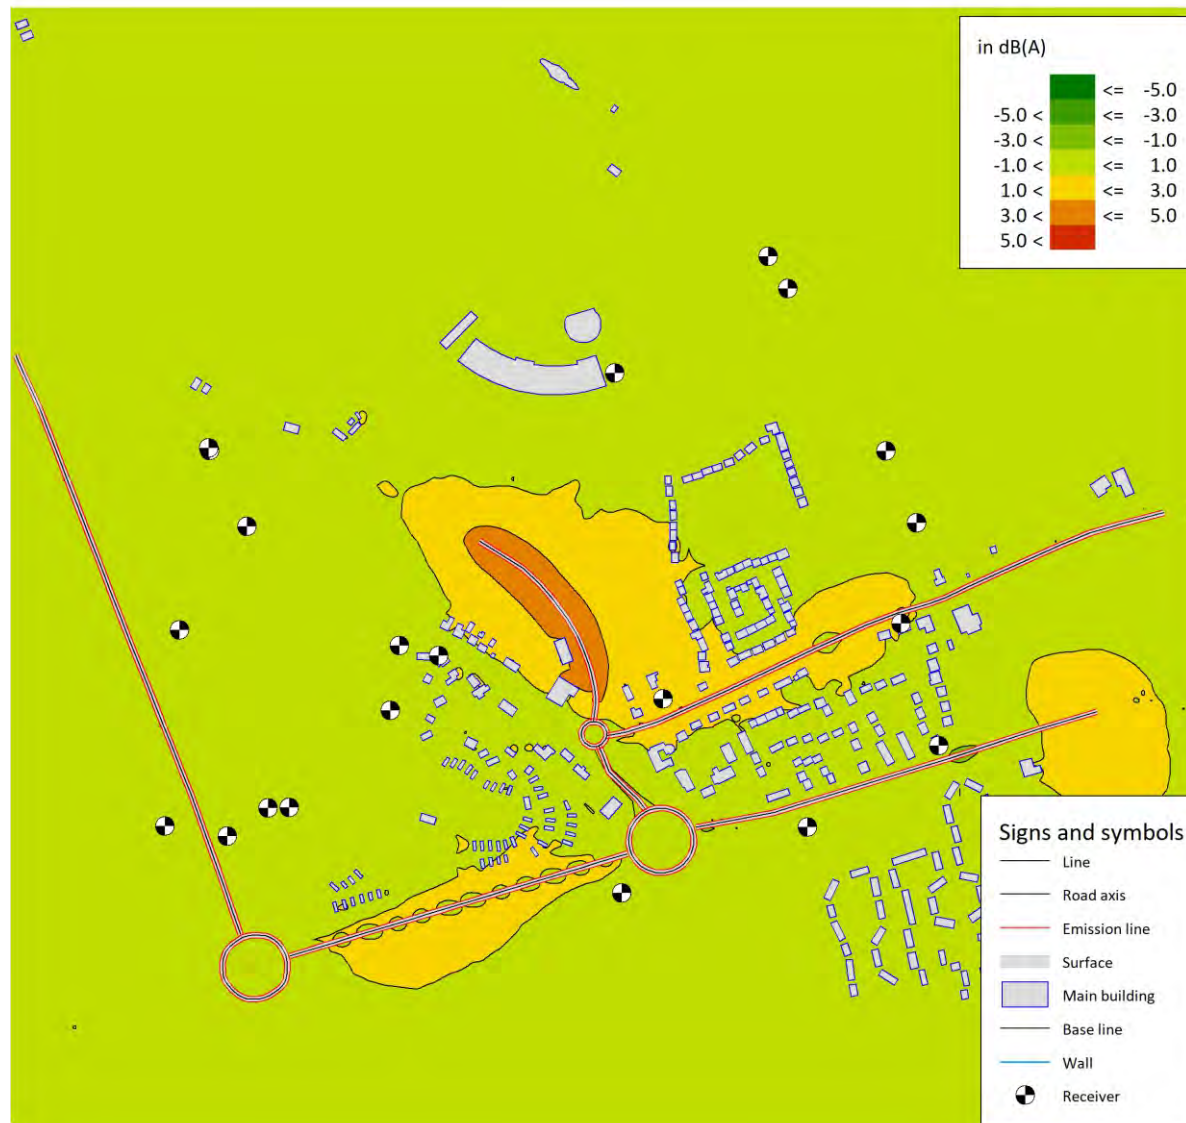
7.8

Daytime Change in Sound Levels $L_{A10, 18\text{hour}}$ With and Without Proposed Development
