13 Archaeology and Cultural Heritage

EIA Addendum Update

This EIA Chapter has been updated to account for the proposed reduction of 22 accommodation units at Woodbank and deletion of Area 10.

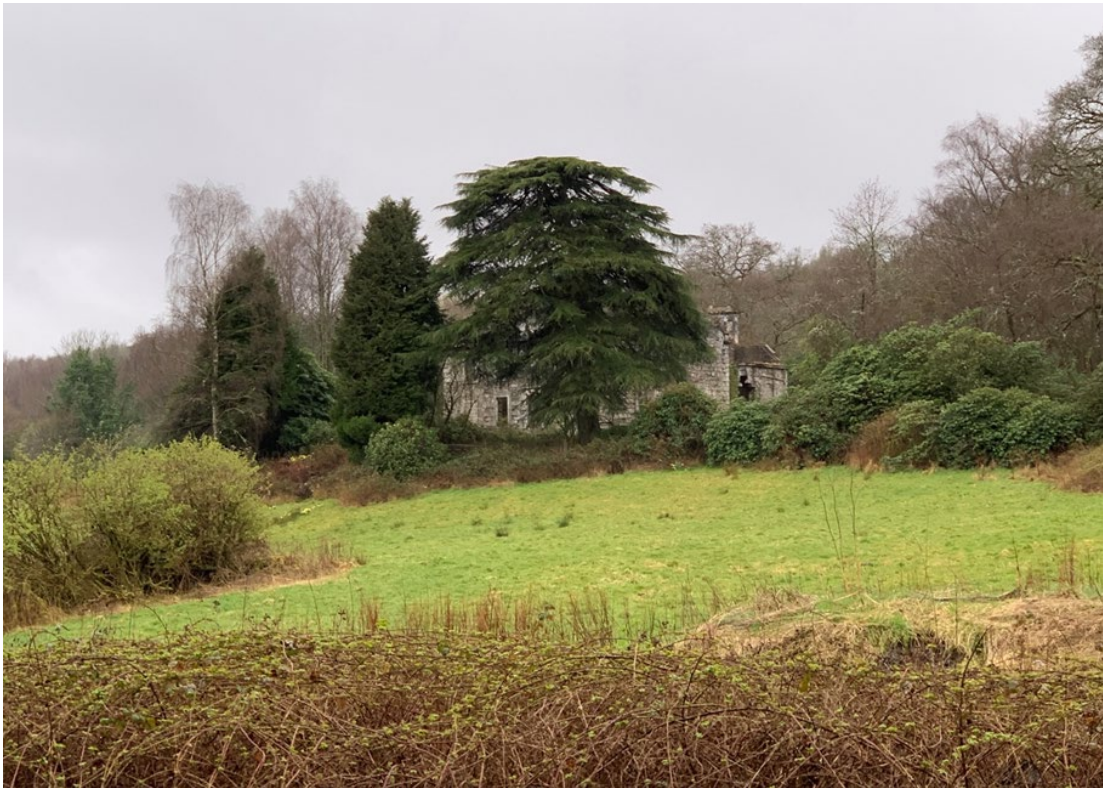
Image 13-1: View South of Woodbank House from Track

- 13.6.17 Views from the eastern elevation of the house are largely screened by trees, however, gaps within the trees allow for views over the grounds to the east and towards Old Luss Road.

- 13.6.18 The driveway curves round to the southern façade of the house, a nineteenth-century addition which now constitutes the main entrance. Again, partially hidden by woodland (depicted on the historic OS mapping), the house can only be glimpsed from the Lower Stoneymollan Road approximately 100m to the south, across an area of open pasture. This careful screen planting appears designed to ensure privacy for the house at the centre of what is a very small estate (**Image 13-2**). From the southern elevation of the house, outward views are largely limited by the trees, and the overall impression is of a house designed to be relatively secluded within a small woodland setting. The drive continues southward to a gate onto Lower Stoneymollan Road – historic mapping indicates this drive and entrance were added in the nineteenth century when the extension was built.

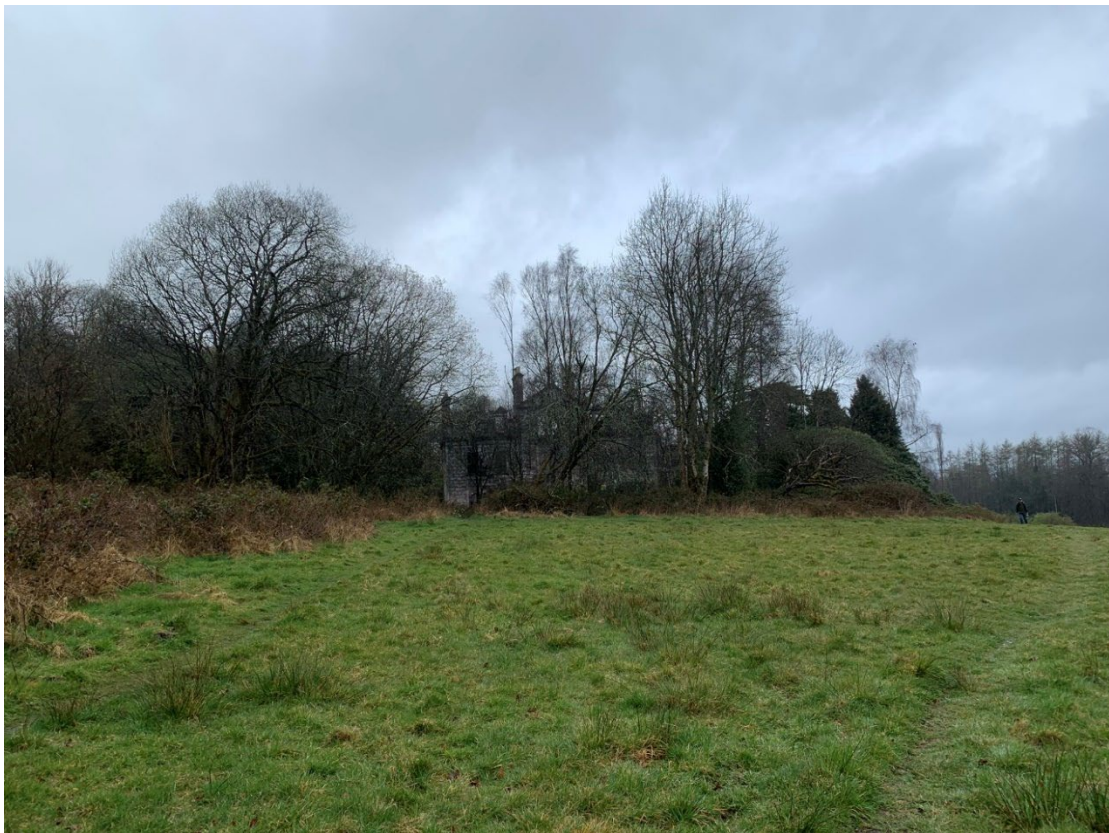
Image 13-2: View NNW of Southern Elevation of Woodbank House from Southern Extent of its Grounds

- 13.6.19 The gazebo (or ‘Garden Building’) element of Woodbank House with Garden Building is not readily appreciable as a landscape feature. Its relationship with the house and grounds is therefore difficult to discern, although it is likely it functioned as a notable landscape feature within the grounds and from which to take in views of the wider garden.

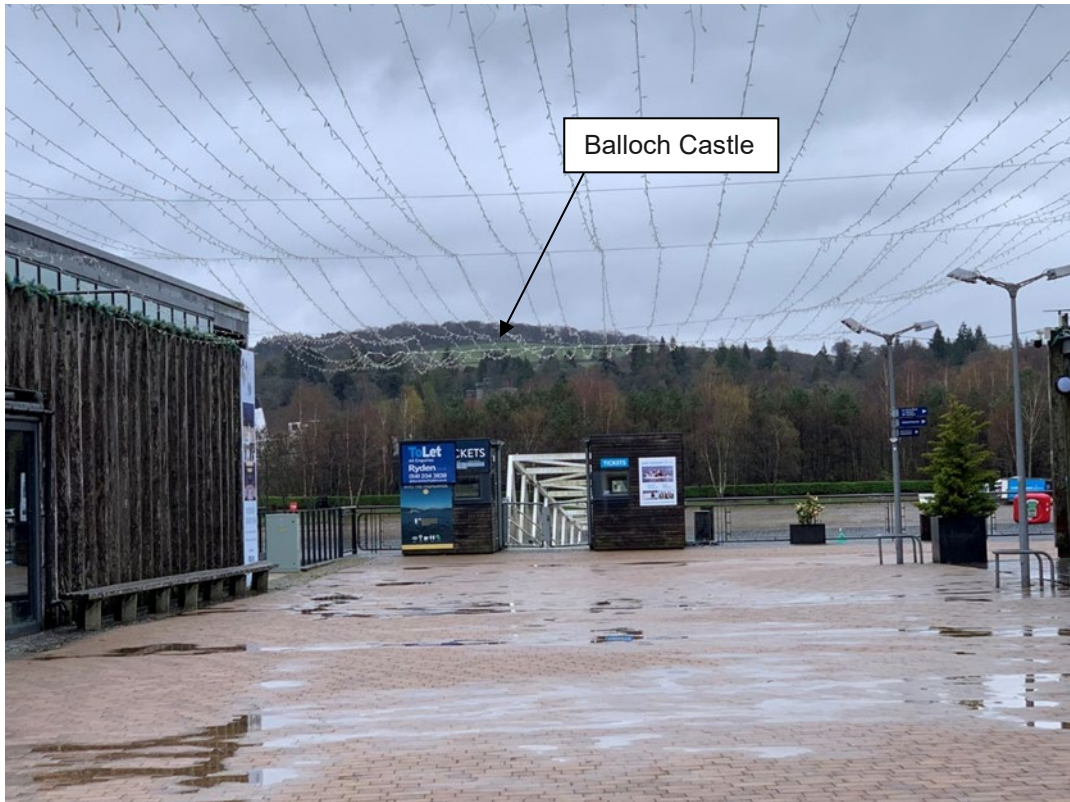
Image 13-3: View North-East from West of Loch Lomond Shore Showing Balloch Castle Amongst Trees

13.6.37 From Loch Lomond Shores, the IGDL and Balloch Castle are only partially visible on the approach to the shores along the paved area which runs north-east from the car park at the south-west. From here, the castle is largely obscured by tree cover (**Image 13-3**) and is completely screened by tree cover when looking in this direction from the vicinity of Drumkinnon Tower (Viewpoint 02, **Appendix 12.5**).

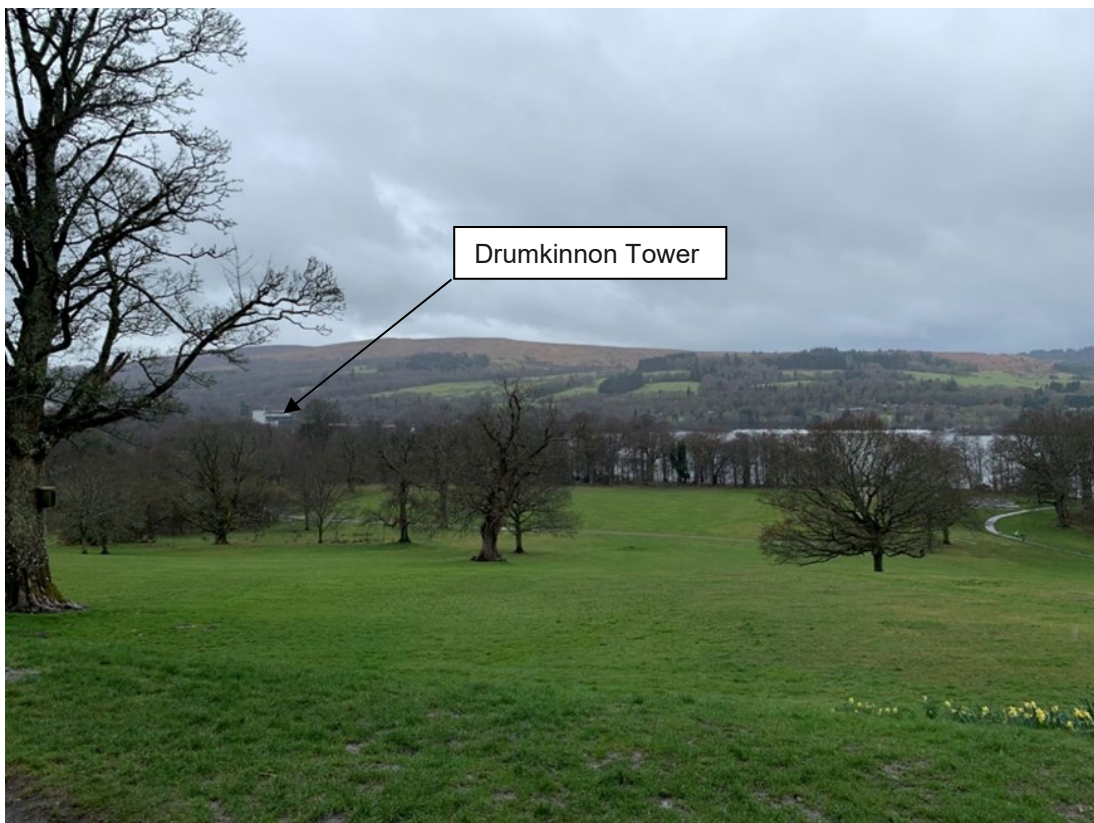
Image 13-4: View South-West From Balloch Castle

13.6.40 Upon reaching the castle, in its position overlooking the parkland, views across the loch open up to the west and north. The ornamental trees and parkland form the foreground of these views, which sweep away west and north, across the loch side woodland. In views to the south-west, the 36m high Drumkinnon Tower of the Loch Lomond Aquarium is just visible above the trees beyond the estate boundaries, with low hills rising to the south-west behind it (**Image 13-4**). To the west and north, across the sloping parkland, Loch Lomond can be seen curving away to the north, with mountains rising behind it. Views are drawn to these more open viewpoints, forming a key visual relationship between the castle, IGDL and the loch.

13.6.42 Views to the south-west from Balloch Castle are not considered to be key contributors to the cultural significance of the IGDL. As detailed in paragraph 13.6.37, the key outward views are considered to be those to the west and north across the loch. The Proposed Development would not appear in these views and would in any case be screened from view by tree cover in south-west facing views and almost completely screened by trees in views from the western extent of the IGDL. It would therefore remain possible to understand, appreciate and experience Balloch Castle and the IGDL and their key relationship to the loch and in terms of the reciprocal relationship between the castle and the IGDL grounds.

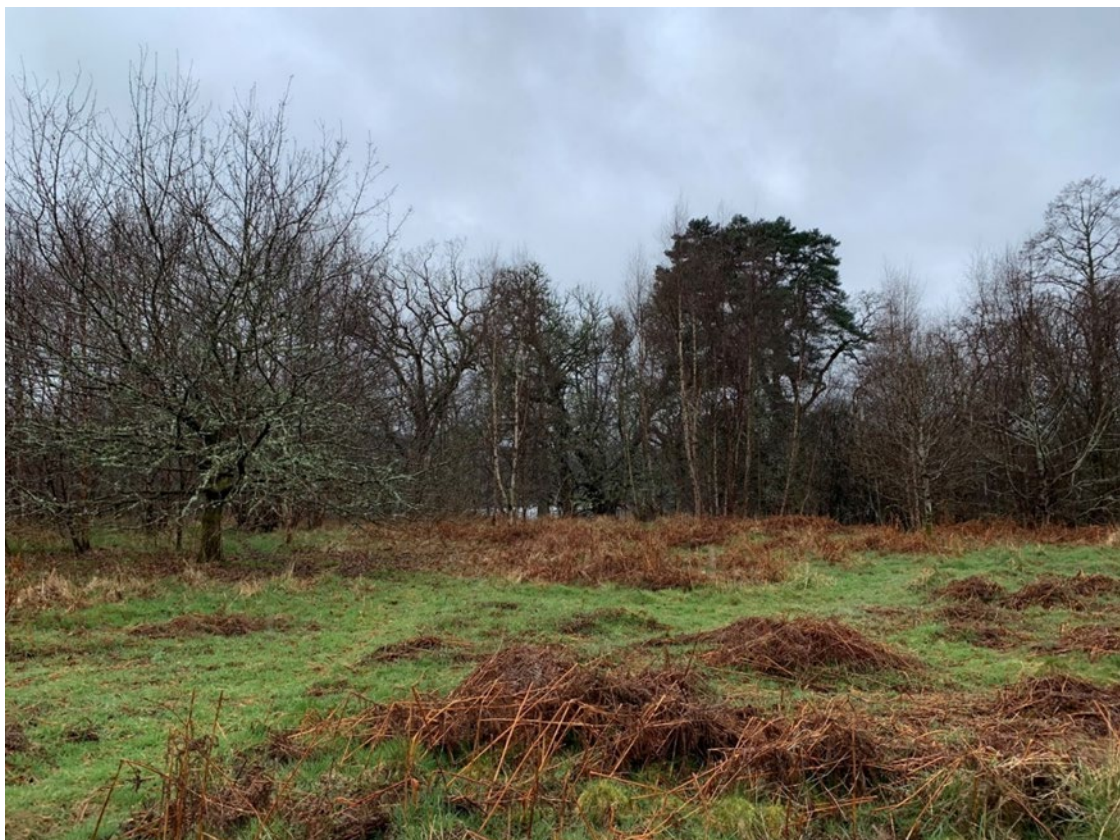
Image 13-5: View South-East from Balloch Castle Earthwork

13.6.47 The Scheduled Monument is currently partially overgrown, and the western half of the mound is within an area of trees know as 'Moat Wood'. The 1864 OS map (**Figure 13-4, Appendix 13.2**) depicts the earthworks, with woodland paths on two sides indicating that the castle was incorporated as a landscape feature on the Balloch Castle estate. Views out across the river mouth and loch are mostly restricted by the loch-side woodland of the Balloch estate, but it remains possible to appreciate and understand the reasons behind the Lennox's choice of location, albeit within a much reduced setting. Views westward are restricted by the trees, and the existing buildings around Loch Lomond Shores are not visible (**Image 13-5**).

13.6.48 The Scheduled Monument is on the eastern bank of the River Leven approximately 75m from the Proposed Development. Currently, the western bank is forested and crossed by footpaths
