## LOMOND BANKS – LVIA VISUAL REPRESENTATIONS FOR PLANNING SUBMISSION

## METHODOLOGY STATEMENT

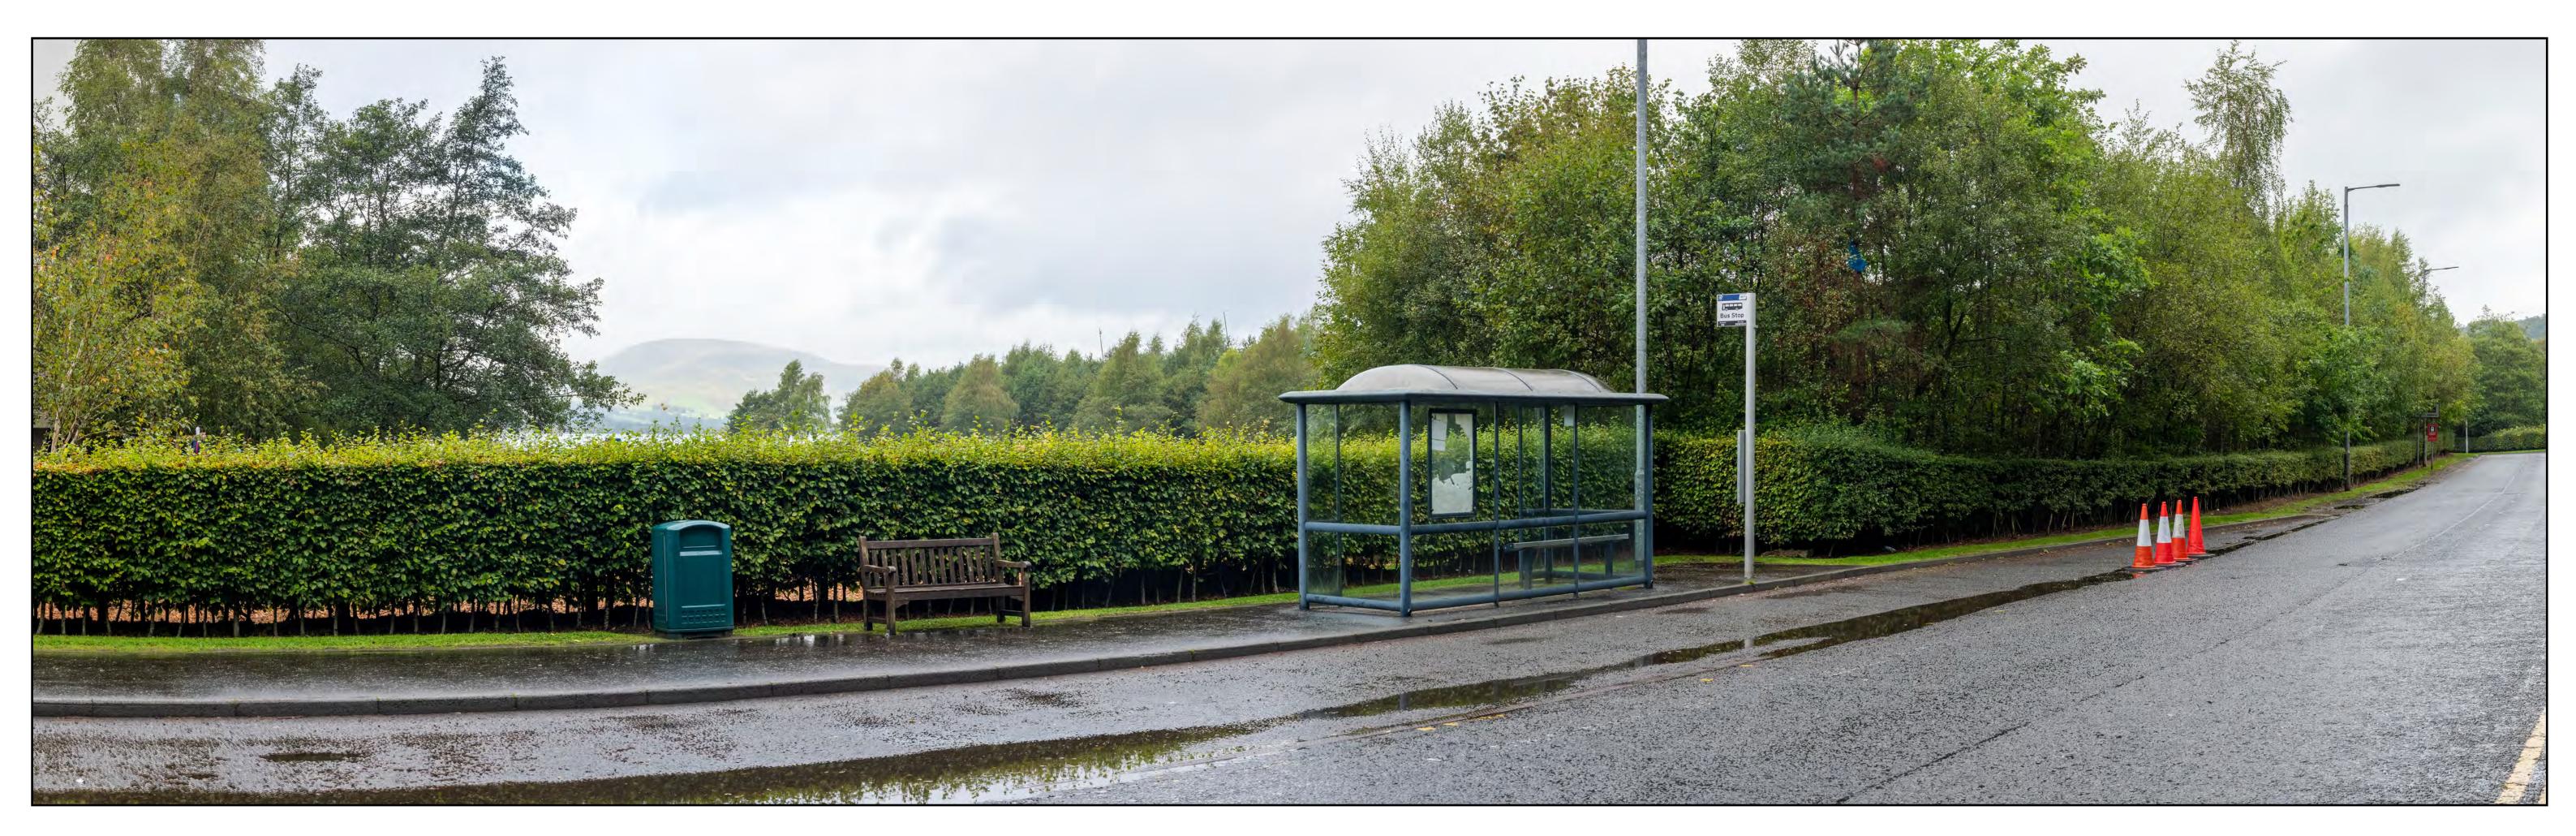
#### PHOTOGRAPH OF EXISTING LANDSCAPE FROM VIEWPOINT – SUMMER (90° FIELD OF VIEW)

Grid Ref: 56.005494, -4.589763; General Direction of View: North-West 321°; Date & Time of Photograph – 24/09/21 @ 11.25; Weather/Visibility – Rain/Poor; Camera – Nikon D810, AF-S NIKKOR 50mm f/1.4G Fixed Lens

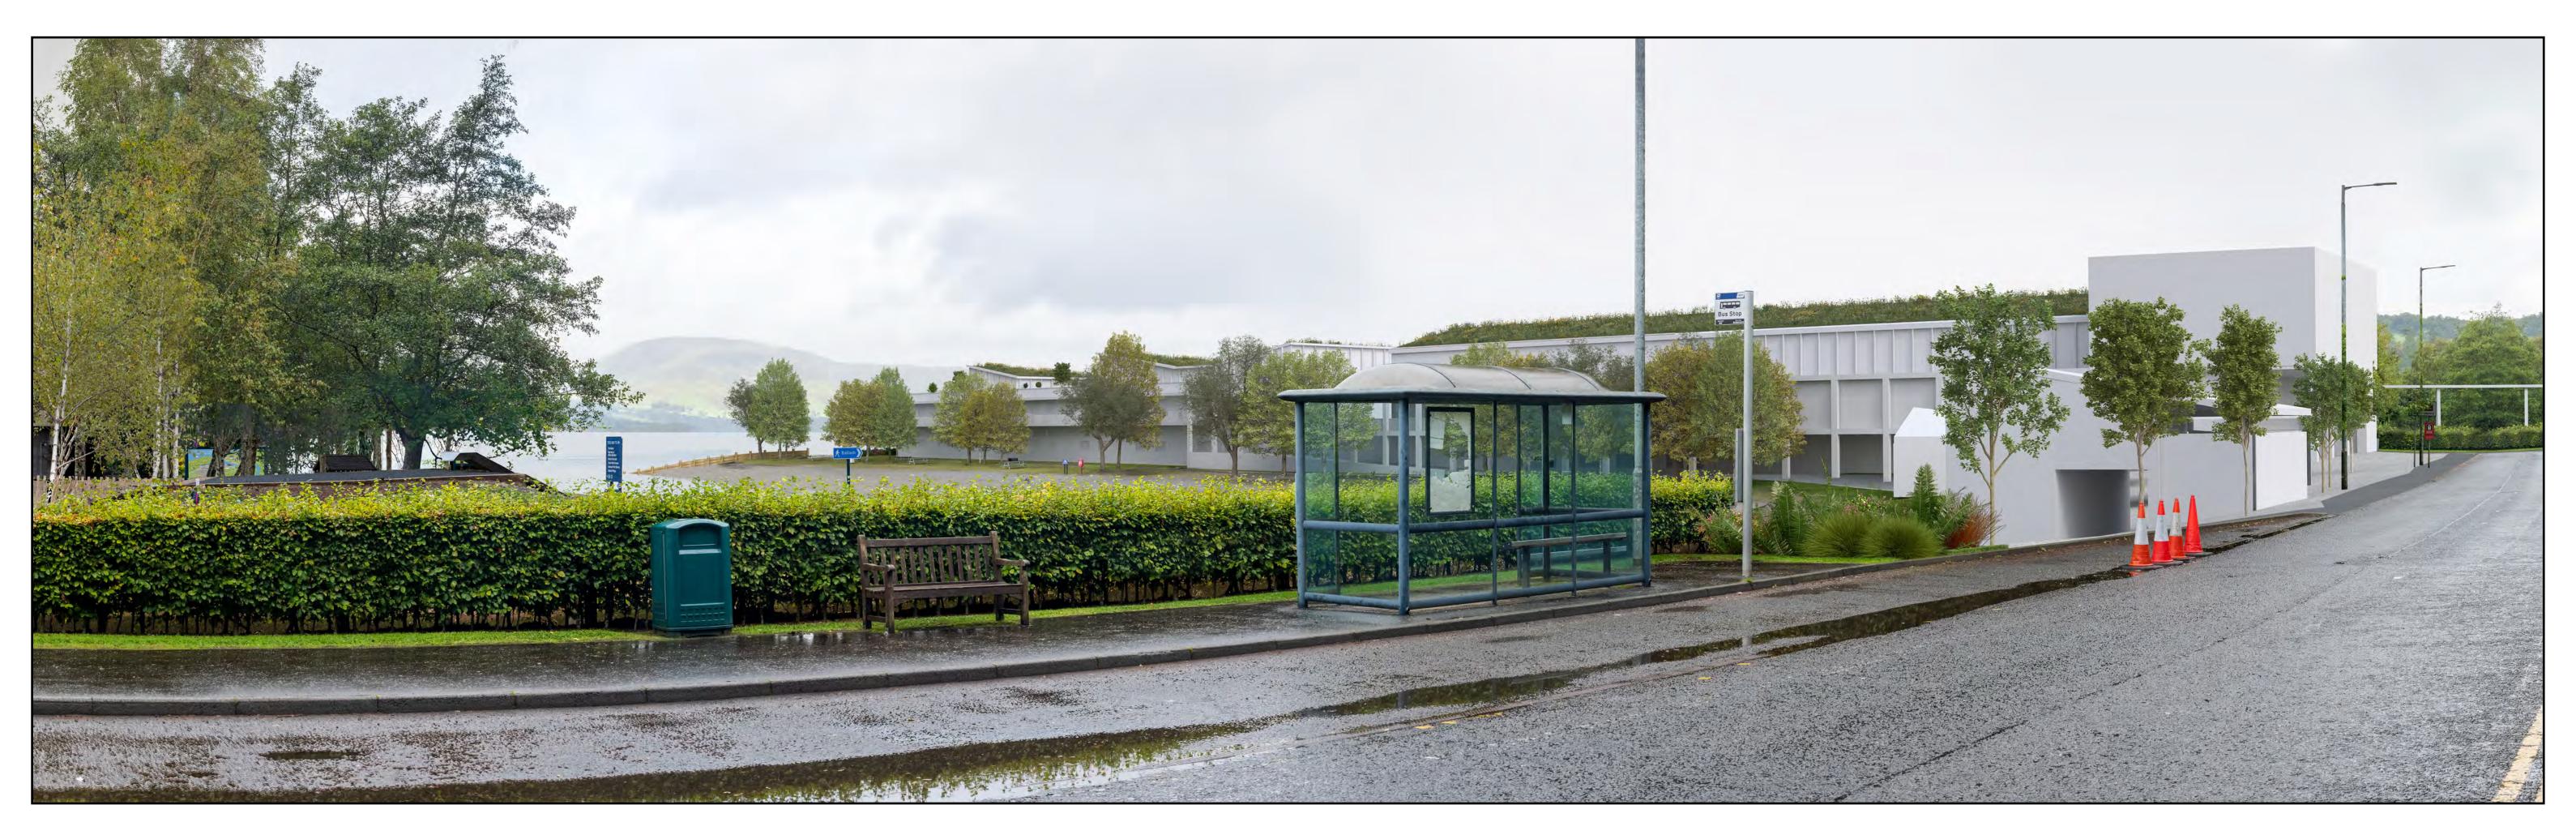
#### TYPE 3 VISUALISATION – AVR LEVEL 2 – SUMMER (90° FIELD OF VIEW)

Grid Ref: 56.005494, -4.589763; General Direction of View: North-West 321°; Date & Time of Photograph – 24/09/21 @ 11.25; Weather/Visibility – Rain/Poor; Camera – Nikon D810, AF-S NIKKOR 50mm f/1.4G Fixed Lens

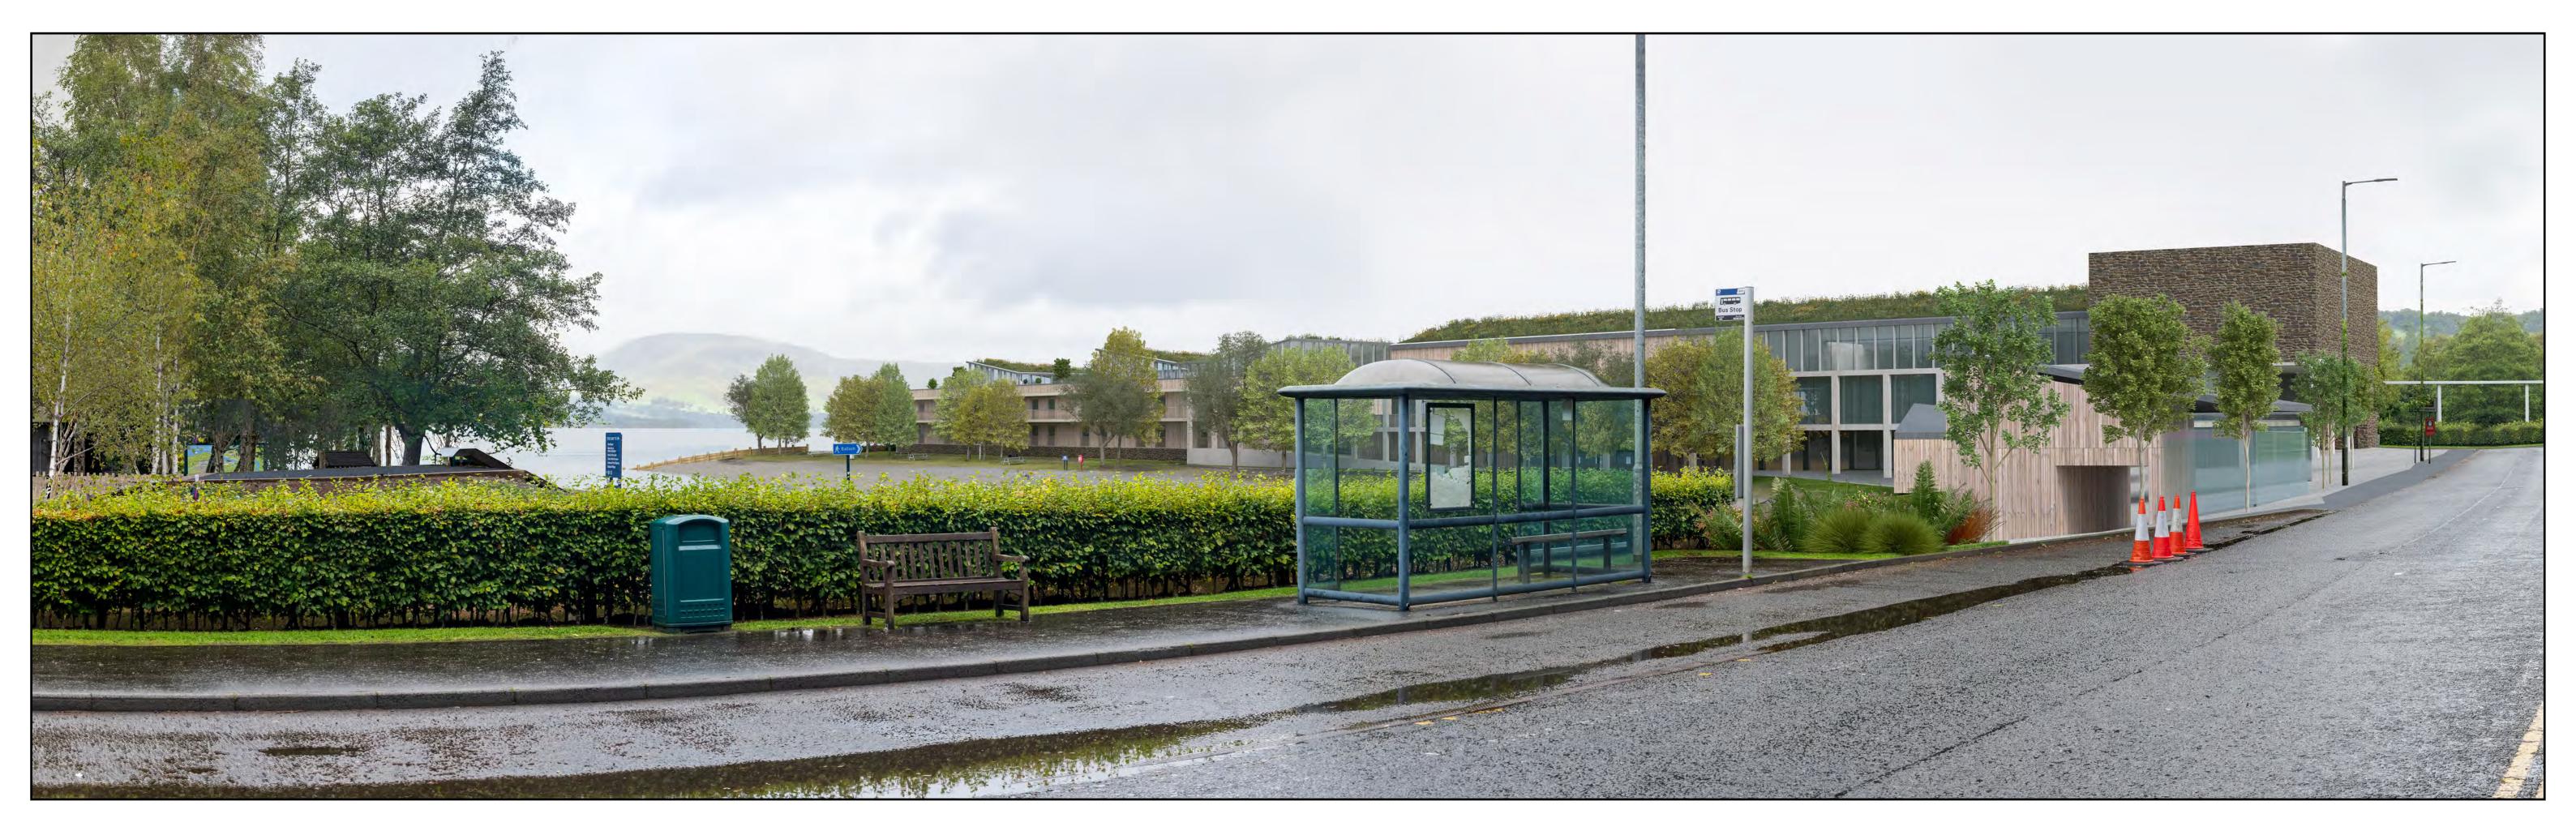
TYPE 3 VISUALISATION – AVR LEVEL 3 – SUMMER (90° FIELD OF VIEW)

Grid Ref: 56.005494, -4.589763; General Direction of View: North-West 321°; Date & Time of Photograph – 24/09/21 @ 11.25; Weather/Visibility – Rain/Poor; Camera – Nikon D810, AF-S NIKKOR 50mm f/1.4G Fixed Lens

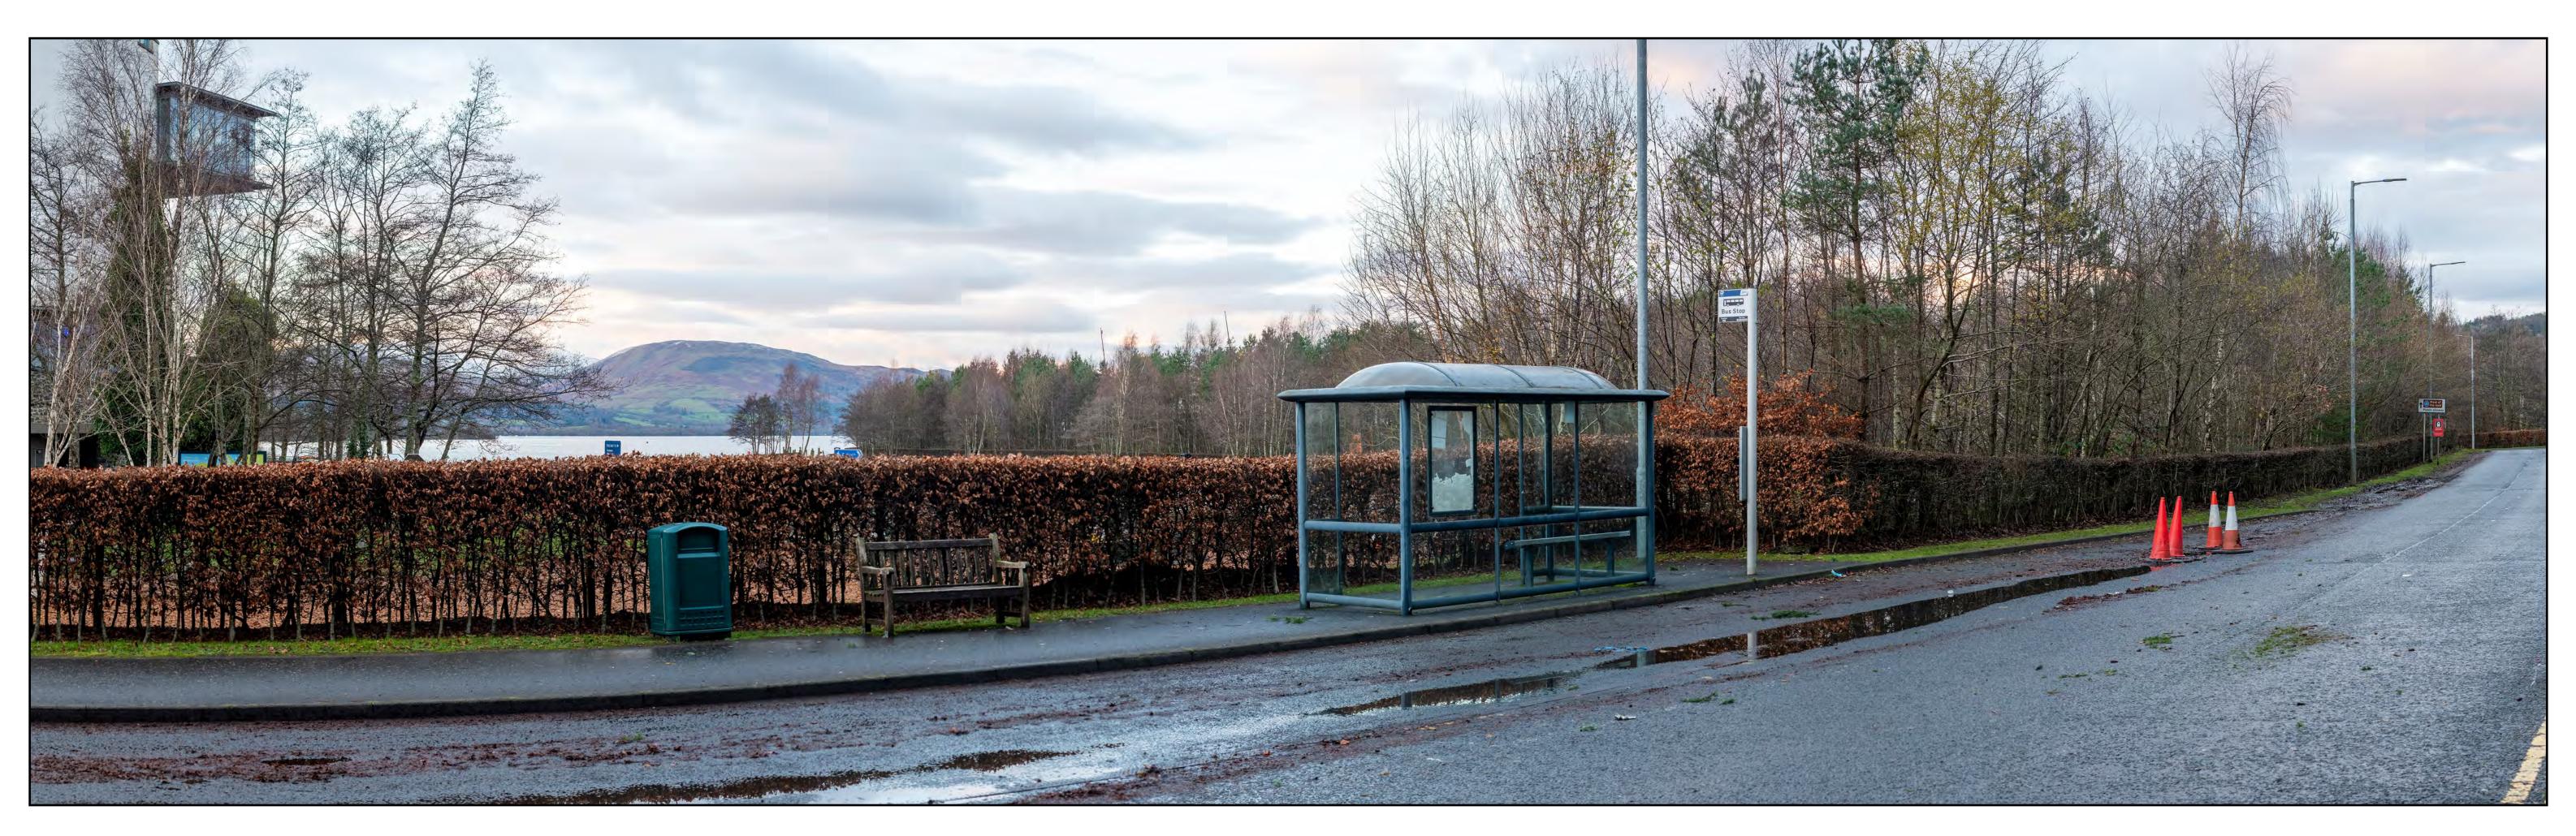
#### PHOTOGRAPH OF EXISTING LANDSCAPE FROM VIEWPOINT – WINTER (90° FIELD OF VIEW)

Grid Ref: 56.005494, -4.589763; General Direction of View: North-West 321°; Date & Time of Photograph – 08/12/21 @ 16.06; Weather/Visibility – Fine/Good; Camera – Nikon D810, AF-S NIKKOR 50mm f/1.4G Fixed Lens

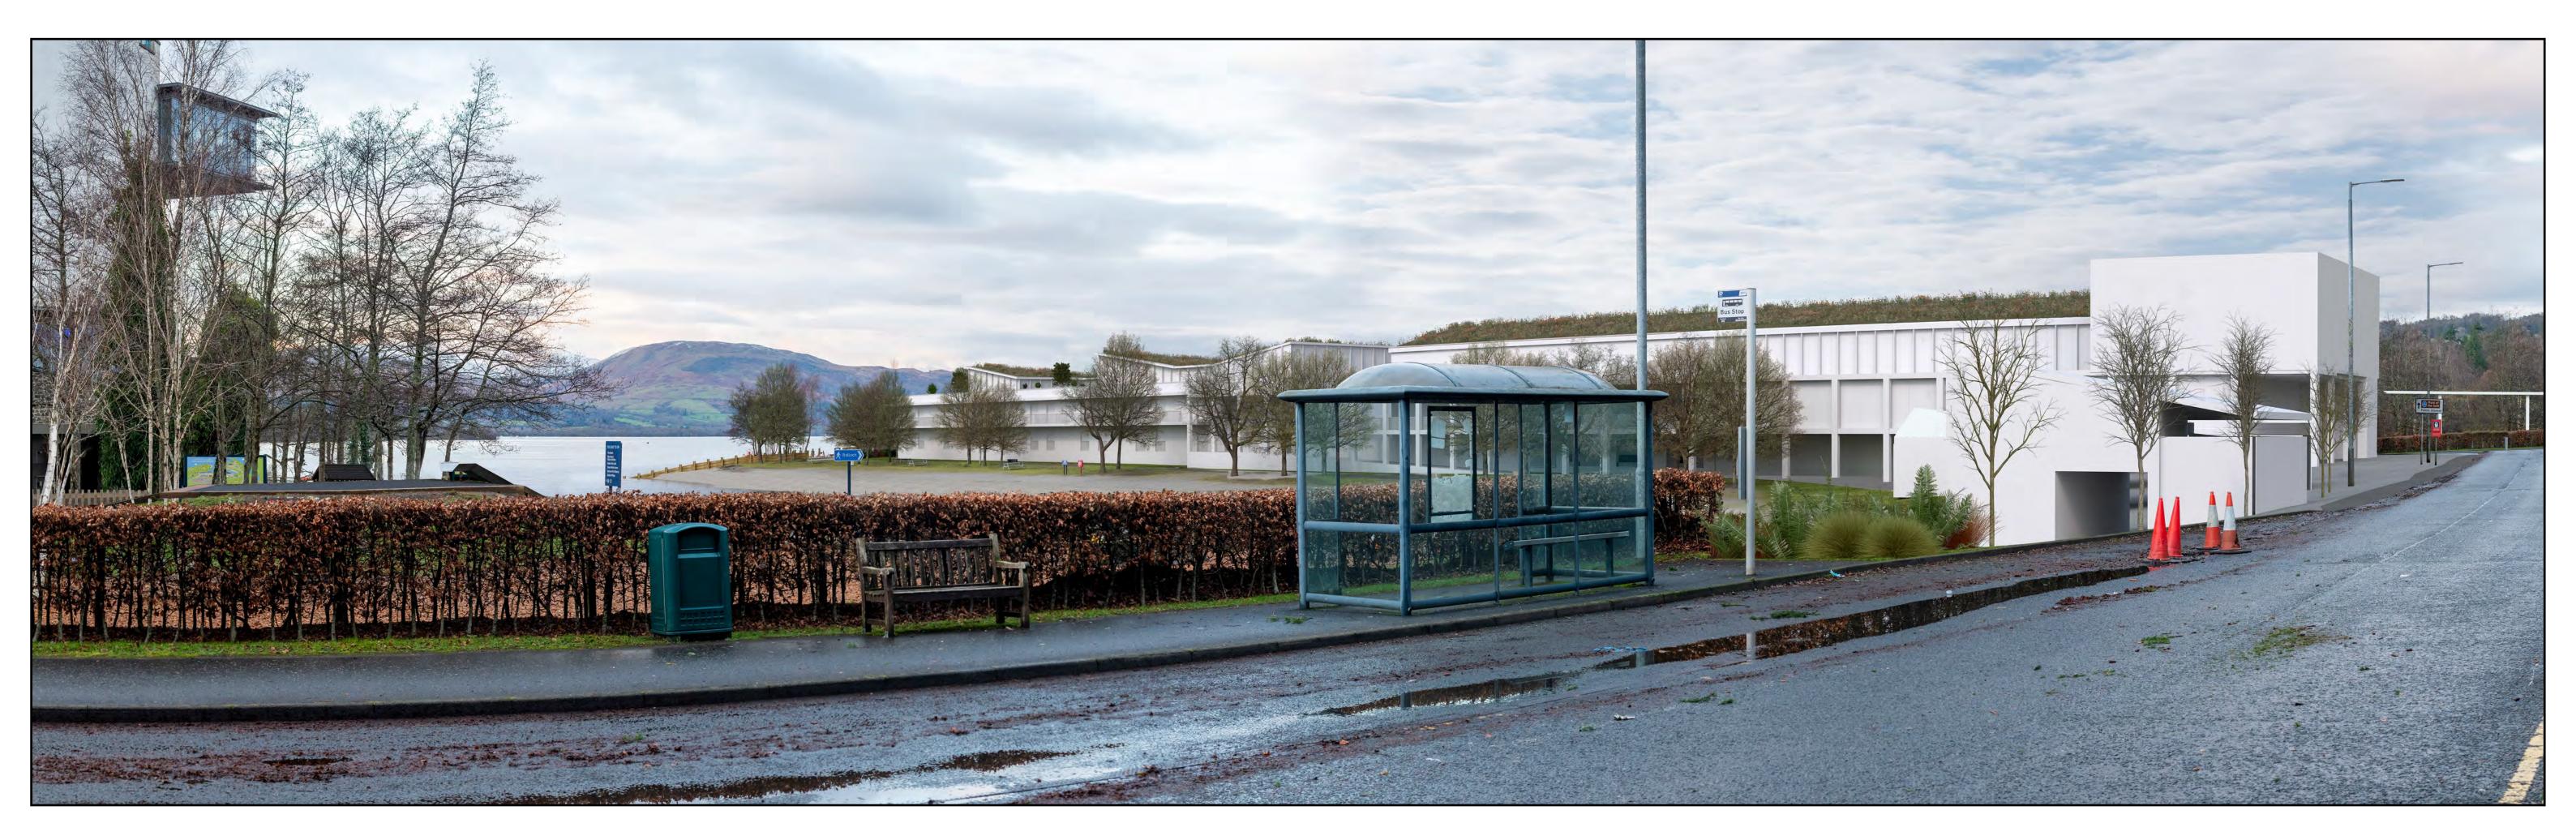
TYPE 3 VISUALISATION – AVR LEVEL 2 – WINTER (90° FIELD OF VIEW)

Grid Ref: 56.005494, -4.589763; General Direction of View: North-West 321°; Date & Time of Photograph – 08/12/21 @ 16.06; Weather/Visibility – Fine/Good; Camera – Nikon D810, AF-S NIKKOR 50mm f/1.4G Fixed Lens

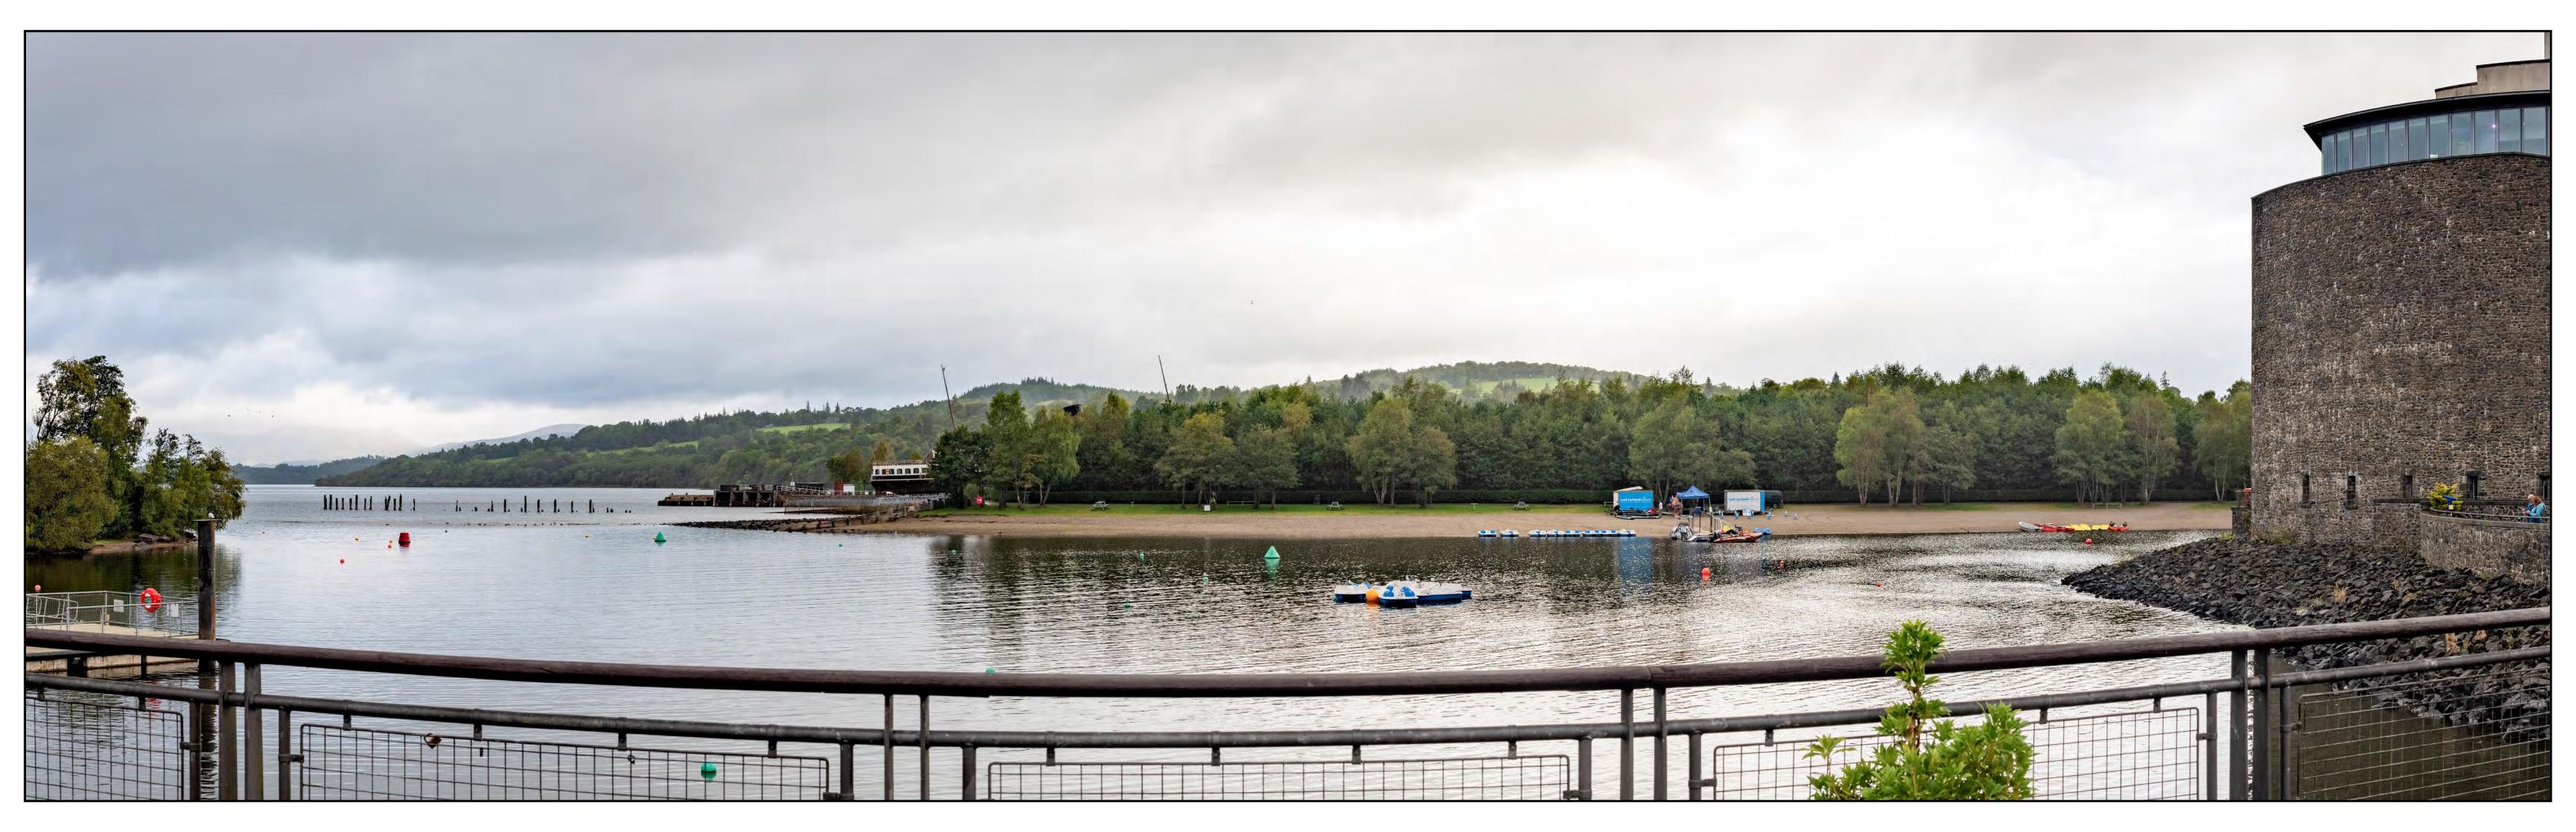
#### PHOTOGRAPH OF EXISTING LANDSCAPE FROM VIEWPOINT – SUMMER (90° FIELD OF VIEW)

Grid Ref: 56.005600, -4.592513; General Direction of View: North-East 45°; Date & Time of Photograph – 23/09/21 @ 10.38; Weather/Visibility – Rain/Poor; Camera – Nikon D810, AF-S NIKKOR 50mm f/1.4G Fixed Lens

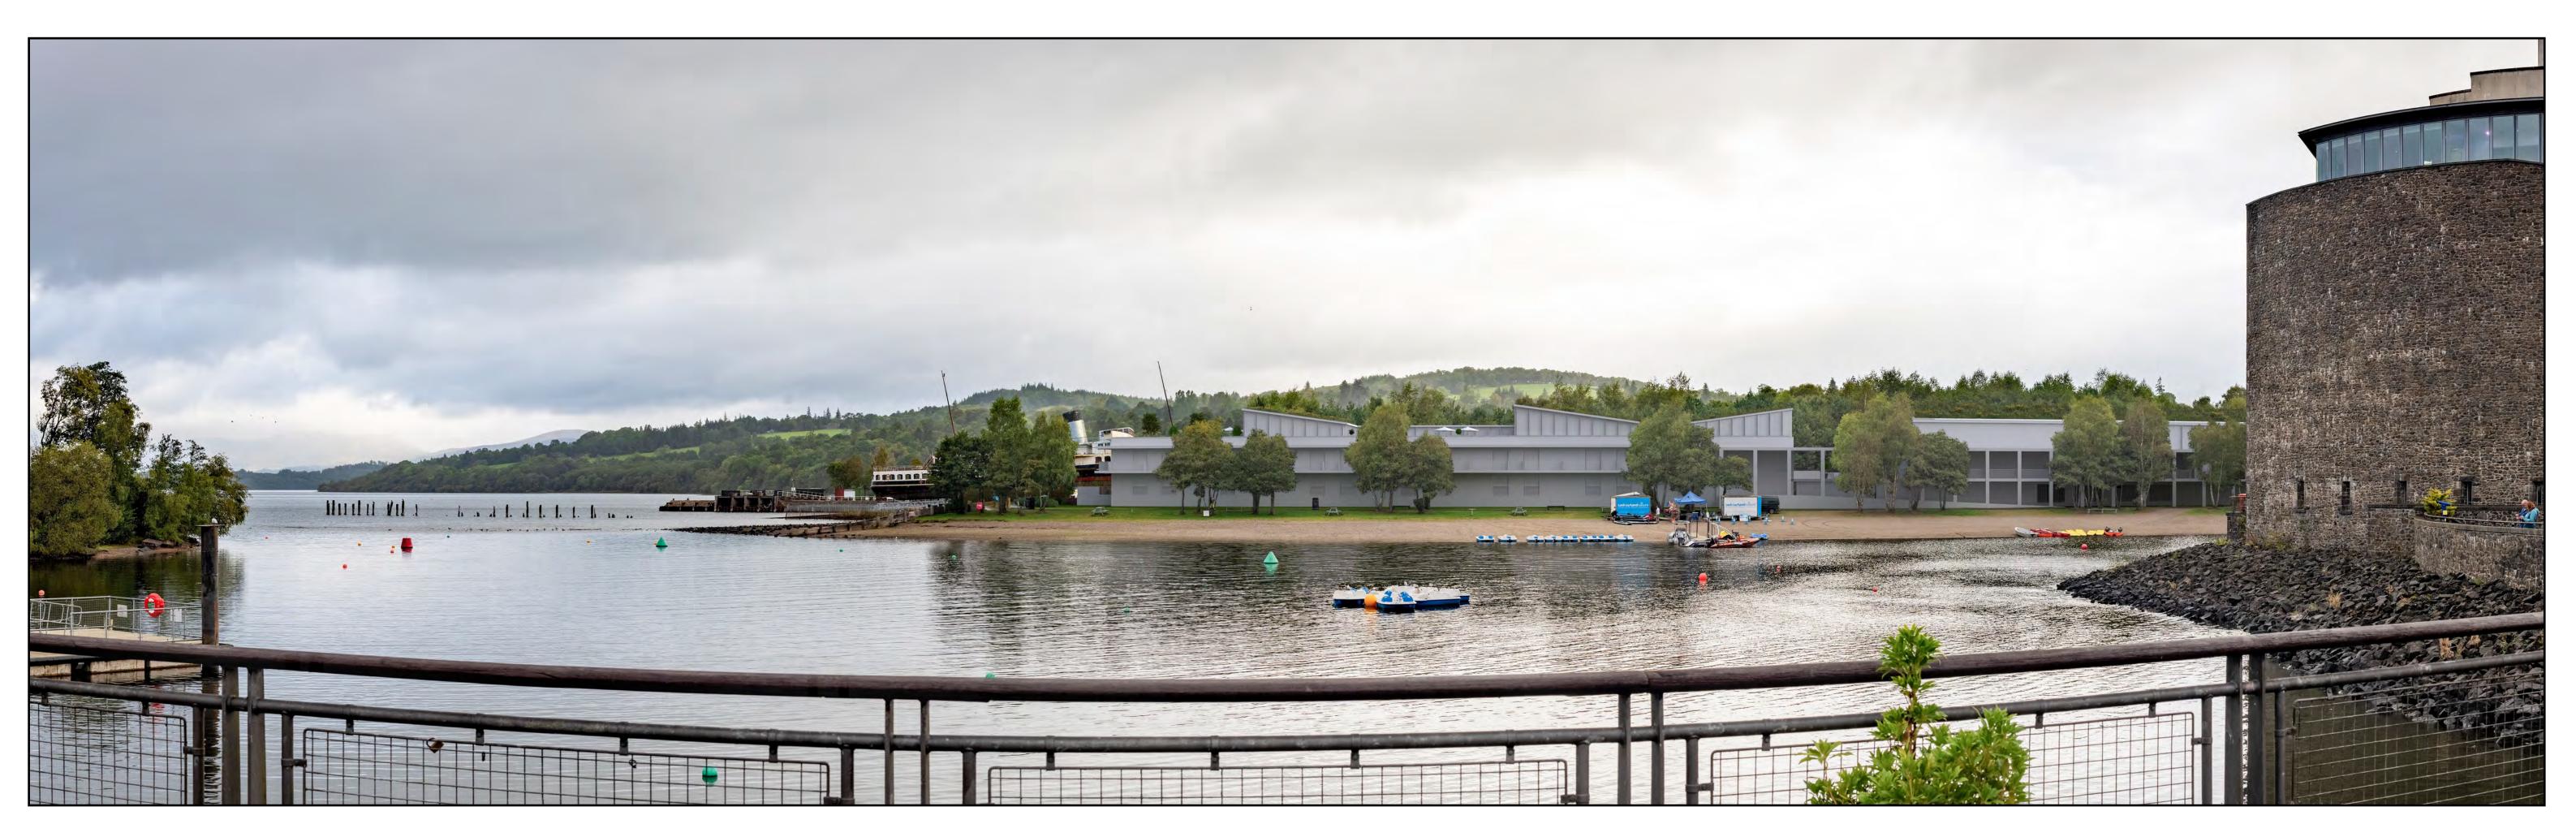
TYPE 3 VISUALISATION – AVR LEVEL 2 – SUMMER (90° FIELD OF VIEW)

Grid Ref: 56.005600, -4.592513; General Direction of View: North-East 45°; Date & Time of Photograph – 23/09/21 @ 10.38; Weather/Visibility – Rain/Poor; Camera – Nikon D810, AF-S NIKKOR 50mm f/1.4G Fixed Lens

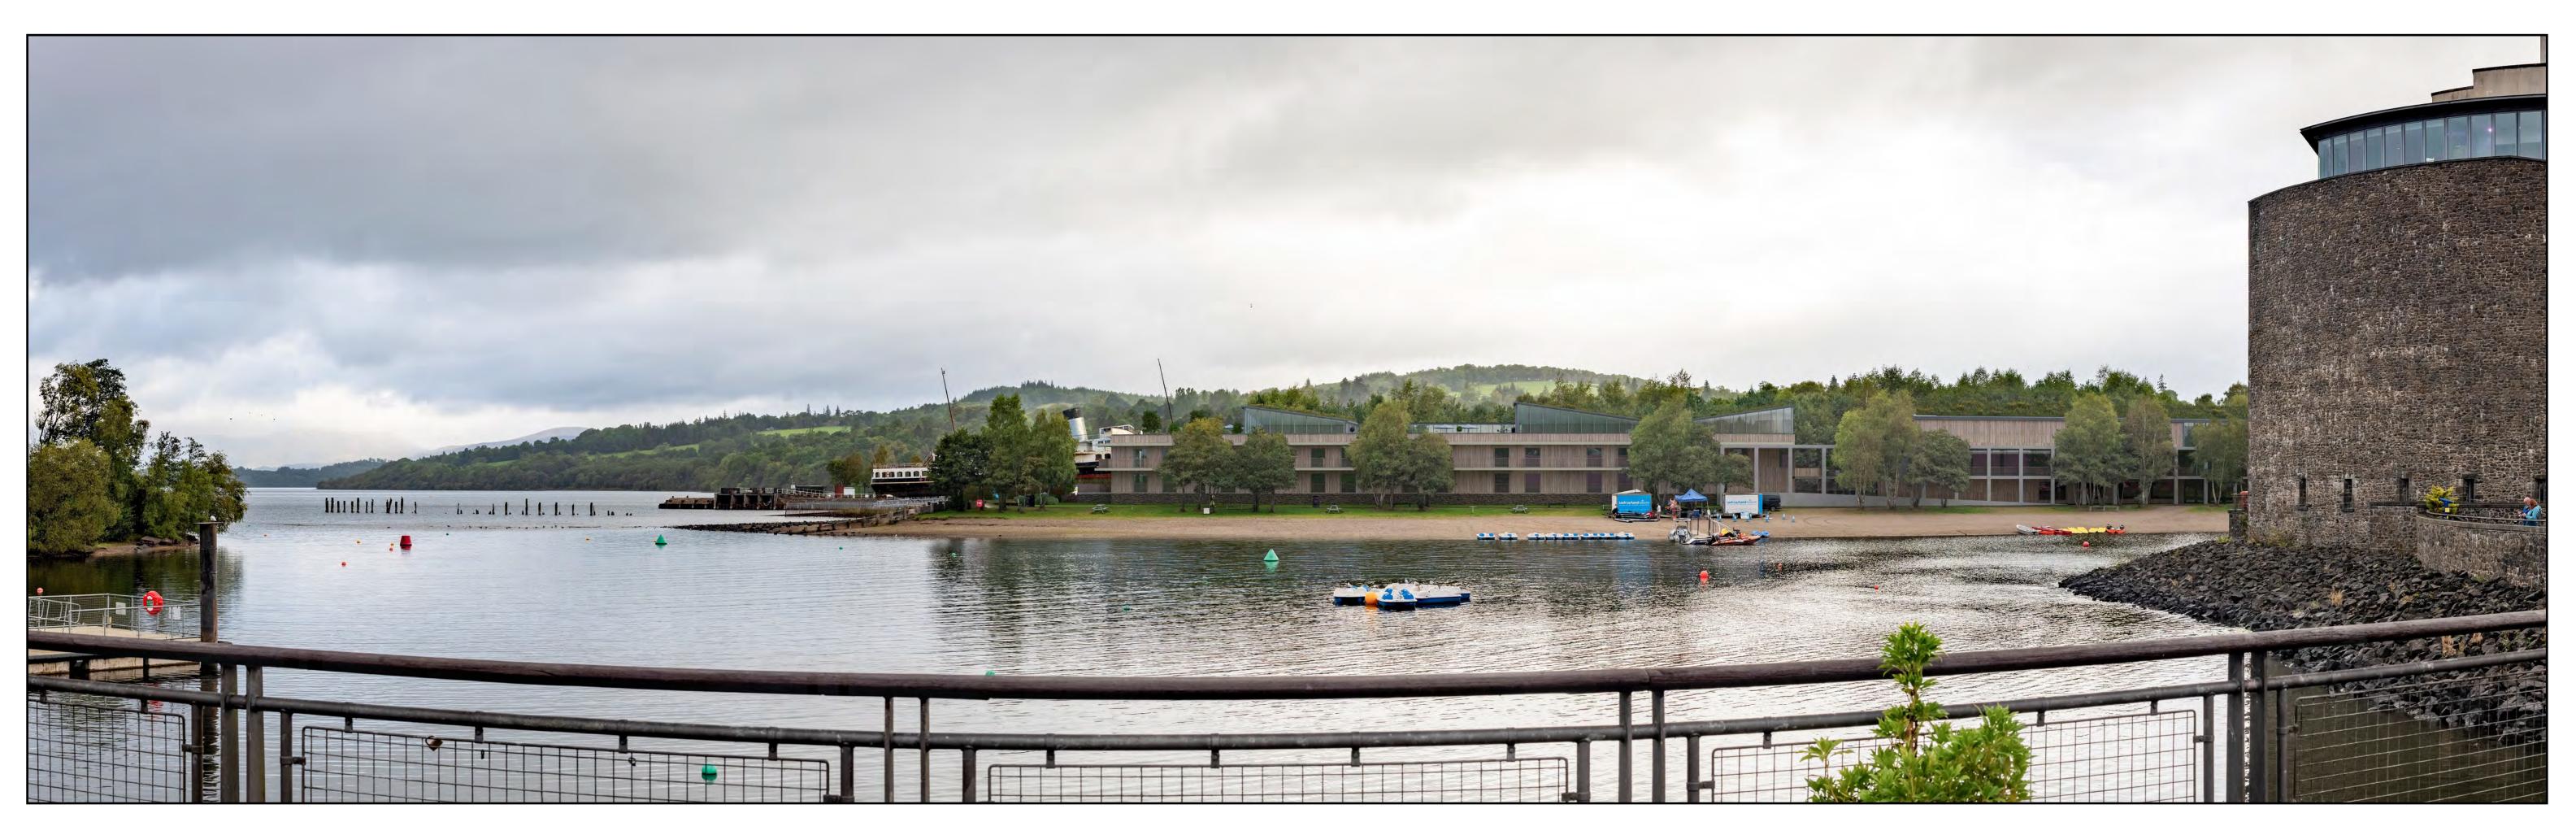
TYPE 3 VISUALISATION – AVR LEVEL 3 – SUMMER (90° FIELD OF VIEW)

Grid Ref: 56.005600, -4.592513; General Direction of View: North-East 45°; Date & Time of Photograph – 23/09/21 @ 10.38; Weather/Visibility – Rain/Poor; Camera – Nikon D810, AF-S NIKKOR 50mm f/1.4G Fixed Lens

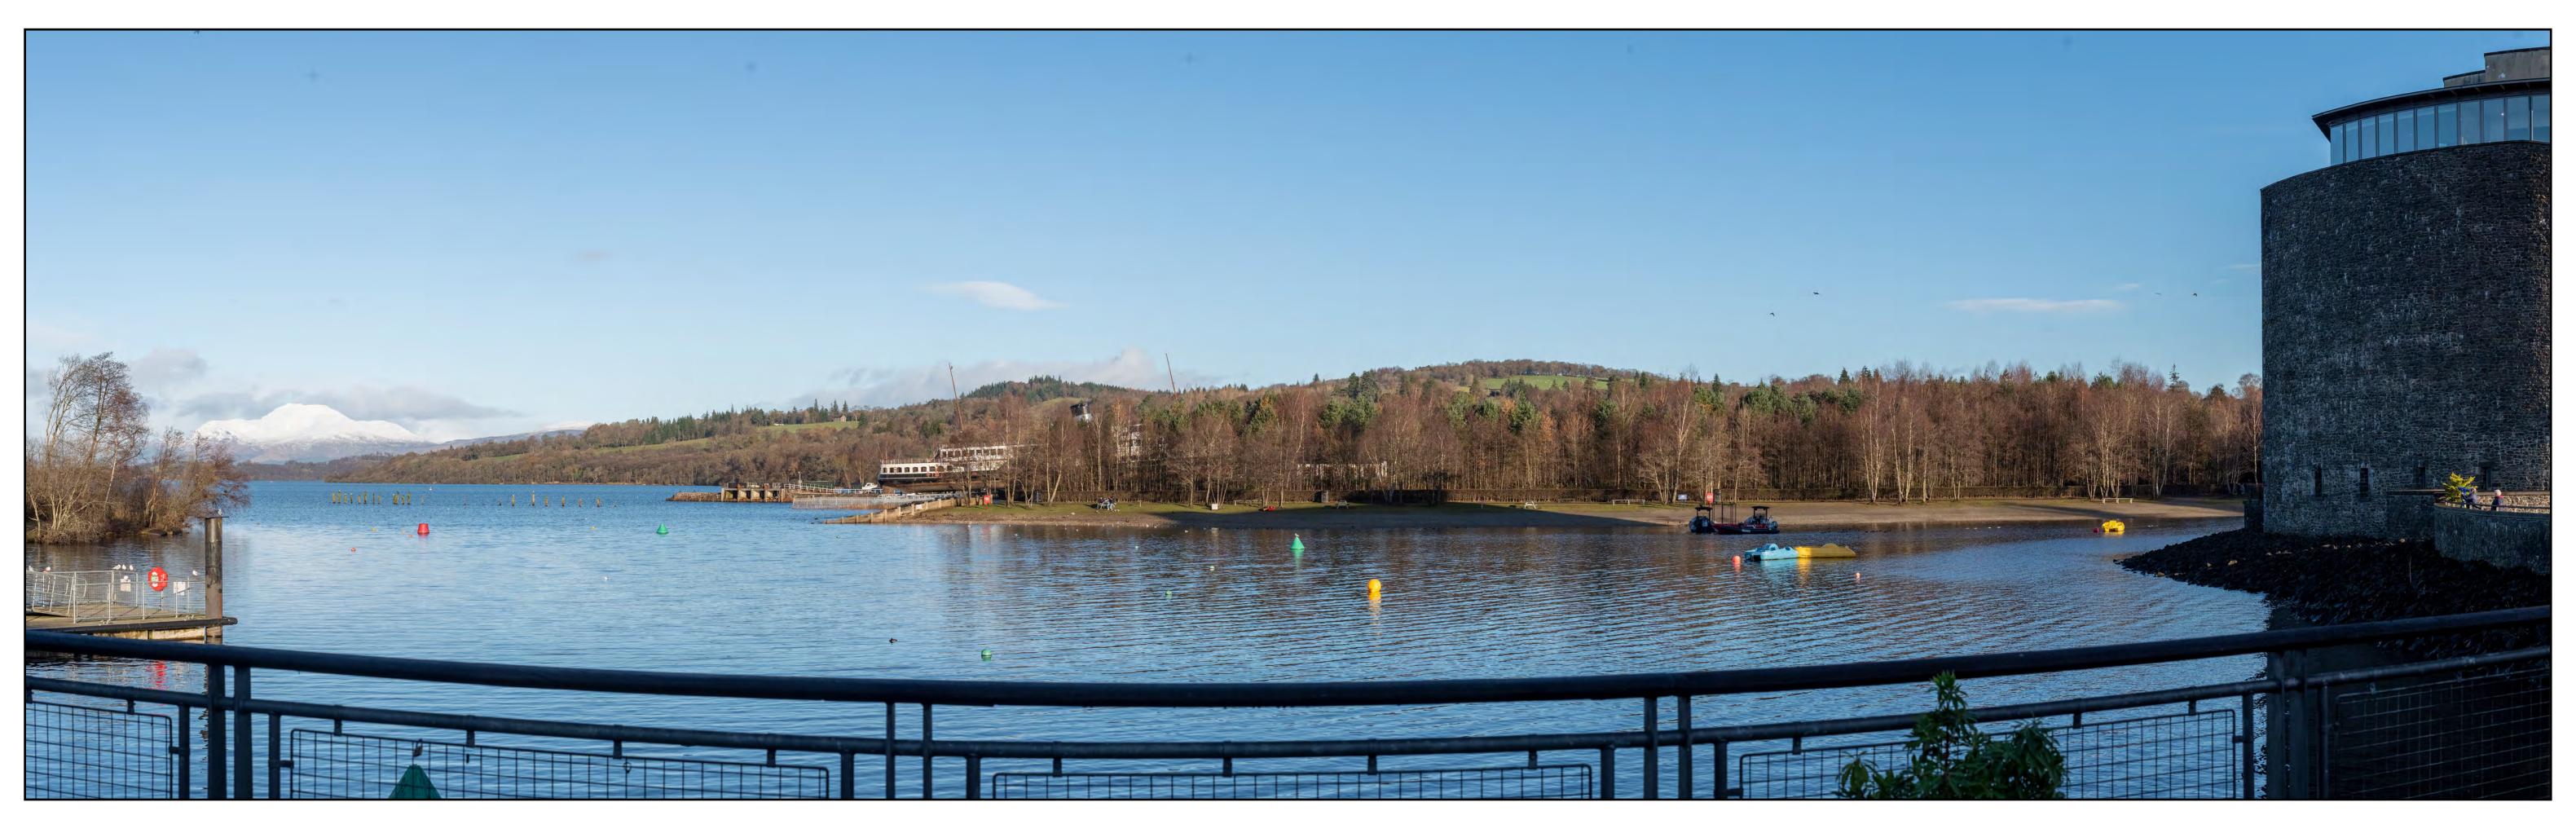
#### PHOTOGRAPH OF EXISTING LANDSCAPE FROM VIEWPOINT – WINTER (90° FIELD OF VIEW)

Grid Ref: 56.005600, -4.592513; General Direction of View: North-East 45°; Date & Time of Photograph – 10/12/21 @ 12.41; Weather/Visibility – Sunny/Clear; Camera – Nikon D810, AF-S NIKKOR 50mm f/1.4G Fixed Lens

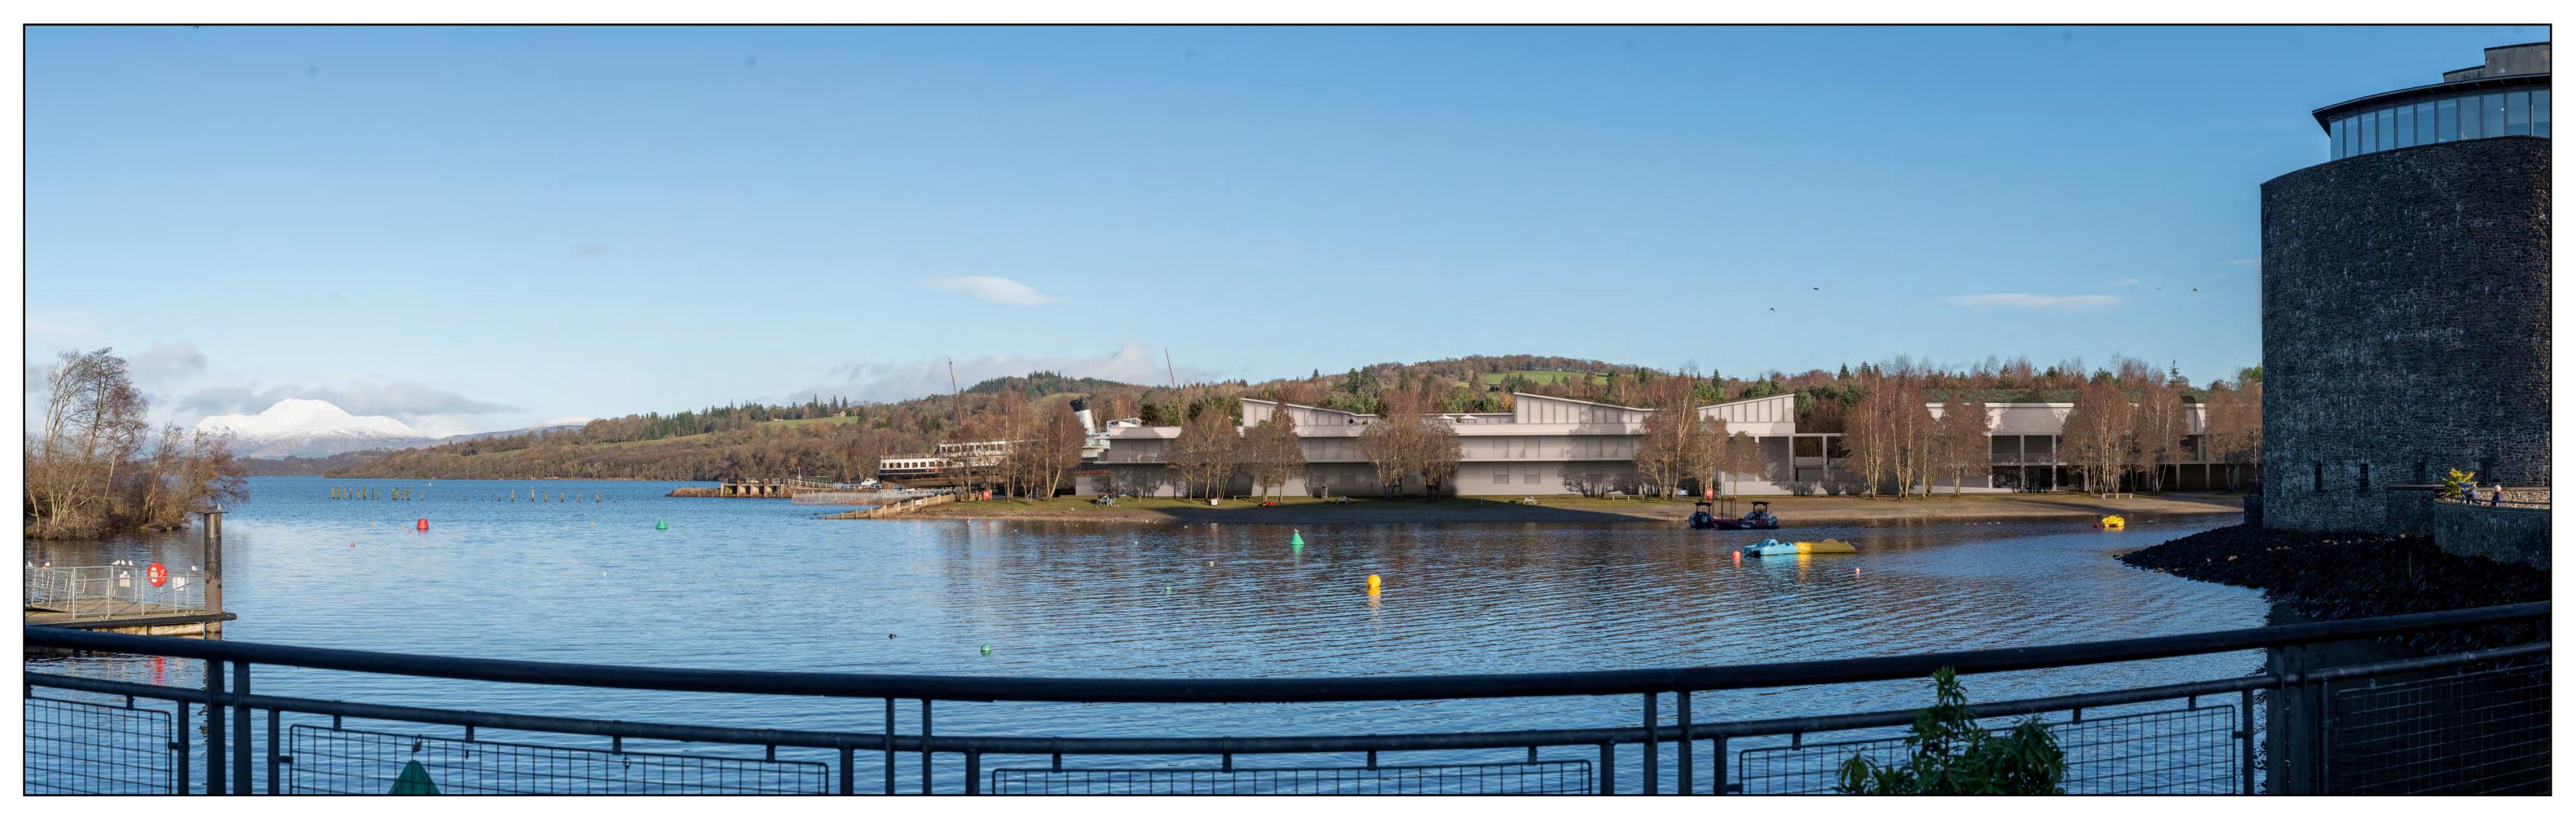
TYPE 3 VISUALISATION – AVR LEVEL 2 – WINTER (90° FIELD OF VIEW)

Grid Ref: 56.005600, -4.592513; General Direction of View: North-East 45°; Date & Time of Photograph – 10/12/21 @ 12.41; Weather/Visibility – Sunny/Clear; Camera – Nikon D810, AF-S NIKKOR 50mm f/1.4G Fixed Lens
