## LOMOND BANKS – LVIA VISUAL REPRESENTATIONS FOR PLANNING SUBMISSION

## METHODOLOGY STATEMENT

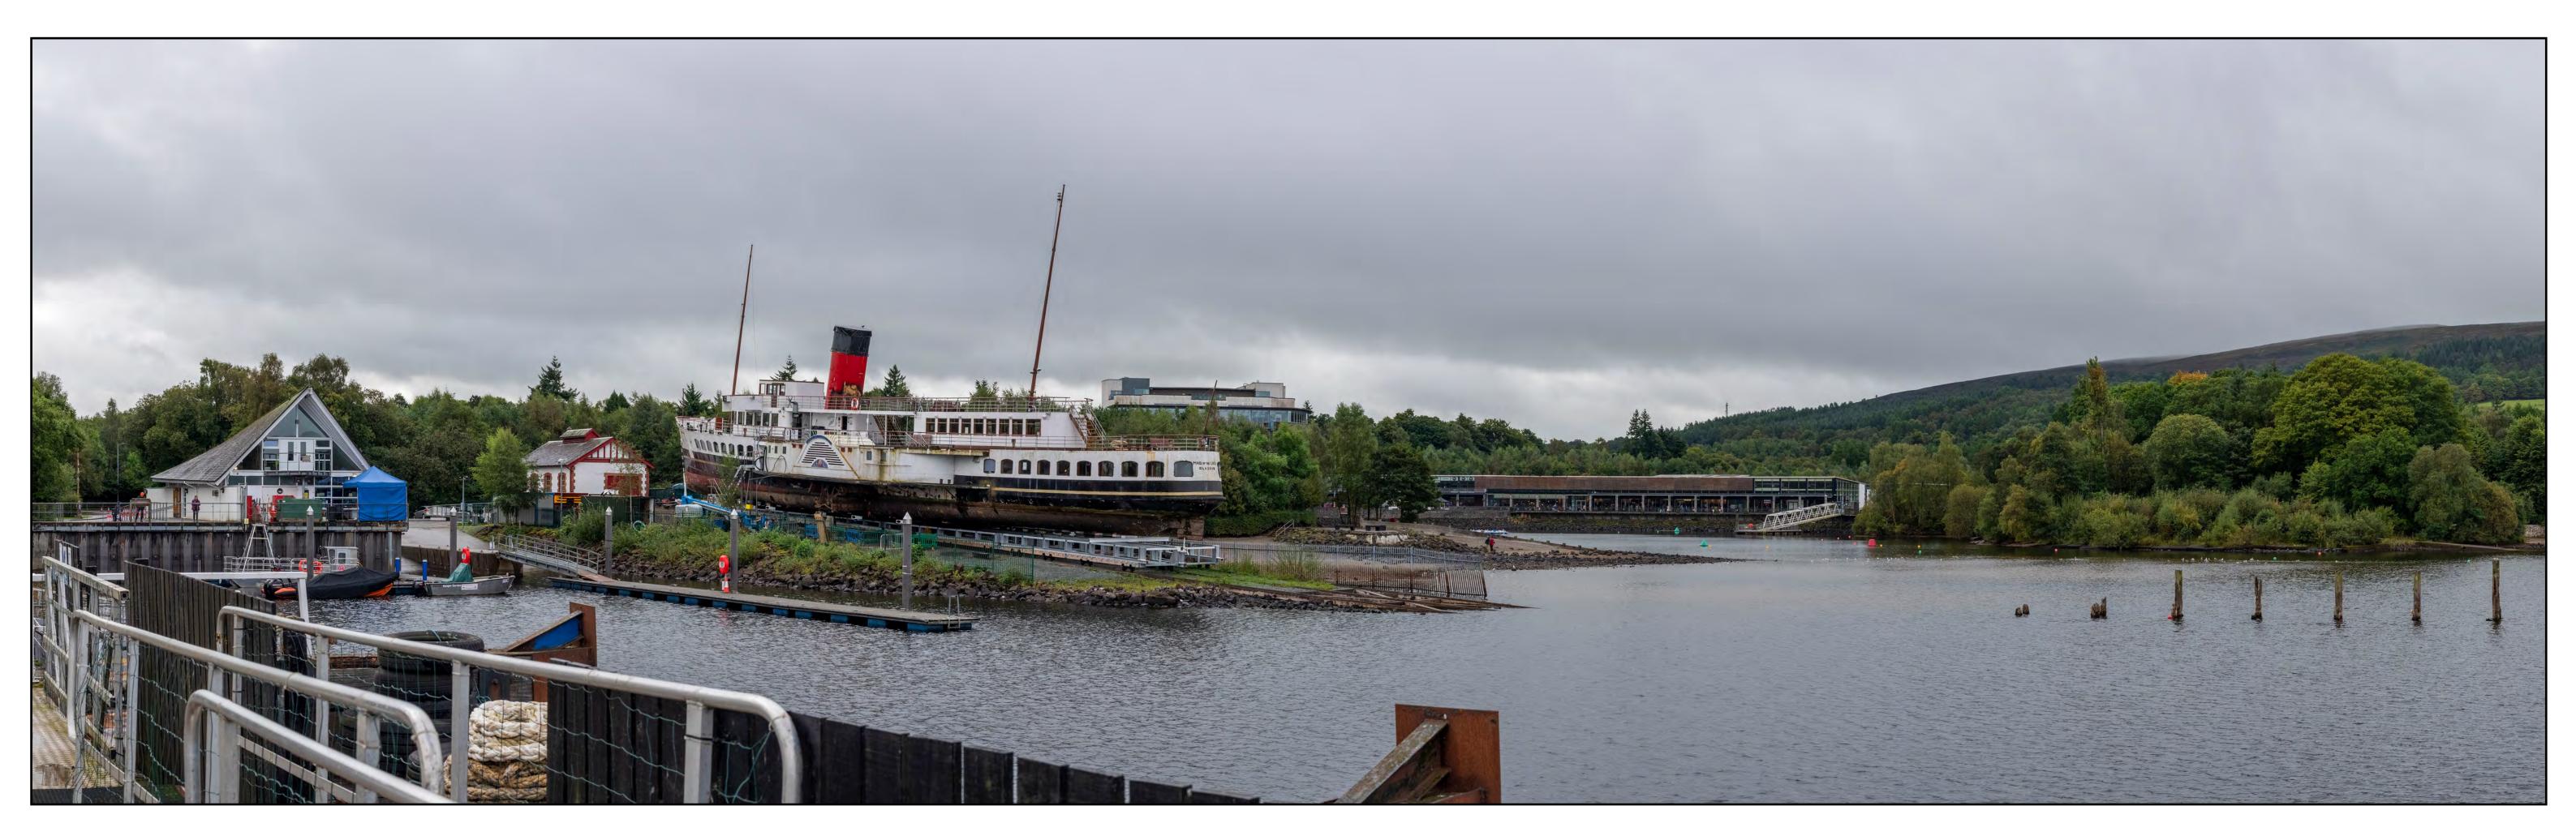
#### PHOTOGRAPH OF EXISTING LANDSCAPE FROM VIEWPOINT – SUMMER (90° FIELD OF VIEW)

Grid Ref: 56.008808, -4.591770; General Direction of View: South-East 149°; Date & Time of Photograph – 24/09/21 @ 11.57; Weather/Visibility – Rain/Poor; Camera – Nikon D810, AF-S NIKKOR 50mm f/1.4G Fixed Lens

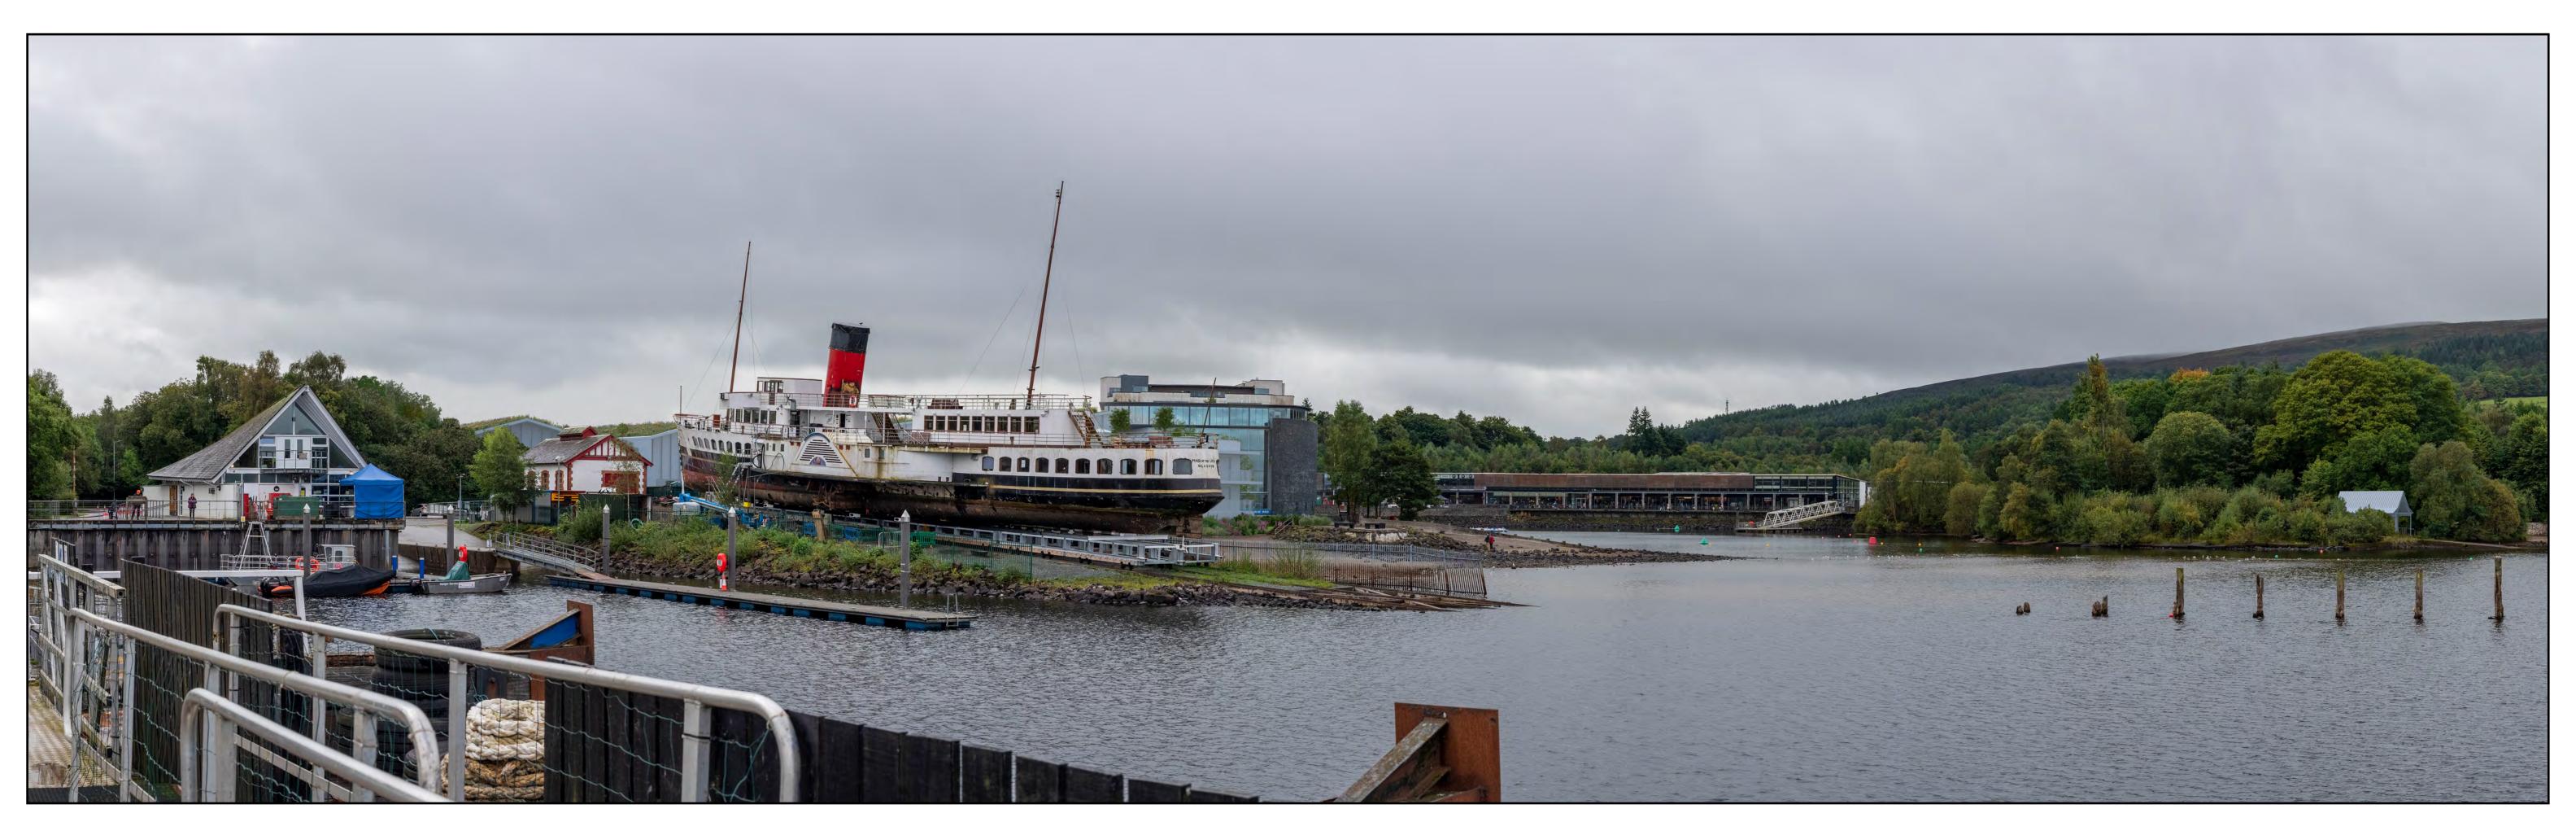
TYPE 3 VISUALISATION – AVR LEVEL 2 – SUMMER (90° FIELD OF VIEW)

Grid Ref: 56.008808, -4.591770; General Direction of View: South-East 149°; Date & Time of Photograph – 24/09/21 @ 11.57; Weather/Visibility – Rain/Poor; Camera – Nikon D810, AF-S NIKKOR 50mm f/1.4G Fixed Lens

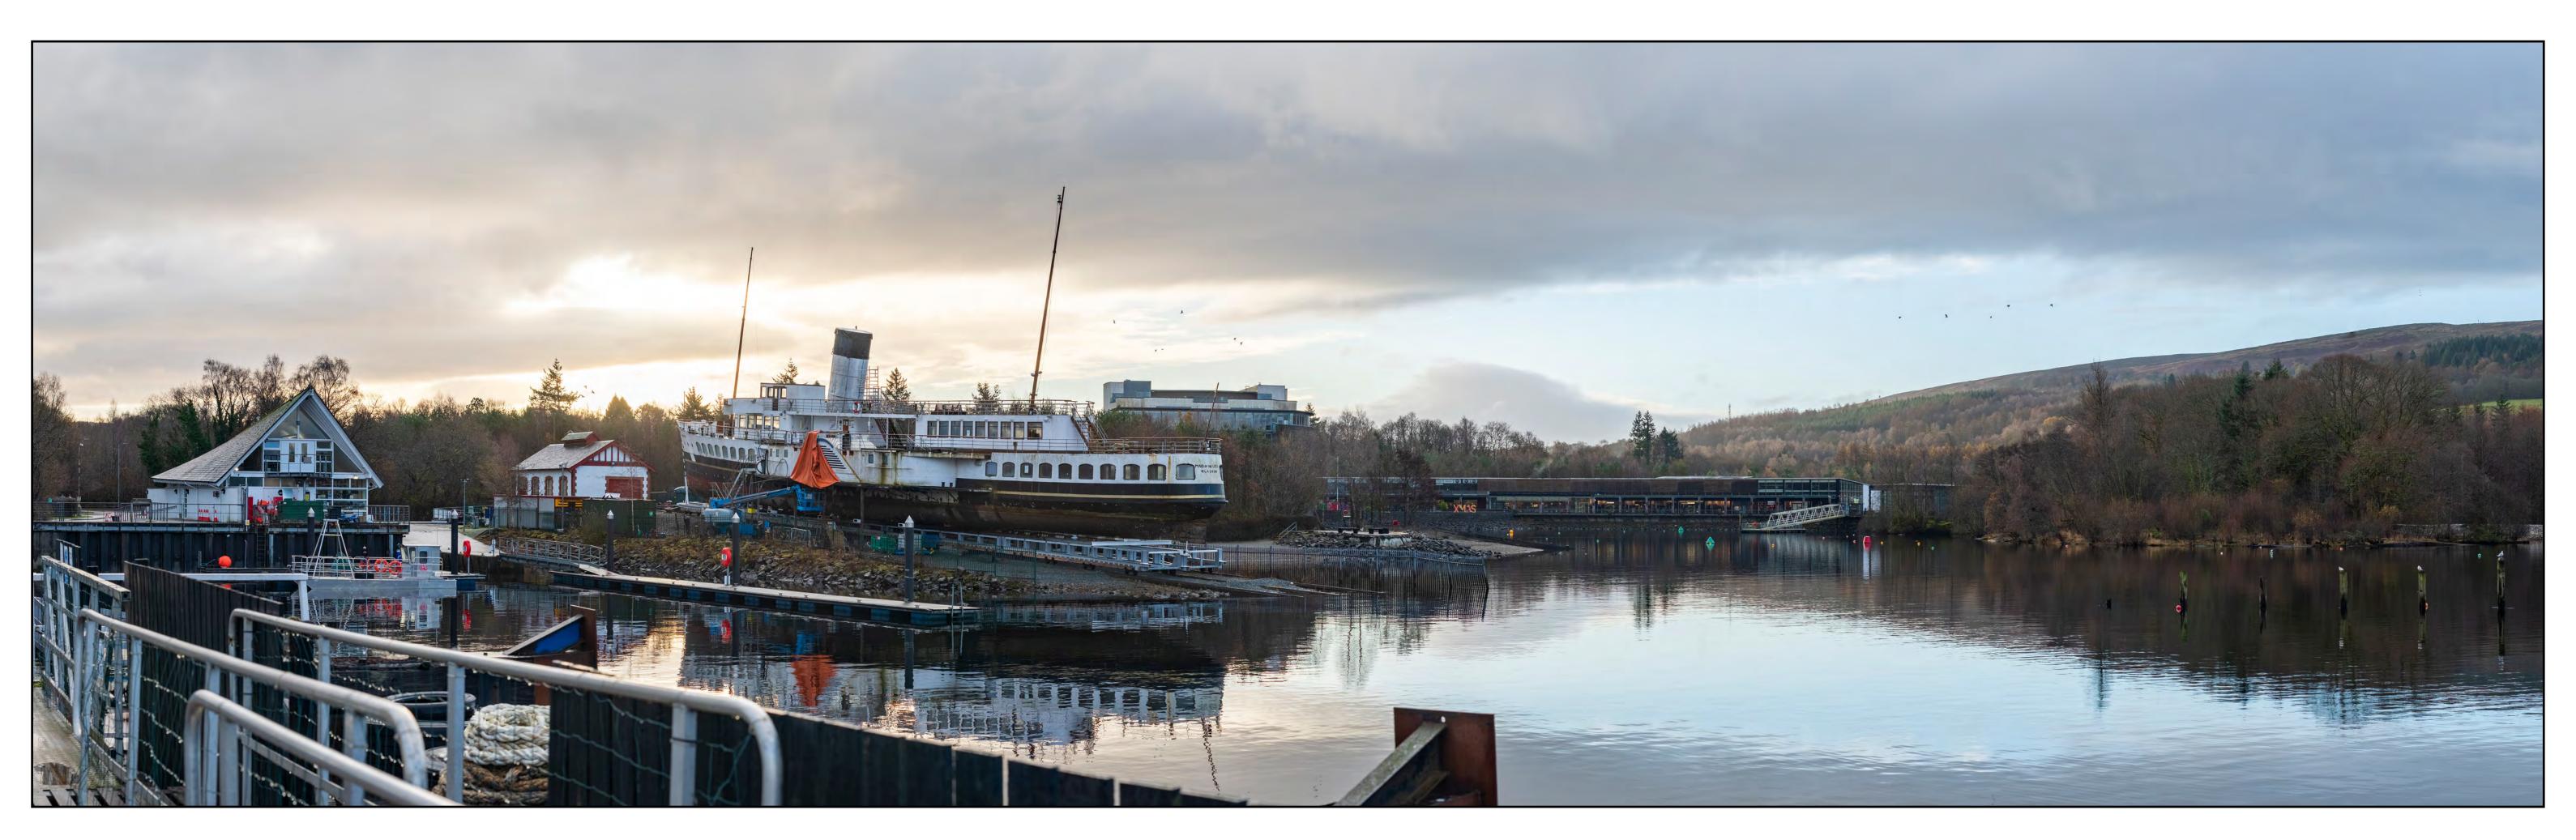
#### PHOTOGRAPH OF EXISTING LANDSCAPE FROM VIEWPOINT – WINTER (90° FIELD OF VIEW)

Grid Ref: 56.008808, -4.591770; General Direction of View: South-East 149°; Date & Time of Photograph – 09/12/21 @ 10.58; Weather/Visibility – Cloudy/Poor; Camera – Nikon D810, AF-S NIKKOR 50mm f/1.4G Fixed Lens

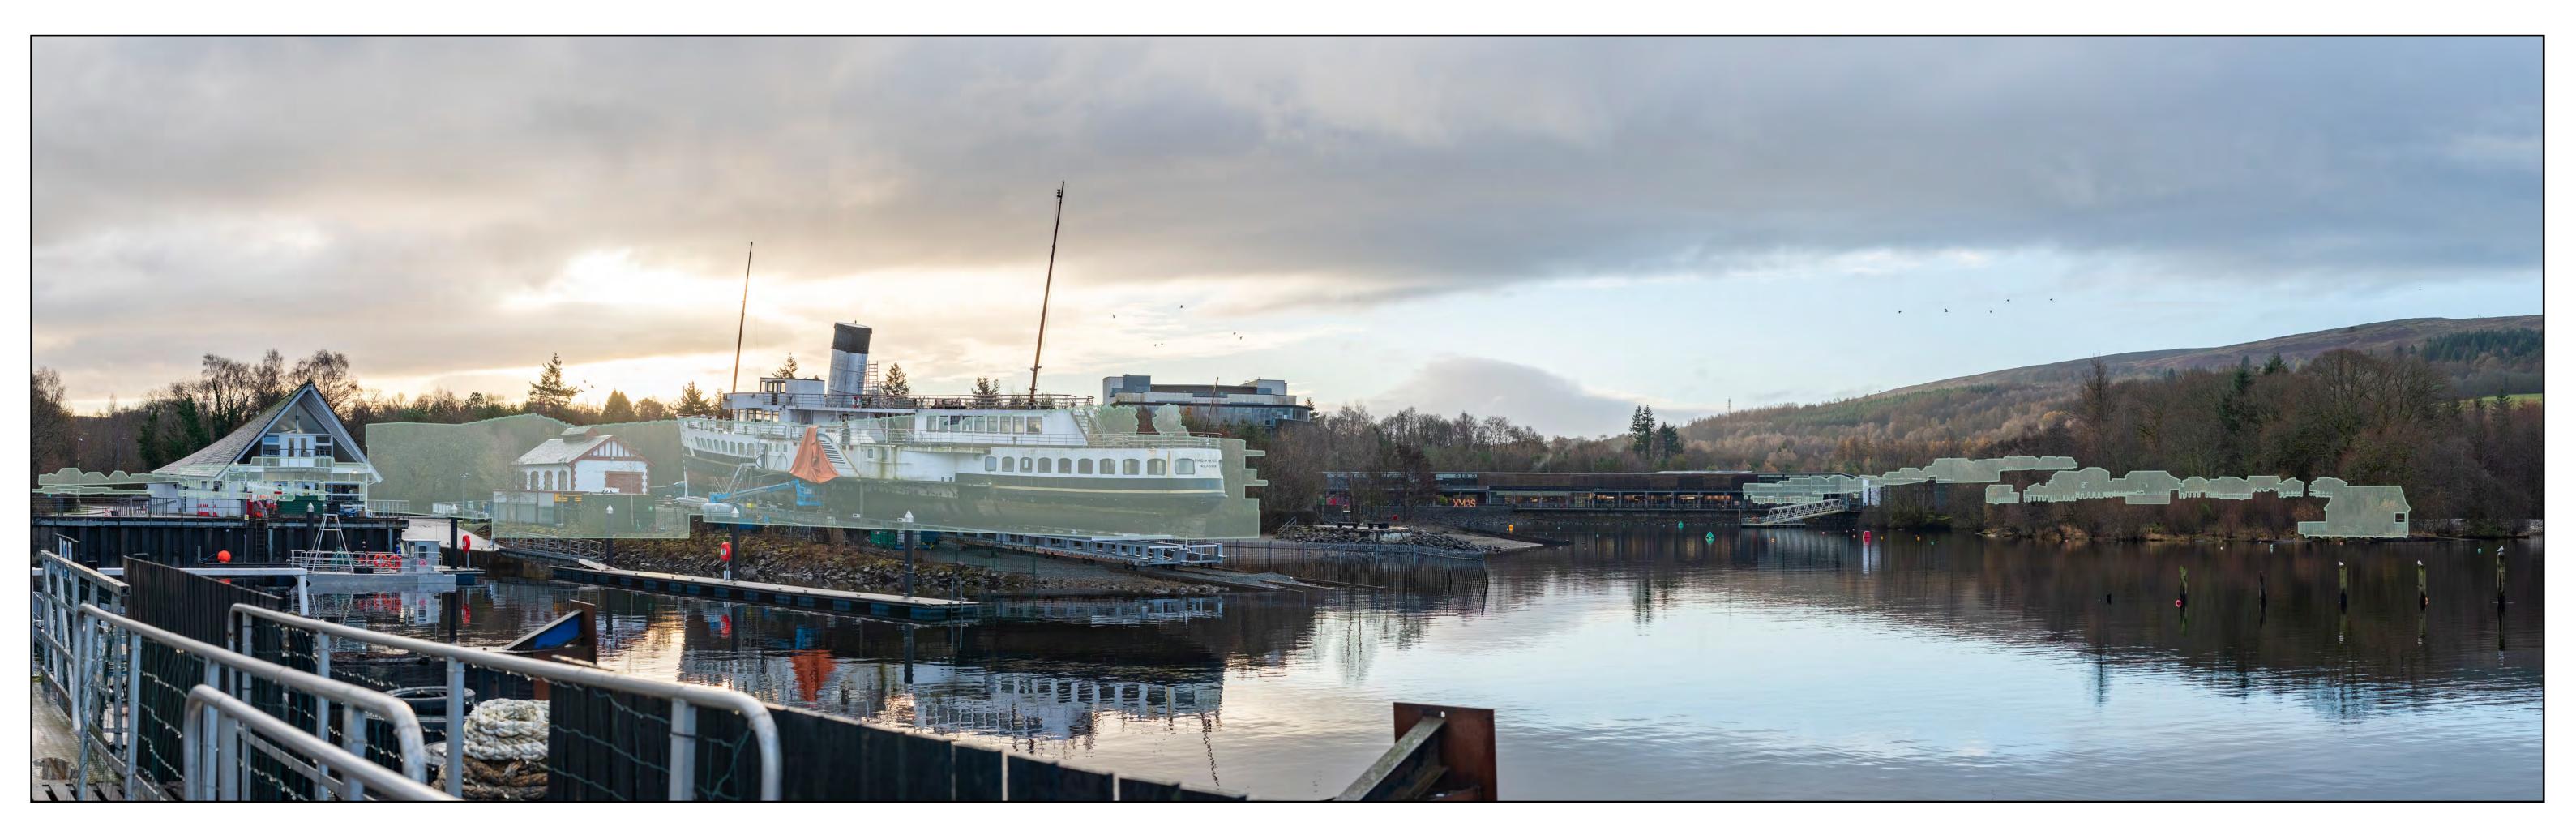
TYPE 3 VISUALISATION – AVR LEVEL O – WINTER (90° FIELD OF VIEW)

Grid Ref: 56.008808, -4.591770; General Direction of View: South-East 149°; Date & Time of Photograph – 09/12/21 @ 10.58; Weather/Visibility – Cloudy/Poor; Camera – Nikon D810, AF-S NIKKOR 50mm f/1.4G Fixed Lens

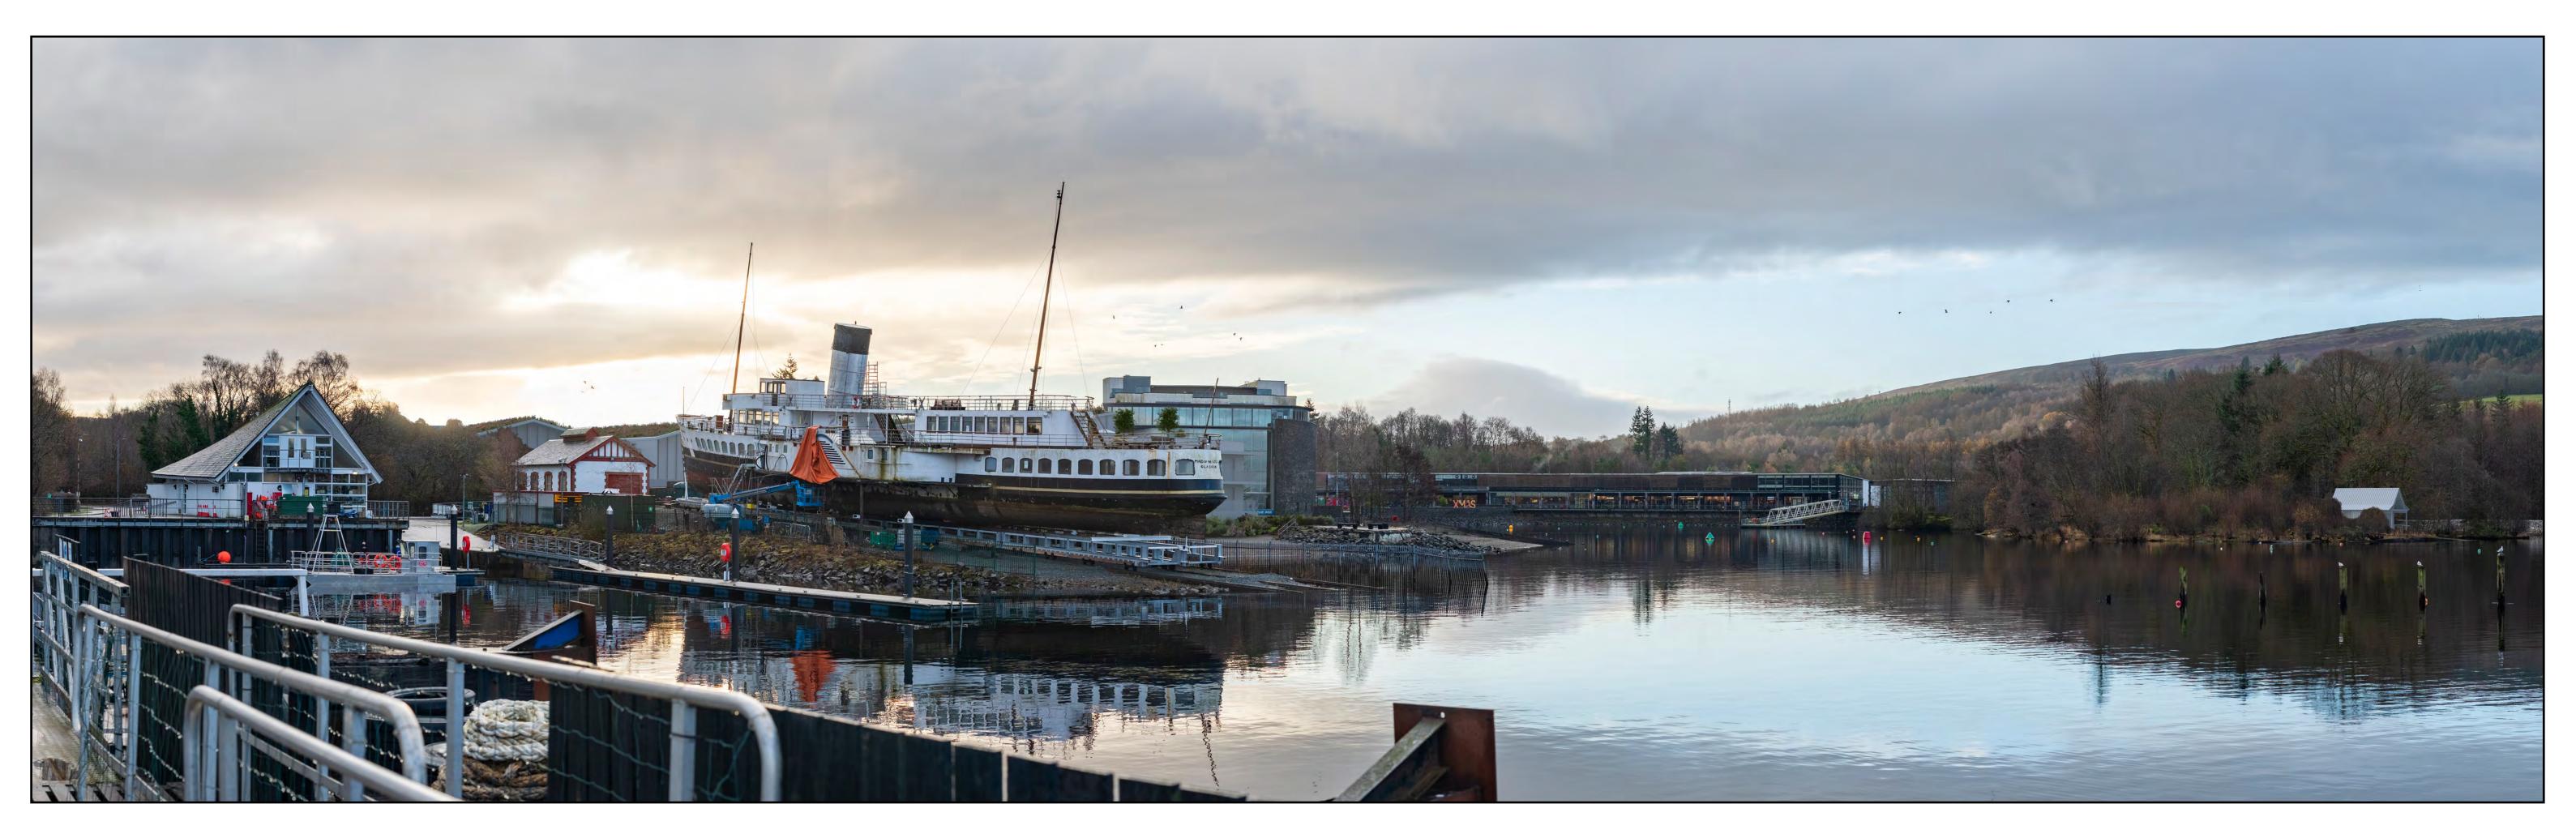
TYPE 3 VISUALISATION – AVR LEVEL 2 – WINTER (90° FIELD OF VIEW)

Grid Ref: 56.008808, -4.591770; General Direction of View: South-East 149°; Date & Time of Photograph – 09/12/21 @ 10.58; Weather/Visibility – Cloudy/Poor; Camera – Nikon D810, AF-S NIKKOR 50mm f/1.4G Fixed Lens

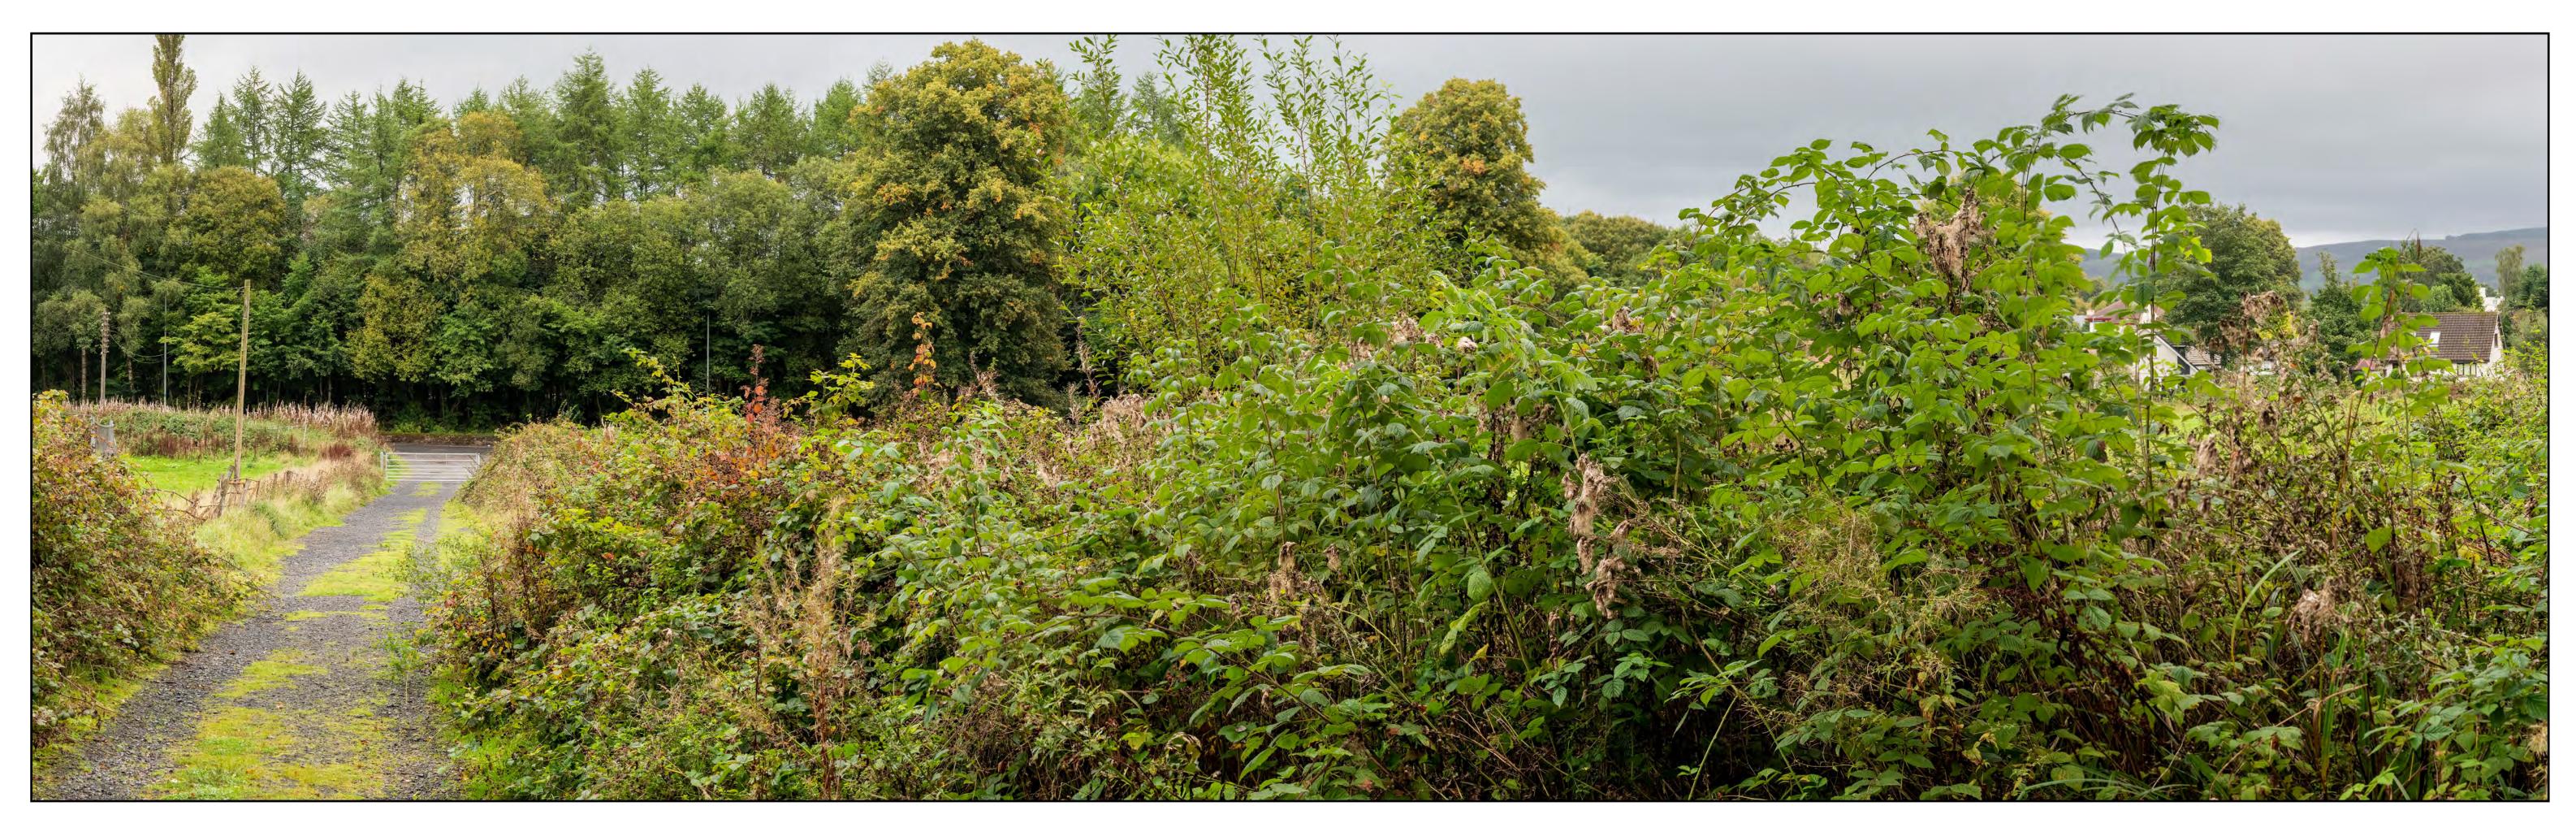
#### PHOTOGRAPH OF EXISTING LANDSCAPE FROM VIEWPOINT – SUMMER (90° FIELD OF VIEW)

Grid Ref: 56.002144, -4.596200; General Direction of View: North-East 40°; Date & Time of Photograph – 23/09/21 @ 17.22; Weather/Visibility – Cloudy/Poor; Camera – Nikon D810, AF-S NIKKOR 50mm f/1.4G Fixed Lens

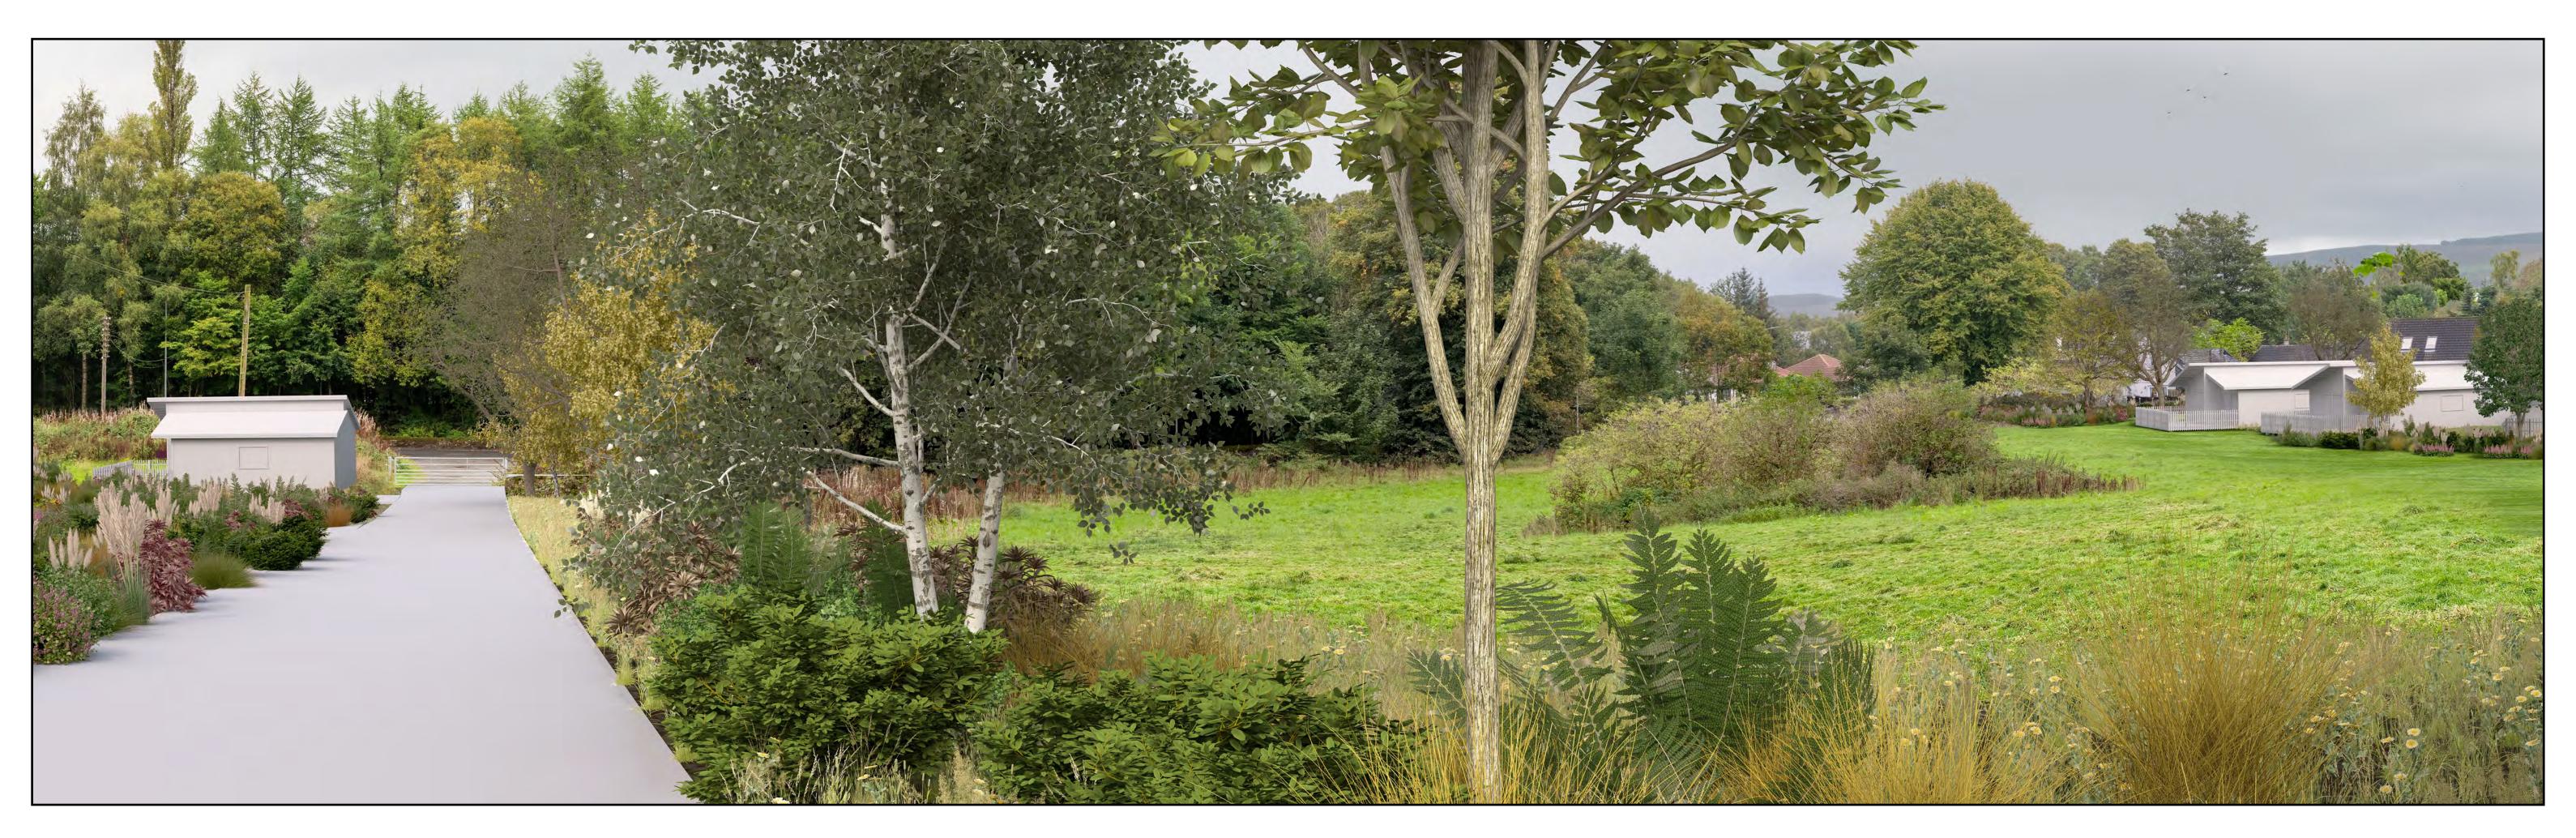
#### TYPE 3 VISUALISATION – AVR LEVEL 2 – SUMMER (90° FIELD OF VIEW)

Grid Ref: 56.002144, -4.596200; General Direction of View: North-East 40°; Date & Time of Photograph – 23/09/21 @ 17.22; Weather/Visibility – Cloudy/Poor; Camera – Nikon D810, AF-S NIKKOR 50mm f/1.4G Fixed Lens

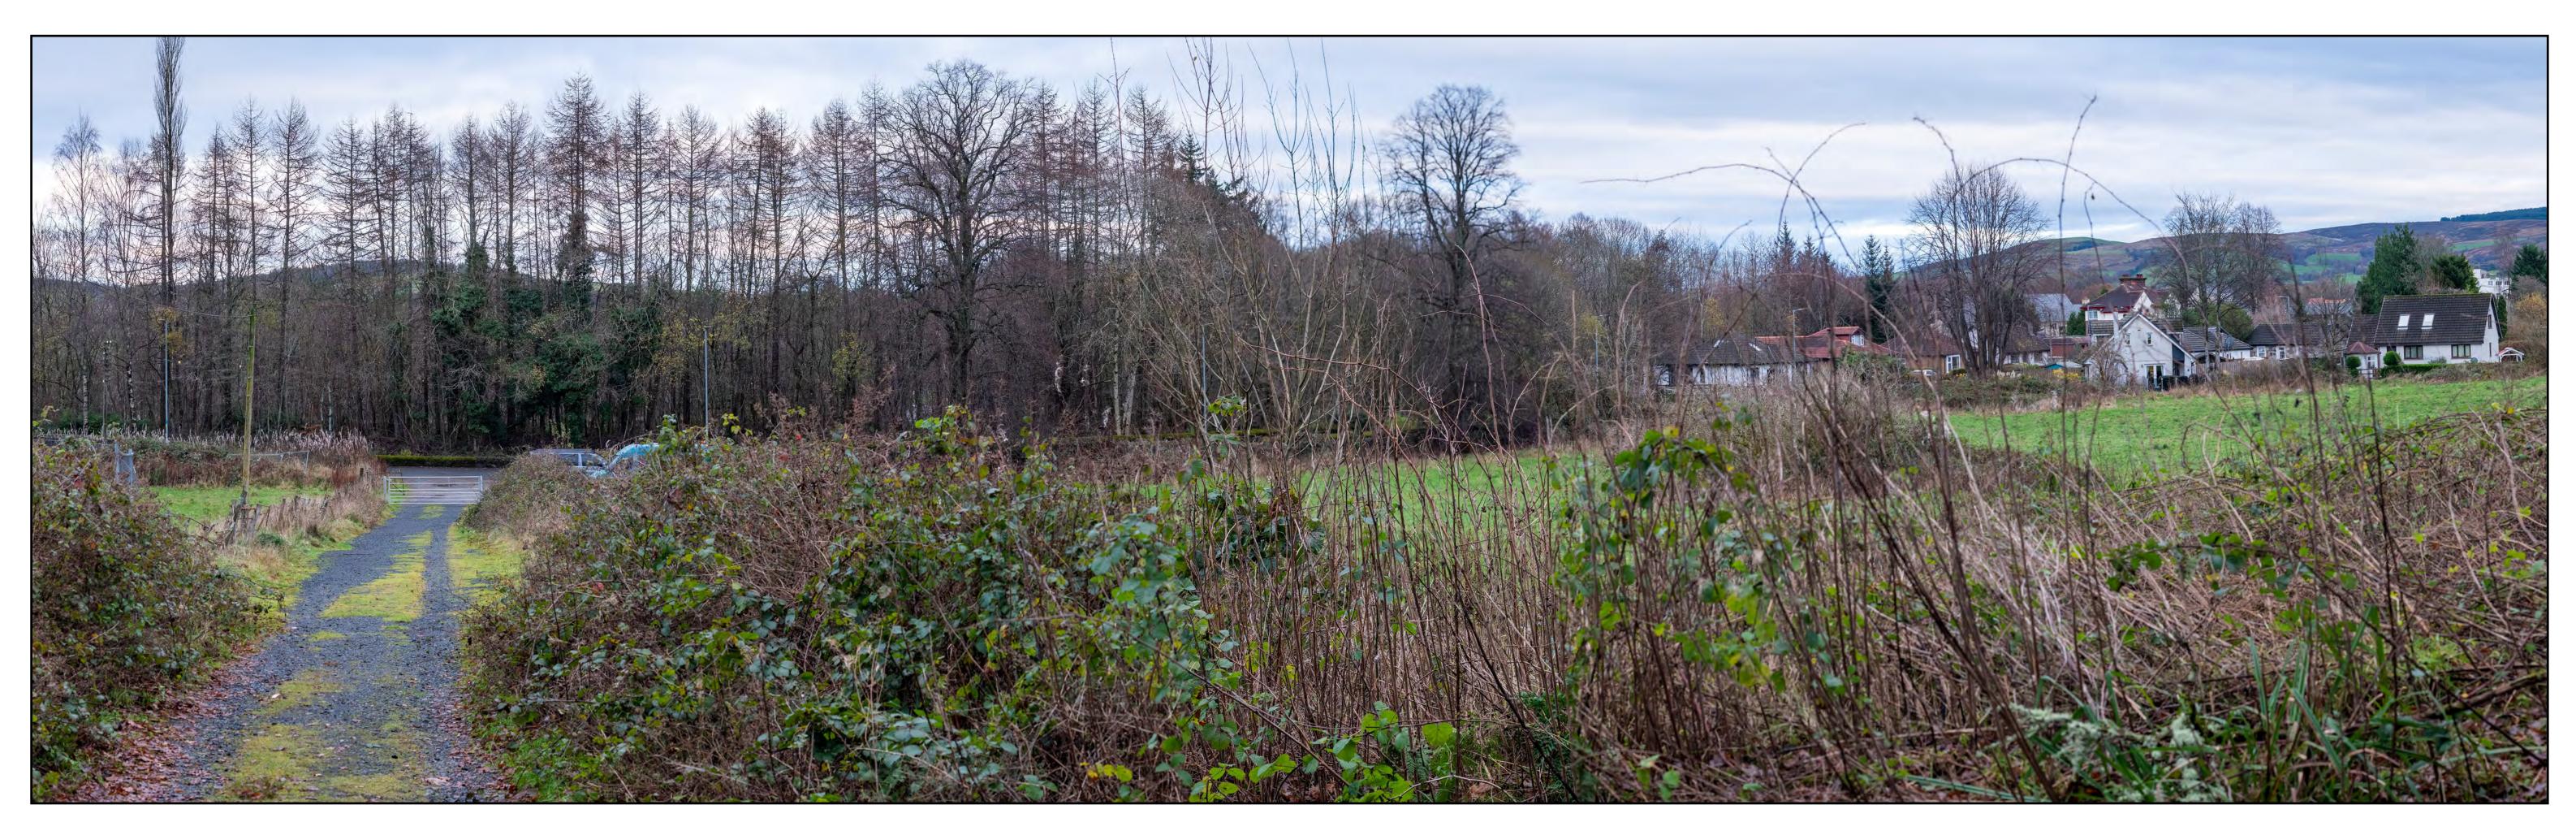
#### PHOTOGRAPH OF EXISTING LANDSCAPE FROM VIEWPOINT – WINTER (90° FIELD OF VIEW)

Grid Ref: 56.002144, -4.596200; General Direction of View: North-East 40°; Date & Time of Photograph – 08/12/21 @ 15.21; Weather/Visibility – Cloudy/Good; Camera – Nikon D810, AF-S NIKKOR 50mm f/1.4G Fixed Lens

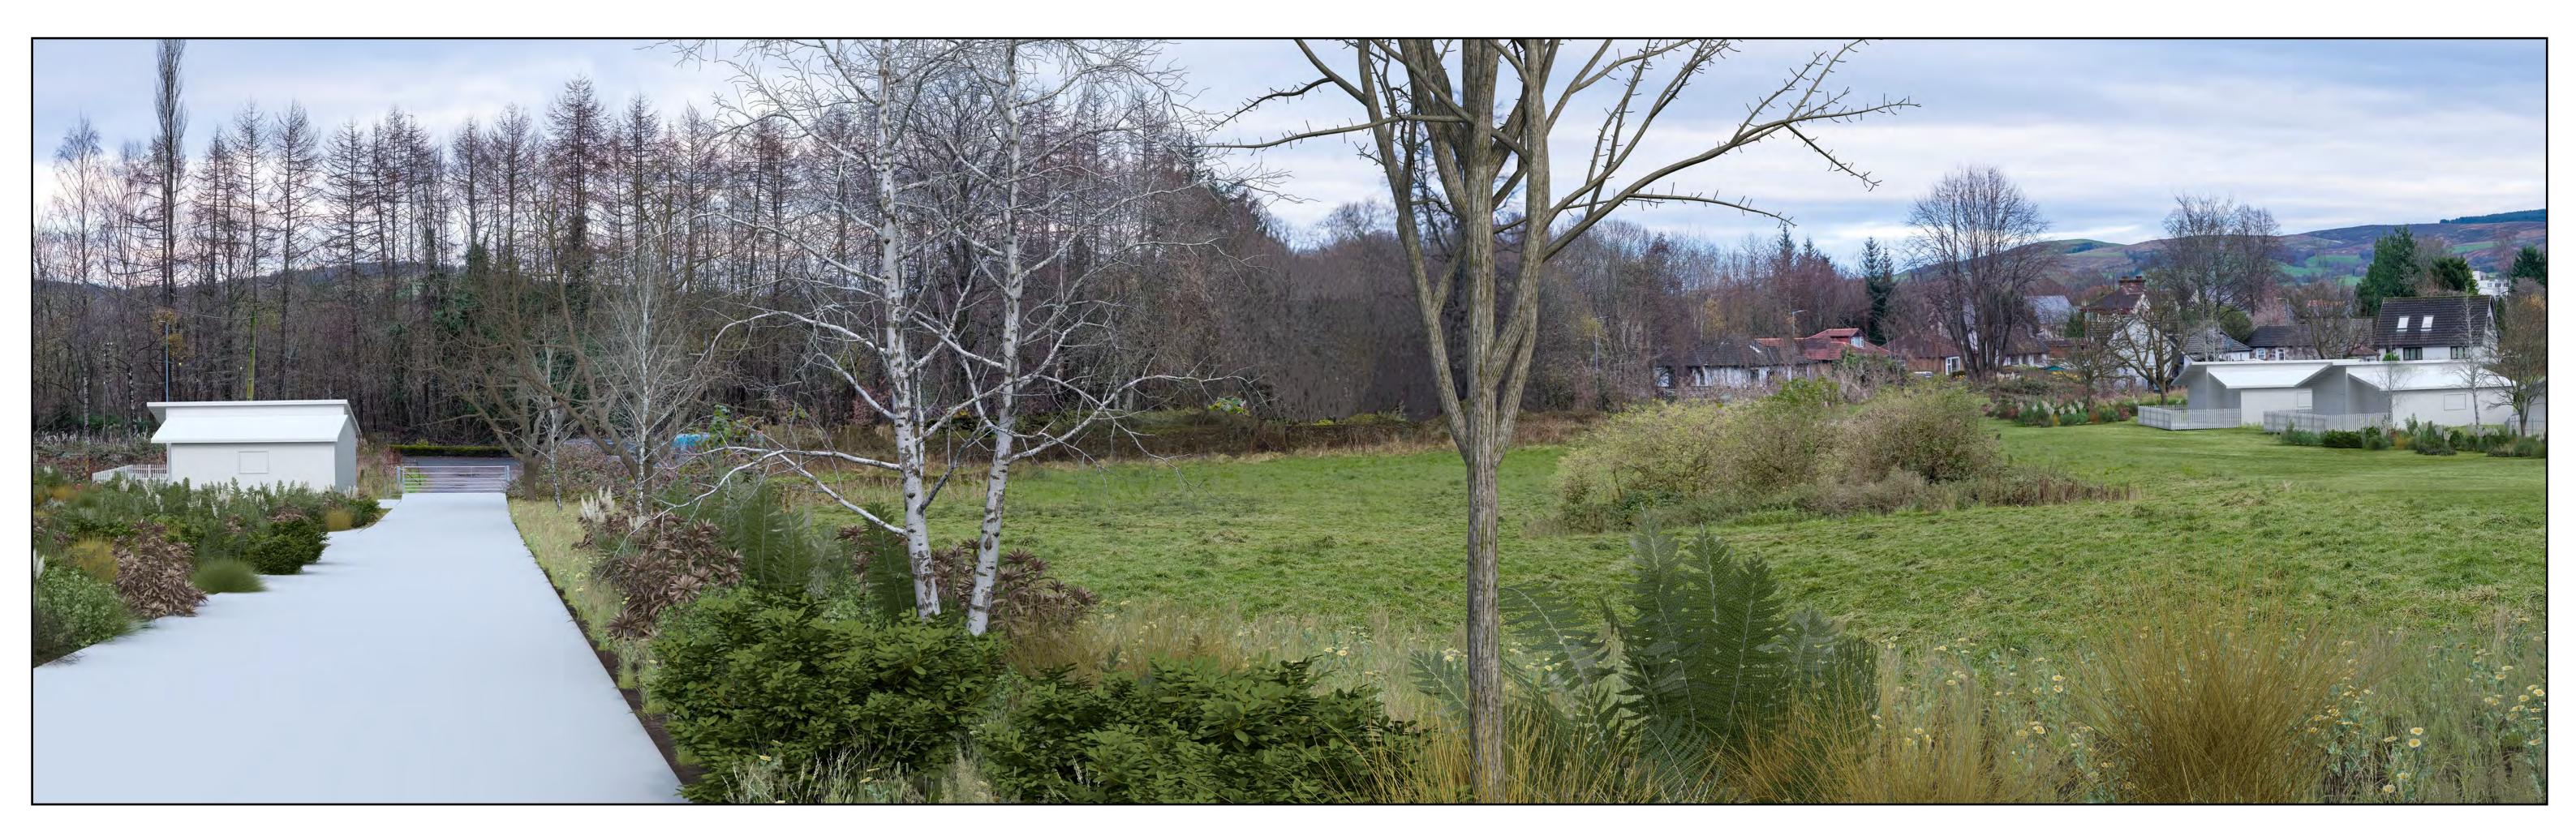
TYPE 3 VISUALISATION – AVR LEVEL 2 – WINTER (90° FIELD OF VIEW)

Grid Ref: 56.002144, -4.596200; General Direction of View: North-East 40°; Date & Time of Photograph – 08/12/21 @ 15.21; Weather/Visibility – Cloudy/Good; Camera – Nikon D810, AF-S NIKKOR 50mm f/1.4G Fixed Lens

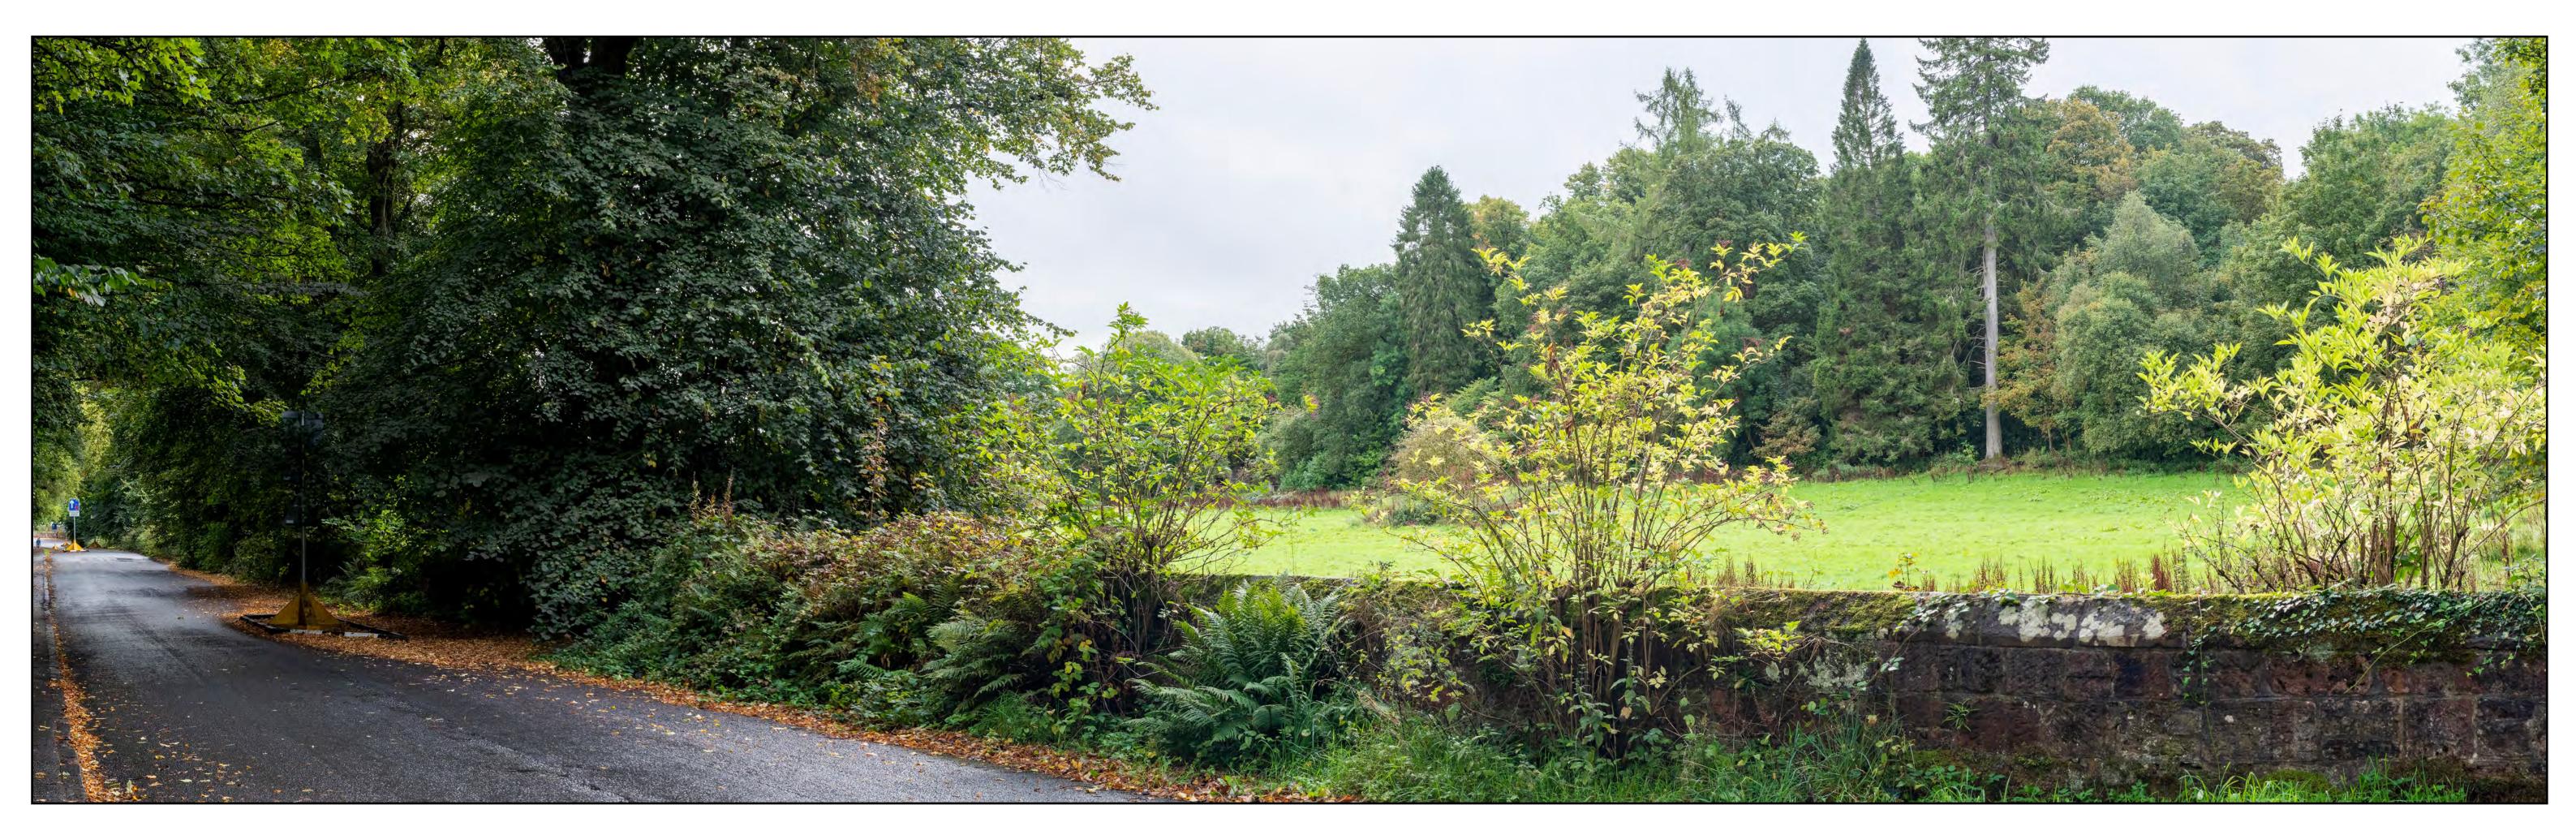
# VIEWPOINT O5: CAMERON HOUSE LODGE, OLD LUSS ROAD (VIEW SOUTH-EAST)

#### PHOTOGRAPH OF EXISTING LANDSCAPE FROM VIEWPOINT – SUMMER (90° FIELD OF VIEW)

Grid Ref: 56.003883, -4.597872; General Direction of View: South 166°; Date & Time of Photograph – 24/09/21 @ 12.40; Weather/Visibility – Overcast/Poor; Camera – Nikon D810, AF-S NIKKOR 50mm f/1.4G Fixed Lens
